CONSERVATION OF CULTURAL PROPERTY IN INDIA

Conservation of M.F.Hussain's Mural- oil painting on canvas – A case study

Akshaye Aggarwal* and Sreekumar Menon**

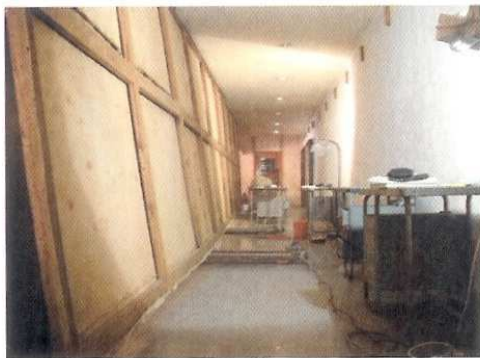
Fig.3. Verso of 'Mural' after removal from the wall. Wooden blocks used for hanging the painting can be seen on top of the wall.

Cleaning of the dust and dirt from the verso of the canvas was carried out by simple dry brushing and simultaneously collecting the loose dust with vacuum cleaner. Then the verso was further cleaned with dry micro glass fibre cloth. Small pin holes were mended with thin nylon cloth using Beva 371® film (Beva 371 dry resin mix: Tala, 330 Morgan Ave, Brooklyn, New York). Verso of the painting was covered with 2 pieces of canvas stitched together to

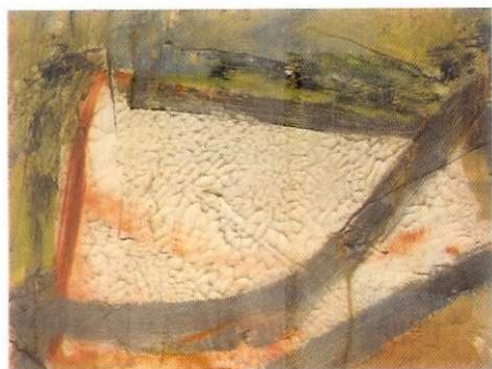
Major portion of the paint layer was in bad condition with excessive amount of flaking and unstable cracks visible in the white paint layer at the centre left, centre right portion and top left portion. Flaking and considerable amount of paint loss were also visible in the blue and green areas, at the top left, top right and bottom left portion of the canvas. Major losses in the paint layer were visible in the joints of the canvas, at the center right portion and along the stitched area at the centre of the canvas. There was fungus infection in some areas of paint layer with major deposition found at the bottom center image of an elephant and present all over the yellow color. Past restoration efforts in the form of retouching of the lost paint layer were also visible. Support and auxiliary support of the painting were in good condition except for some small pin holes in the canvas and accumulation of dust, dirt and cobwebs, Figures 4-5.

Fig.4. Delamination and loss of paint layer (detail)

Consolidation of the paint layer had to be carried out with painting in standing condition. Since paint layer was thick and area of flaking was major, there was a requirement of a stronger adhesive that could be applied in vertical condition. Beva 371 gel was found to be ideal for the purpose due to its adhesive strength, its property of consolidation by re-activation and other tested properties like high durability and compatibility for oil paintings on canvas. Prepared Beva 371 gel was applied with a temperature of about 60°C in the areas of delamination of paint layer using fine brushes and allowed to cool down. After that the adhesive is reactivated with heat there by settling the delaminating paint layer and adhering it to the support. Dust and dirt deposit in the paint layer was removed by dry brushing. It was then decided to get the painting down from the wall so as to have a clear picture of the condition of the verso of the painting. Padding was given on the four trolleys that were to be utilized to move the painting and to the projection on the opposite wall to provide cushioning to the painting when painting would be resting on it after removal from the wall. Figures 6-7.

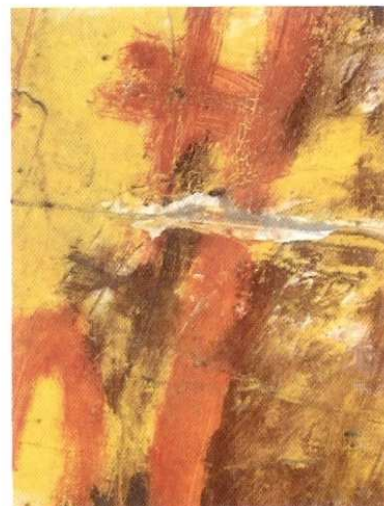
Fig.5. Loss of paint layer along the joints of canvas (detail)

Superficial cleaning of dust and dirt deposit in the paint layer was then carried out with ethanol water mixture (40 ml ethanol and 60 ml water). Excess Beva wherever present over the paint layer was removed using acetone. Areas of loss in the paint layer was filled with a putty of French chalk & kaolin putty (1:1) using dilute PVAc emulsion (Fevicol-SH®) in water. Final inpainting of losses was carried out with Schmincke® pigments(figures 8-11).The small panels could be removed easily and similar conservation treatments imparted and panels were fixed back to the wall.

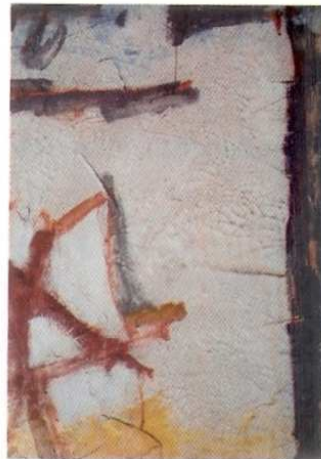
Fig.8. Major Delamination of paint layer – Before Conservation (Detail)

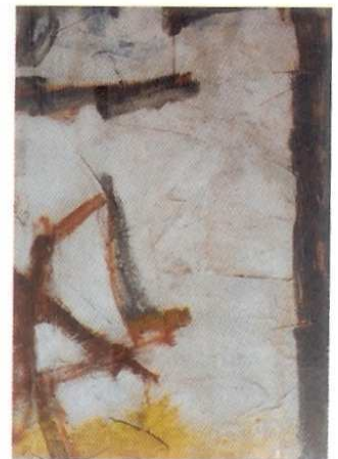
Fig.9. Area of Delamination of paint layer – During Conservation (Detail)

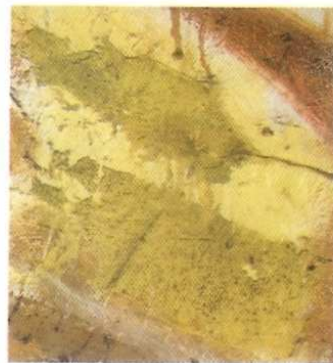
Fig.10. Fungus deposition on paint layer - Before Conservation (Detail)

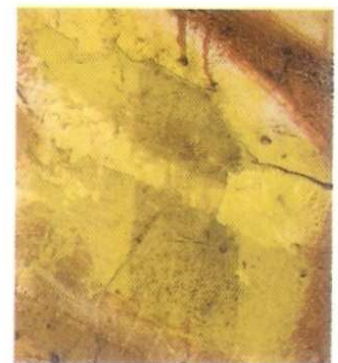
Fig.11. Area of fungus deposition on paint layer During Conservation (Detail)
