# Performance-Based Evaluation of Historical Structures

## IV. CASE STUDY: ERZURUM CLOCK TOWER

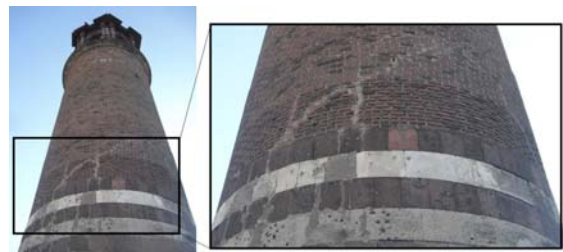
Many historical structures in Erzurum have had some damages and the risk of being razed due to their structural defects over the time. The clock tower, especially, has been substantially deformed and lost its structural integrity and stability. The main problems on the structure are the damage on the structural elements, the loss of material, and the decrease in the structural strength. The mortar on one of the facades of the piers has been partly demolished and many irregular micro cracks have been observed on the tower.

The tower was constructed with rectangular cut-stone blocks, handmade bricks and mortars. During the life of the tower, construction materials have been deteriorated and have lost their qualities due to many reasons such as environmental conditions and earth disasters. These have caused irreversible negative effects on the tower. Observed structural failures have been generally occurred due to the material degradations which have been localized above the tower base and on the tower body facade (Fig. 6). Some damages have occurred especially on the tower body as cracks and the separation of the bricks. Various separations have also been appeared between the stones and bricks. In addition, the tower has been damaged several times due to the natural disasters or human interventions over the past few decades. Therefore, it

The deteriorations of the structural elements and the decay of the structural materials have caused damage on the structural elements at the internal sections. Spalling and flaking have been also visible to the eye in the internal walls. Moreover, structural cracks and fractures have been observed at the internal facades and they are repaired non-technically. All observed damages are considered to be very dangerous for the tower since they may cause destructive crashes and fractures. Therefore, these damages should be considered seriously and some precautions should be taken to avoid or to abate their effects.

Fig. 6. Material degradation and macro cracks

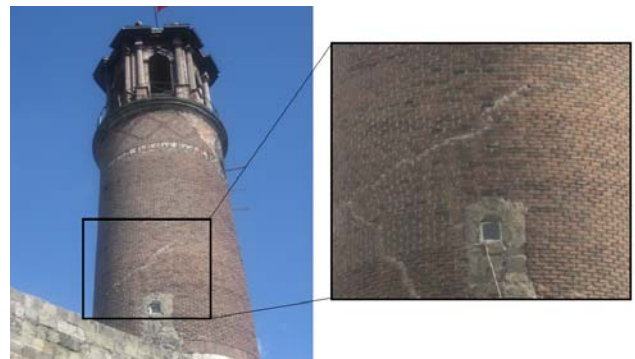
has not been technically repaired, but has been renovated several times by using different materials such as stones and mortar. However, these unconscious repairs have caused more damages to the structure (Fig. 7). The binding material between the masonry units is partially eroded. These abrasions may have caused the structural resistance to get weaker. In some cases, abrasion and degradations are also observed in the stone units of the tower base.

Fig. 7. Unconscious repairs on the tower body

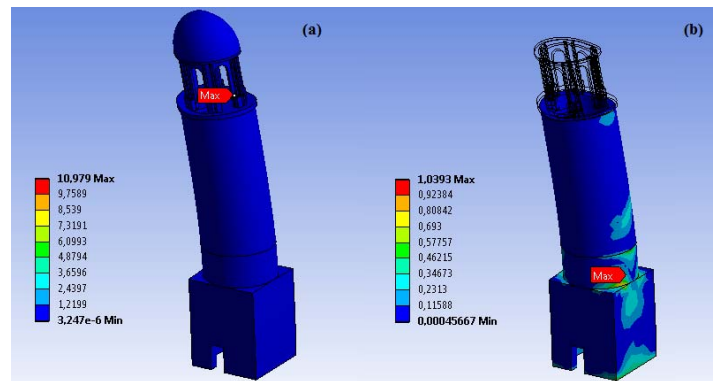
Response spectrum analysis for the tower has been carried out to investigate the behavior of the structure. The maximum normal stress was found to be 10.98 MPa around the cupola of the tower (Fig. 11a), whereas the normal stress was about 1.04 MPa around the transection zone between the tower base and tower body (Fig. 11b). The maximum lateral displacement was observed at the top of the tower about 46.855 mm corresponding to %0.16 drift ratio (Fig. 12). Table 1 indicates that at this drift ratio level, the tower is expected to have a structural response between immediate occupancy and life safety.

Fig. 11. Normal stresses (MPa) under EQ3 (a) Cupola, (b) Tower Body

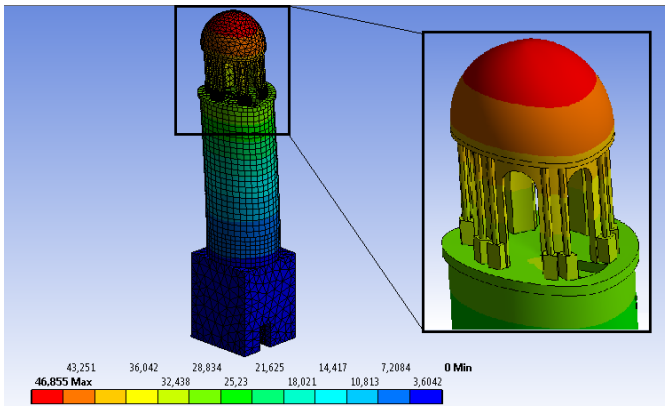
Fig. 12. Deformed shape and maximum displacement (mm) under EQ3
