Original scientific paper

Root cause analysis of the corrosion-related coiled tubing failure

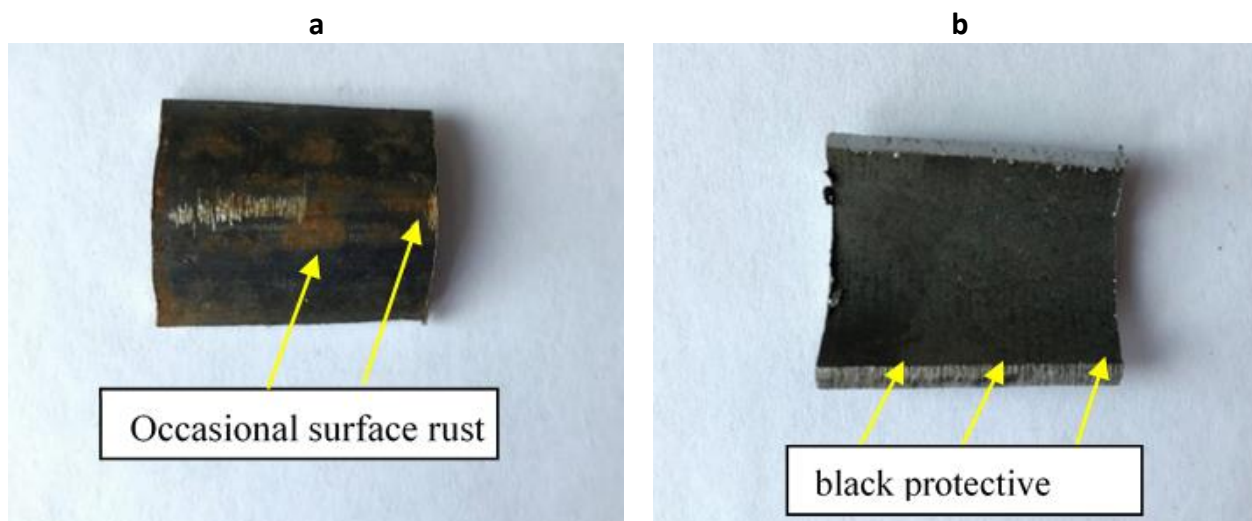
Visual examination of a new CT sample revealed no corrosion damage to the tubing, as shown in Figure 1. A uniform black coating, visually consistent with the corrosion protection applied by the CT manufacturer, was visible on both sides of the CT wall. In addition, surface rust is visible on the exterior wall of CT (Figure 1a) where the black coating is likely mechanically damaged. No rust was observed on the interior wall of CT (Figure 1b). The black coating was not damaged because the interior wall is protected from mechanical impact.

Figure 1. New coiled tubing: **a** - outer surface and **b** - inner surface

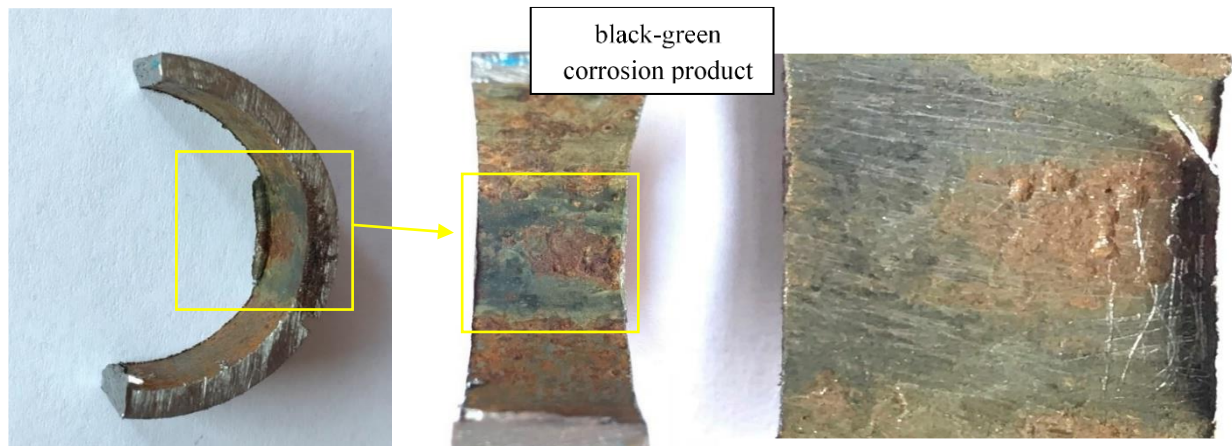
The used CT sample from the well had a metallic appearance on the outside with no visible corrosion products. On the inside, the sample was covered by a layer of brown corrosion products (Figure 2). A black-green corrosion product streak was observed longitudinally across approximately 20 % of the inner diameter.

Figure 2. Black-green corrosion product streak on a coiled tubing sample from the well

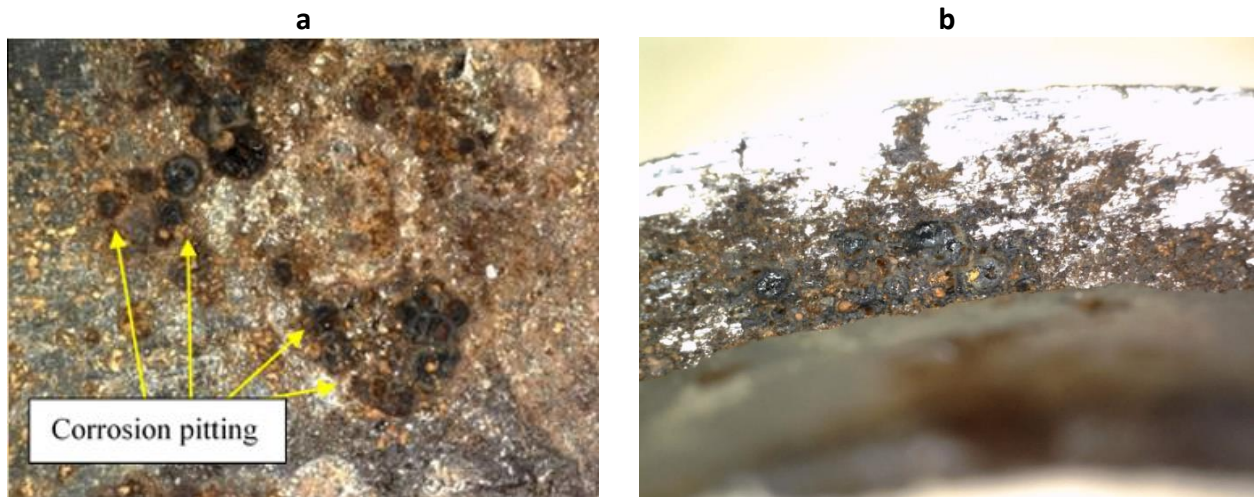
Figure 3 shows the corrosion pits and Figure 4a shows the cracks, both of which occur only within a black-green area. One of the cracks observed on the inside protruded through the wall of CT and was visible on the outside surface, as shown in Figure 4b.

Figure 3. Corrosion pits on the inner wall of the coiled tubing

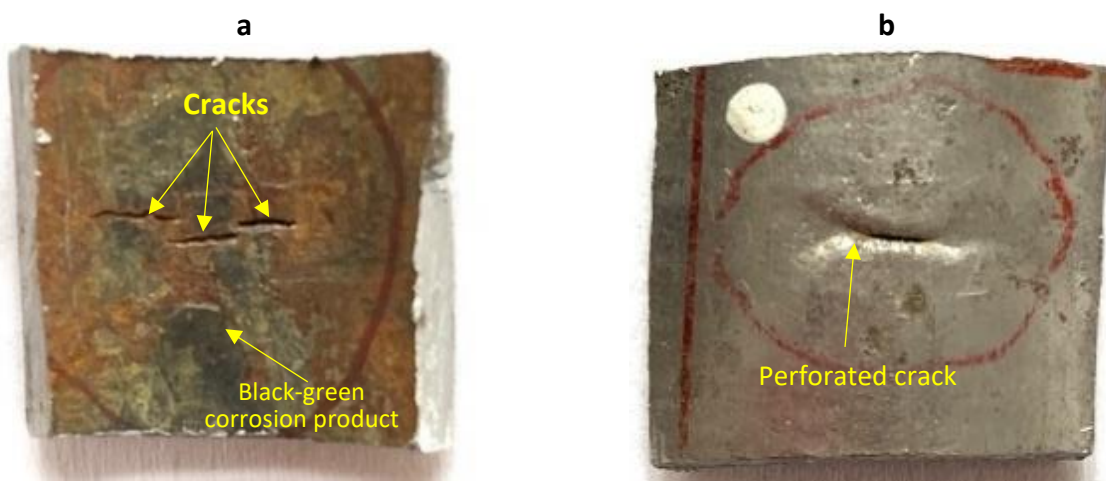
Figure 4. Cracks on **a** - the inner surface and **b** - the outer surface

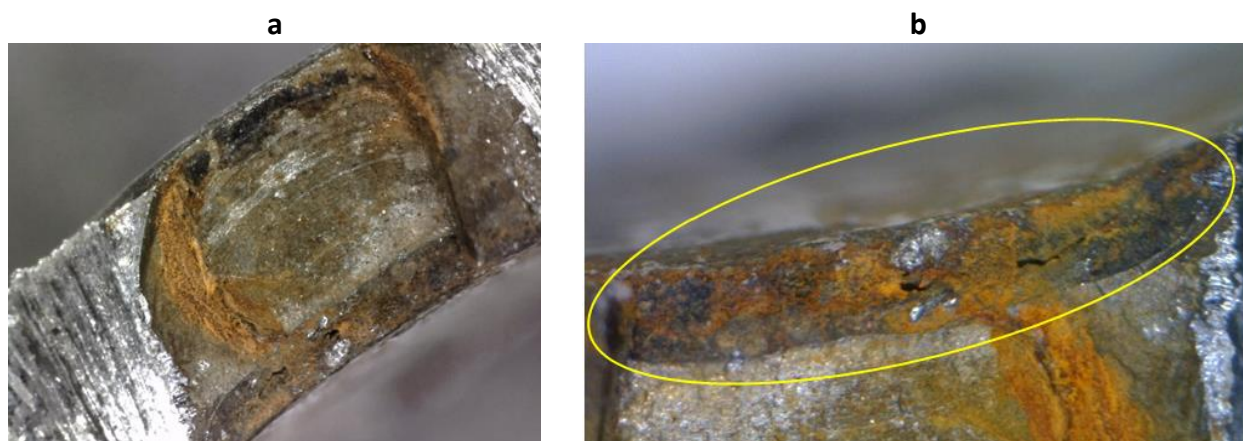
For close observation and examination, the sample was cut open to expose the fracture surface (Figure 5a). The edge of the corrosion damage in Figure 5b is the source of the striation marks and therefore likely served as the fracture origin. In the central part of the wall, a large area of striation marks perpendicular to the fracture direction was observed. The striations represent the propagation front of the fatigue crack and indicate that the fracture was caused by material fatigue. The Y-shaped crack ends shown in Figure 4b, also support the fatigue hypothesis. In addition, ridges have formed along the inner edge of the fracture parallel to the direction of fracture propagation, which can be

attributed to micro-cracking outside the central fracture plane. Terraces (stepped structures) are formed along the edges of the fracture, which are due to the initial development of the fracture in different planes.

The uniformity of striations indicates the homogeneity of the metallurgical structure of the material. The spacing between the striations usually gives information about the growth rate of the cracks ($\mu\text{m}/\text{cycle}$).

Figure 5. Light microscope photographs of **a** - fracture surface and **b** - fracture initiation site

The number of striations is greater than the number of tube straightening and bending cycles, which may indicate a corrosion-related fatigue fracture. As the tip region of the fracture is repeatedly covered with a layer of corrosion products, the growth of the striation mark slows down. It can be argued that the numerous striation marks are due to the acceleration and deceleration of the growth of a fracture during each cycle. Becker and Lampman [12] reported that under many loading conditions, the pre-existing macroscopic crack-like defect blunts with increasing load and a new crack form by ductile tearing, creating a striation zone. Consequently, continued increase in loading causes the crack propagation mechanism to change to cleavage or quasi-cleavage.

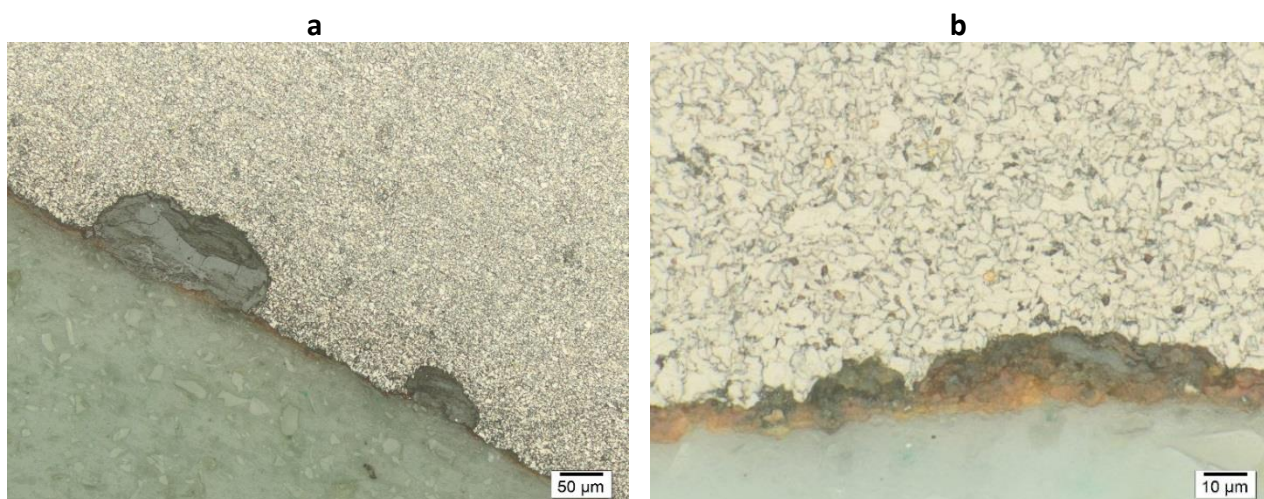
The internal surface shown in Figure 3a was examined under a metallographic microscope (Figure 6) and the corrosion pits contained a black corrosion product. Brown-orange corrosion product was seen above the black one on the surface of the shallower defects. The appearance of the corrosion damage suggests atmospheric corrosion of the steel with unobstructed oxygen flow outside the pit and a de-aerated space at the bottom of the pit. The corrosion, more pronounced on the inner diameter, is in good agreement with Still and Rolovic [13].

Figure 6. The corroded inner surface at different zones

- To prevent storage corrosion, it is necessary to properly maintain the tubing between acidizing operations by the following procedures:
 - nitrogen purging, preferably using a polyurethane ball to expel electrolytes from the tubing and subsequent capping the tubing ends,

- application of vapor phase corrosion inhibitors.

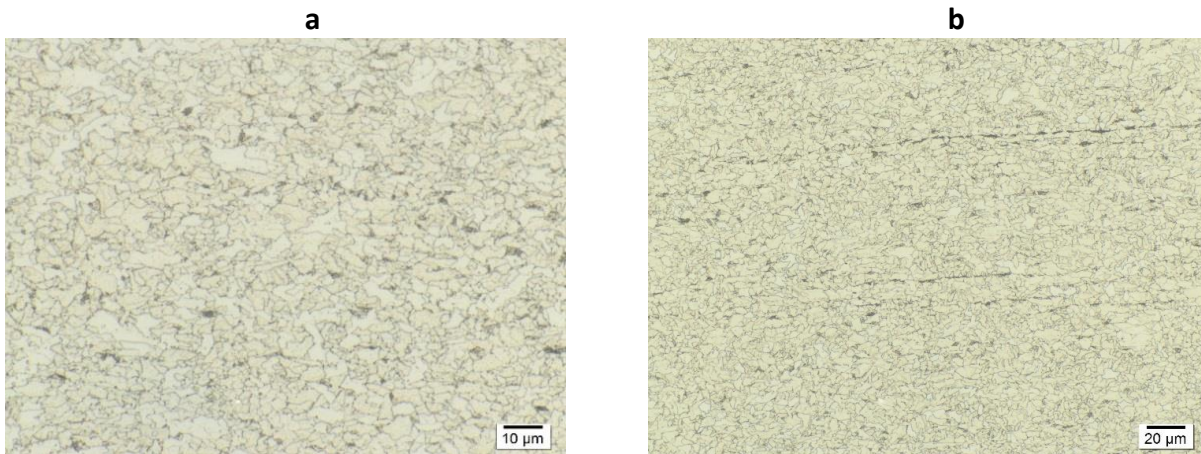
The polished and etched used CT had a fine-grained microstructure (ASTM sizes 13 to 14) with evenly distributed areas of ferrite and pearlite and some bainite, as shown in Figure 7a. Short banded structures of pearlite are observed in some places in the centre of the wall section (Figure 7b). No cracks are visible on the metallographic samples.

Figure 7. Fine-grained structure of quasi-polygonal ferrite with uniformly distributed areas of pearlite and bainite

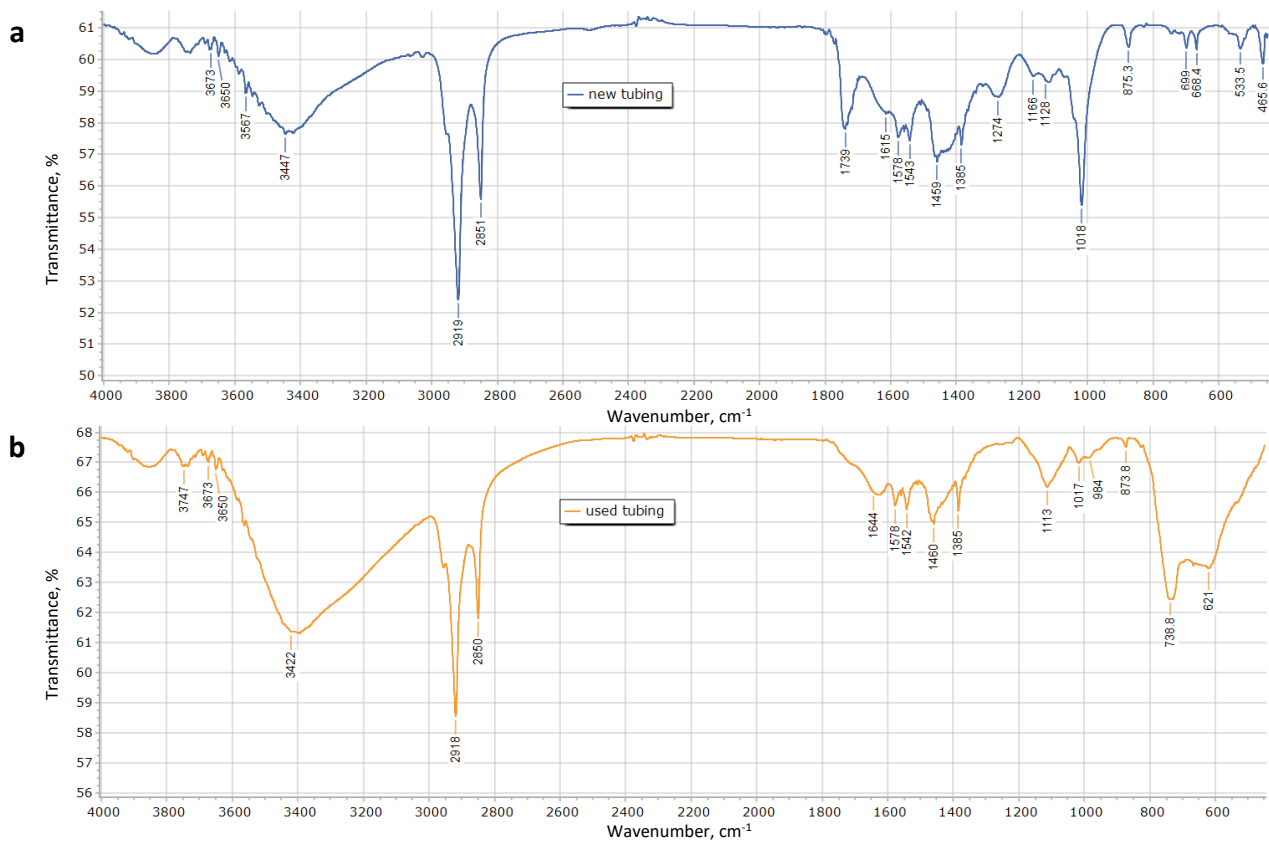
The layers on the inner surfaces of the new and used CT samples were rubbed with KBr, which was later pressed into pellets for FTIR analysis. The FTIR spectrum of the new CT sample, Figure 8a, shows no clear bands of iron oxides, confirming the absence of corrosion on the inner diameter of the new CT sample. The observed bands indicate the presence of an organic corrosion inhibitor used by the manufacturer of the CT. The FTIR spectrum of the used sample CT is shown in Figure 8b and indicates the presence of antimony oxide. Antimony salts were used as a component of the acidizing corrosion inhibitor and the inner surface of CT is partially covered with deposited metallic antimony, which oxidizes to antimony oxide when exposed to air.

Figure 8. FTIR spectra for **a** - new tubing and **b** - used tubing from the well

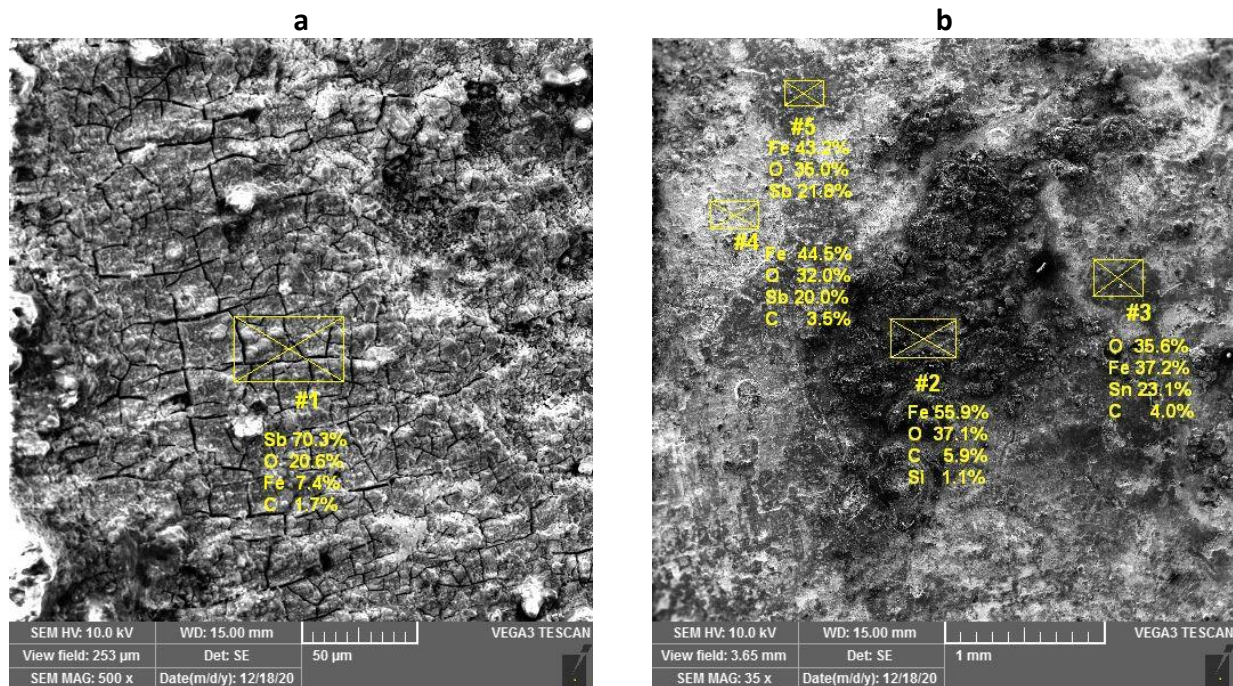
Figure 9a shows a cracked but layer of antimony at the inner surface of the used CT (measurement point #1), located away from the analysed crack. The inner surface near the crack in

Figure 9b shows that no continuous antimony layer is present (measurement points #3 to #5), and in particular, no antimony is found within the pit (measurement point #2)

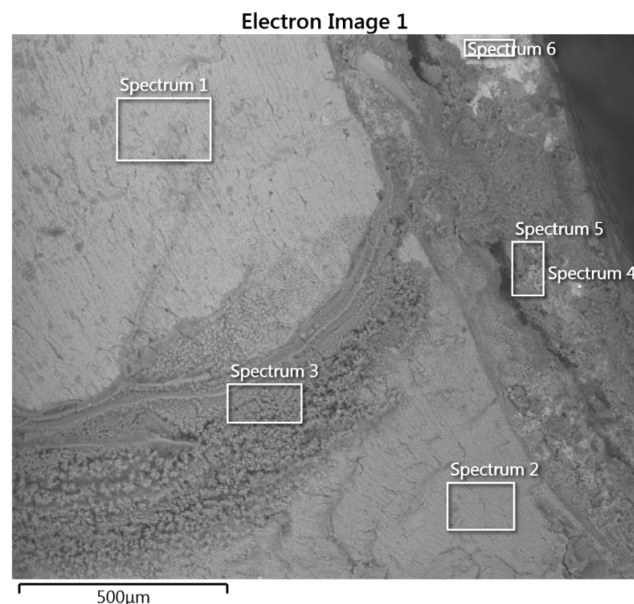
The EDS was performed at different locations on the fracture surface (Figure 10). Representative EDS spectra are shown in Figure 11, and the results are summarized in Table 2. The EDS elemental analysis of the fracture indicates elements that can originate from the metal substrate (Fe, Cr, Si, C) or the environment (O, C, S, Si, Cl, Sb). Carbon can originate from the organic component of the corrosion inhibitor. Small amounts of sulfur were detected during the test. The sulfur could be from H_2S from the environment and/or microbiological corrosion induced by sulfate-reducing bacteria (SRB). However, the amount of sulfur is minimal and the source of the sulfur could not be clearly determined from this analysis. The presence of sulfides was not detected by the lead acetate paper test.

Figure 10. EDS spectra locations at the fracture surface of the perforated sample

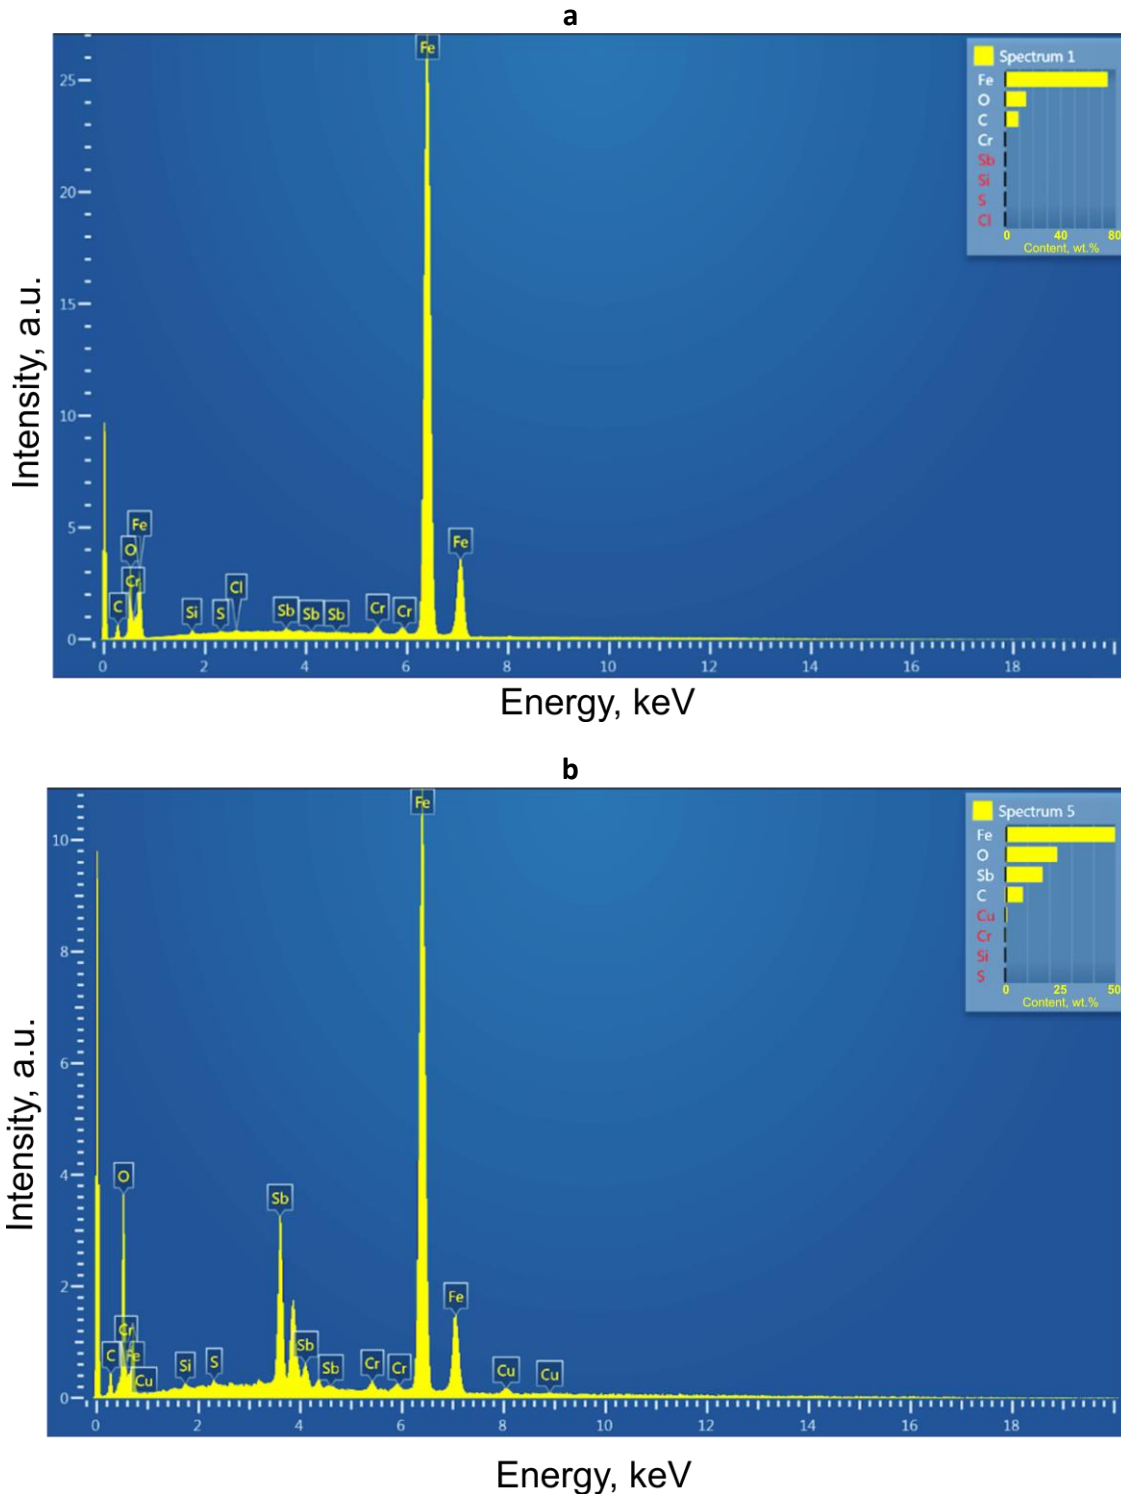
Figure 11. Representative EDS spectra of the fracture surface in Figure 10 at different locations: **a** -location 1 and **b** - location 5

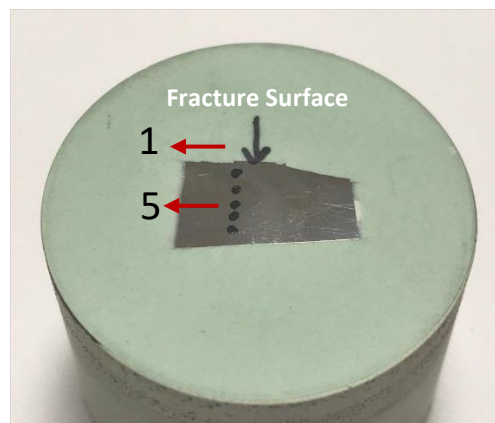
Figure 12 shows the locations where the hardness measurements were made, and the results are summarized in Table 3. The hardness values were relatively consistent and agreed well with the declared value of 91.87 HRB (190 HV) of the CT-80 tubing parent material. Given the relatively small grain size (ASTM 13 to 14) and the fact that hardness decreases with decreasing grain size, this is the expected value of the measured hardness. H. Ghiasi [14] reported that the microstructure affects the improvement of properties and fatigue life. By decreasing the grain size, the mechanical properties and fatigue life increased.

**Figure 12.** Vickers microhardness examination sites**Table 3.** Vickers hardness values near the fracture at different locations
