# FATIGUE BEHAVIOUR AT ROOM TEMPERATURE OF A METAL FOAM BASED EXHAUST AFTERTREATMENT SYSTEM FOR PASSENGER CARS

Proceedings of the 3<sup>rd</sup> International Conference on Manufacturing Engineering (ICMEN), 1-3 October 2008, Chalkidiki, Greece

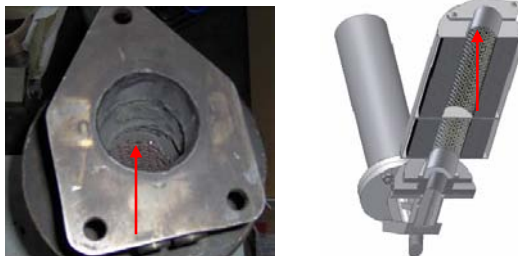
After approximately 30 minutes of testing, small pieces of the fiber material were cut out and fell out of the tube of the specimen. Nevertheless, the test has been further carried out.

After 2 hours of testing, the perforated tube was also damaged. The red arrows in [figure 10](#) points out the damage position near the gas inlet and the type of damage (total fracture along the periphery of the tube).

**Figure 10:** Failure position of prototype 5 after 2 hours.

The results of the tests can be used by the manufacturers for evaluation of the filter integrity and the extent and nature of damage in order to make the necessary modifications, i.e. to increase the strength of the perforated tube by enforcing the critical spots.

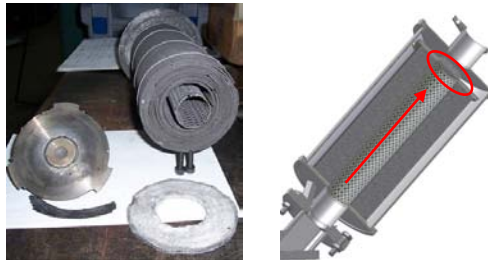
After approximately 3 hours of testing, the specimen was disassembled and inspected. The fiber material has been wearied out. Small pieces of the fiber material were cut out and fell into the steel shell of the specimen. Nevertheless, the test has been further carried out.

After 10 hours of testing the specimen was disassembled and inspected again. The fiber mat and the foam were able to revolve around the perforated tube.

After 18.5 hours of testing, the perforated tube of the specimen was damaged. The red arrow in Figure 13 points out the damage position near the gas inlet and the type of damage (total fracture along the periphery of the tube). Because of the failure of the perforated tube, two or three foam layers near to failure position were damaged. The fiber material was not totally damaged, see figure 13.

**Figure 13:** Failure position of prototype 2 after 18.5 hours.
