Diagnosis of painted wood ceiling planks from an eighteen century building

Teresa Sande Lemos¹, Mafalda Sobral¹ and Lina Nunes^{1,2}

¹ Fundação Ricardo do Espírito Santo Silva (FRESS), Escola Superior de Artes Decorativas, Portugal

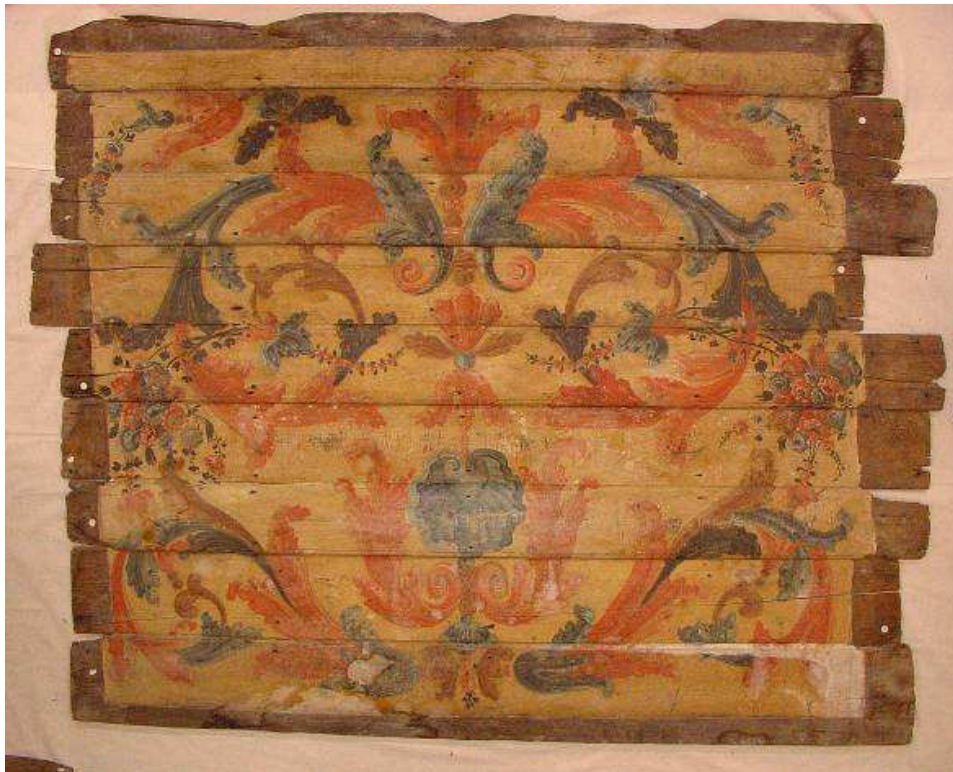
Figure 1 – Front view of ceiling panel n° 1

This structure, of approximately 2.16 x 1.65 m, is formed by nine planks with polychromes and the usual decoration motifs of the “*brutesco*” (Figure 1).

The planned intervention in this panel, in what respects the conservation of the wooden substrate, will involve the careful cleaning of the surfaces and the posterior use of two complementary techniques: application of small grafts of wood from the same species to restore the volumetric dimensions of the initial panel and consolidation of the unpainted surface with an acrylic polymer in organic solvent. Paraloid B72 is one of the materials most used for consolidation of wood objects [2] and it will be the most probable choice for this work.

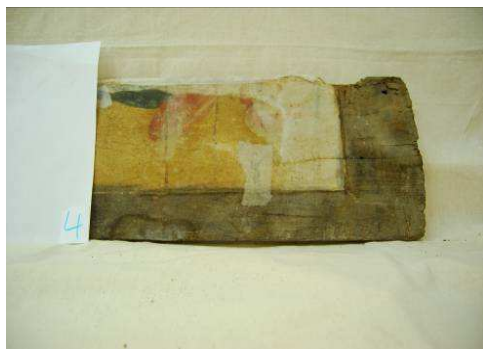
The planks, in Portuguese chestnut wood, are made mostly of heartwood in reasonable state of conservation though with the already referred problems of bow, warp, cracks and loss of material due to insect activity (Figure 2).

Figure 2 – Ceiling panel nº 1. Details a) zone with detachment of the painting; b) severe cracking; c) moisture stain better seen in the back view and d) insect damage and consequent loss of material

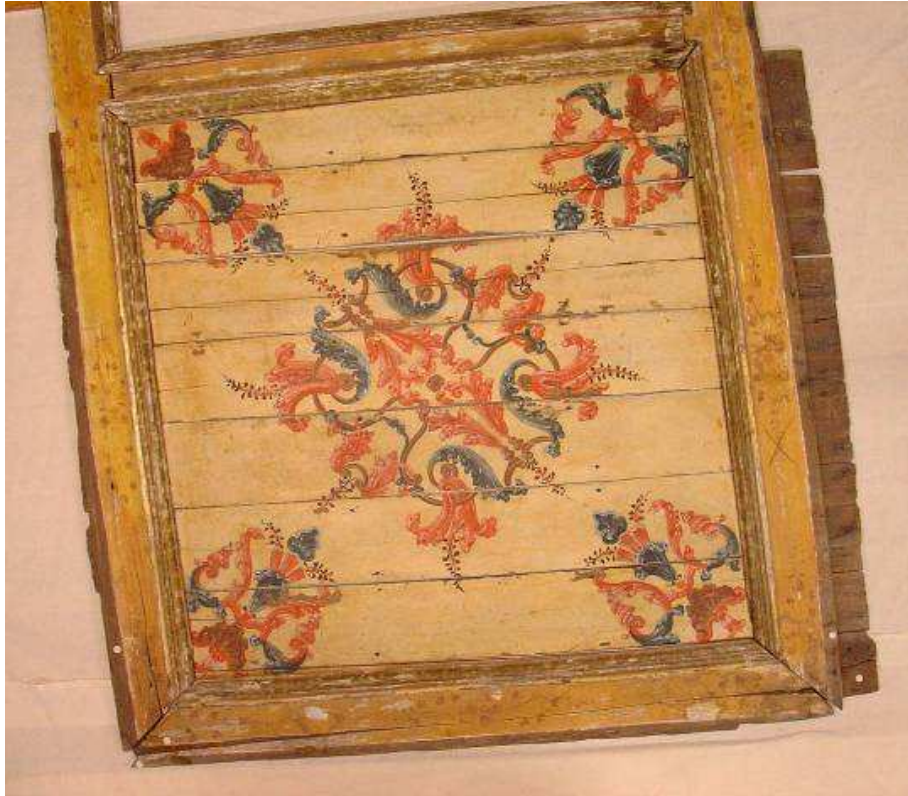
Figure 3 – Front view of ceiling panel n° 2

This structure, of approximately 2.03 x 1.70 m, is formed by eight planks with polychromes with the same usual motifs of the “*brutesco*” framed by a gold and yellow painted border (Figure 3).

The planned intervention in this panel, in what respects the conservation of the wooden substrate, will again involve the careful cleaning of the surfaces followed by spot impregnation, namely of the holes caused by metal elements, with an acrylic resin in organic solvent.

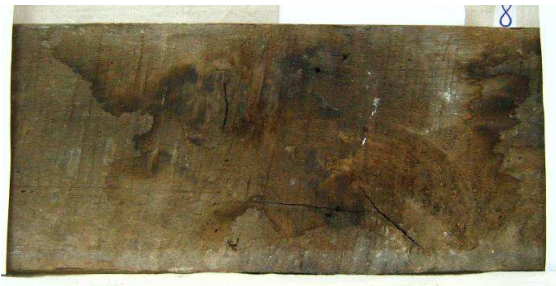
The planks, in Portuguese chestnut wood, are made again mostly of heartwood in reasonable state of conservation. Figure 4 shows some details of the rear view of the ceiling plank underlying the most important problems found in panel nº2. In this case, and due to the very small amounts of sapwood used, there were very few signs of insect degradation and considerably less loss of material.

Figure 4 – Ceiling panel n° 2. Details of rear face a) dust deposits and moisture stains; b) dust deposits and corrosion stains; c) bow, severe cracks and moisture stains

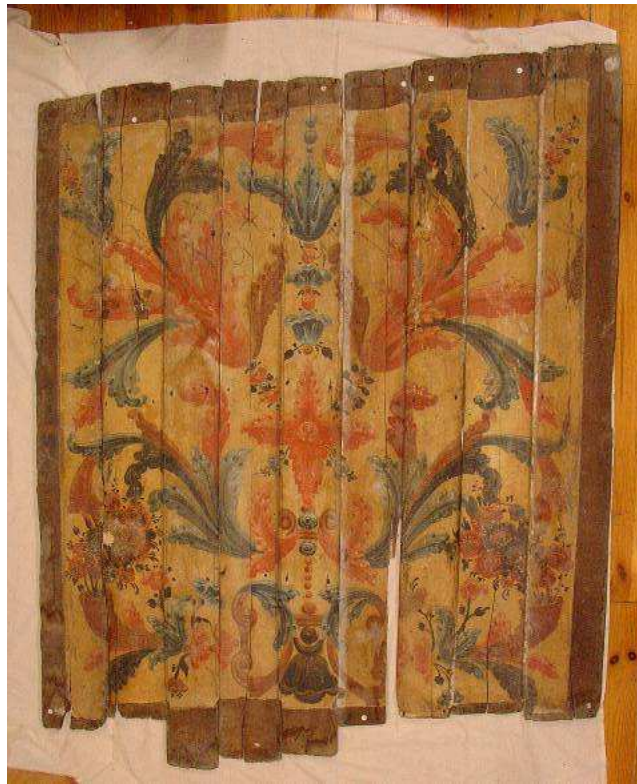
Figure 5 – Front view of ceiling panel nº 3

This structure, of approximately 2.05 x 1.673 m, is formed by nine planks with polychromes and the usual decoration motifs of the “*brutesco*” in this case very similar to the ones applied in ceiling panel nº 1 (Figure 5) .

The planned intervention in this panel, in what respects the conservation of the wooden substrate, will involve again the careful cleaning of the surfaces and the subsequent use of the two complementary techniques described: application of small grafts of wood and consolidation of the unpainted surface with an acrylic polymer in organic solvent.

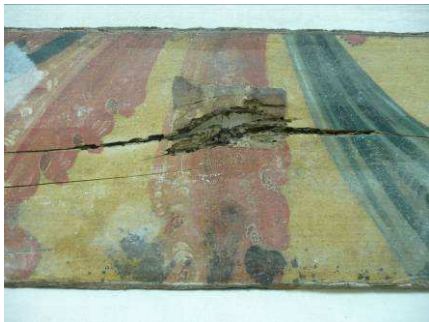
The planks, of Portuguese chestnut wood, are made mostly of heartwood in reasonable state of conservation though with problems similar to those described for ceiling panel nº 1. The loss of material was, in the case of this panel, more evident and had a stronger impact in the painted surface (Figure 6).

Figure 6 – Ceiling panel nº 3. Details a) front view with loss of material due to insect attack b) back view of the same zone
