FAILURE ANALYSIS OF HYDROGEN EMBRITTLEMENT IN SHIP GEARBOX HEX BOLTS

ABSTRACT

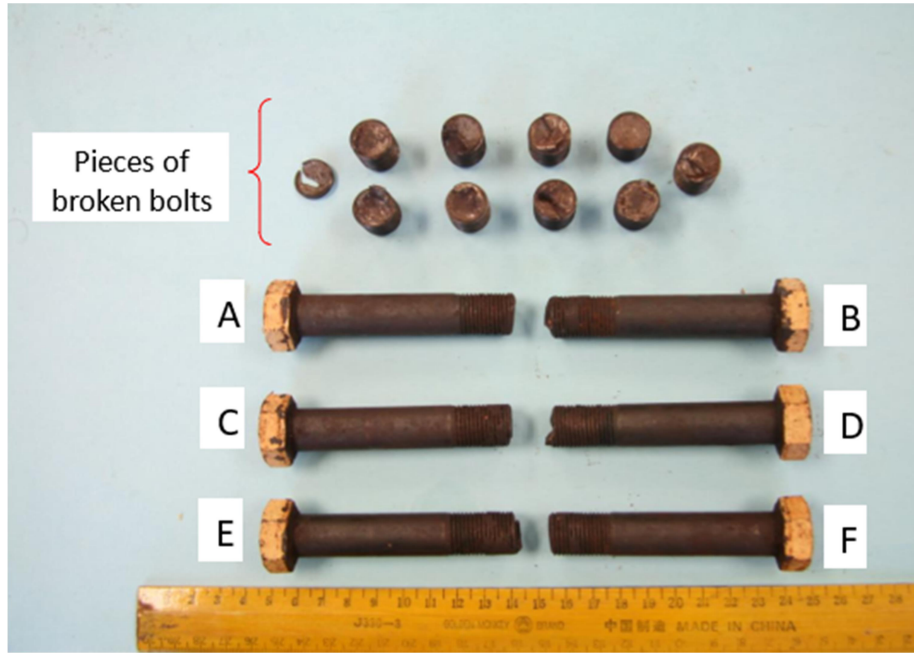
In this paper, a study was carried out on a series of fractured hex bolts in a ship gearbox that failed during cruising. The hex bolts were used to connect the engine gearbox's outer shaft to the flange (Figure 1). The failed samples were thoroughly investigated in order to determine the cause of the failure.

Figure 1: Six failed hex bolts, labelled as A, B, C, D, E and F, as well as pieces of ten broken bolts.

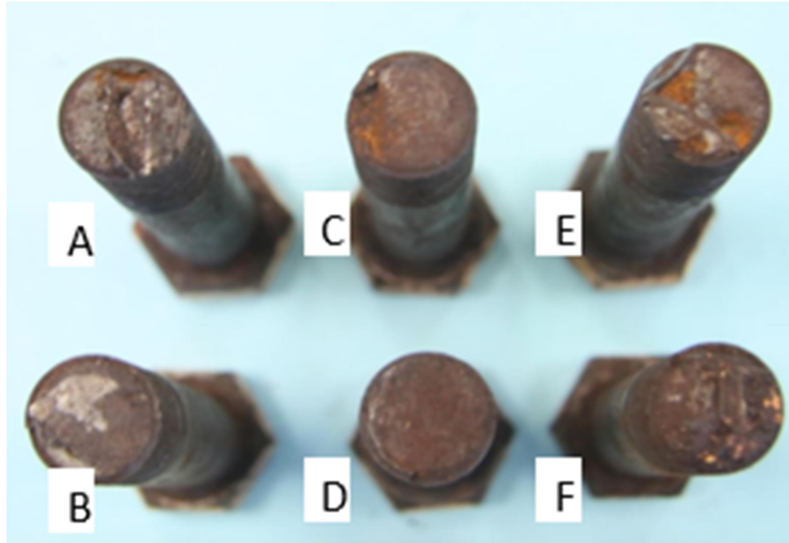
The fractured hex bolts were examined visually to study the failure mode. All the samples revealed that the external surfaces were rusted and the fractures took place in the threaded regions. Figure 3 shows the fracture surfaces of the bolts. The surfaces were found to be flat, with very little shear lip or plastic deformation. According to the examination, the flat areas that cover most of the fracture surfaces could suggest the brittle failure of the bolts. This failure demonstrates that the hex bolts failed suddenly with minimal elastic or plastic deformation before rupture.

Figure 3: Fracture surfaces of hex bolts.

According to the visual and microscopic examinations, the fracture surfaces of failed hex bolts revealed that the mode of failure was brittle. This is due to the evidence that most of the fracture surfaces were dominated by smooth and flat regions. The brittle failure shows that the hex bolts experienced sudden failure during operation with low intensity of elastic or plastic deformation (rough surface) before the final rupture. This type of brittle failure is undesirable in any mechanical system because it can occur suddenly and without warning, resulting in catastrophic or complete system failure (Bill, 2013; Knott, 2015).

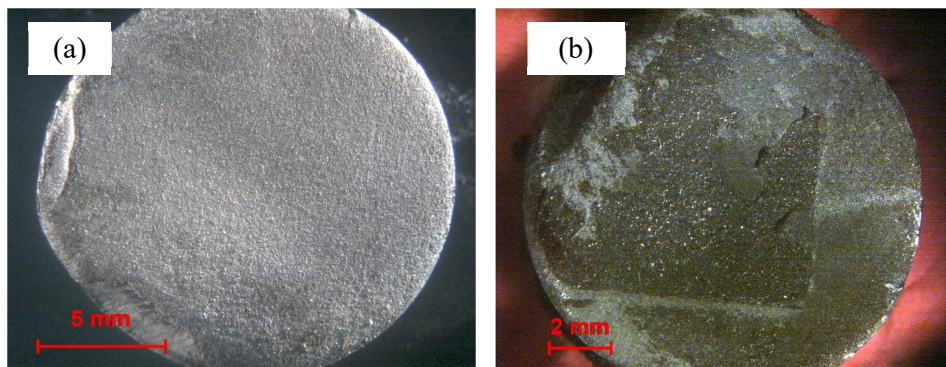
A Carl Zeiss Stemi SV 11 stereo microscope and Axio Vision software for image post-processing analysis were used out to enlarge the fracture surface. The examination shows that the regions of the flat zones are dominated on the fracture surfaces rather than the rough zones. The rough zones indicate that elastic or plastic deformation has occurred. The flat surface of brittle fracture is believed to be the source of the beginning of crack propagation. Due to low magnification of the macroscopic examination, no cracks were found on this flat zone. The images captured on the fracture surfaces of the failed hex bolts of samples B and D are shown in Figures 4(a) and 4(b) respectively.

Figure 4: Macroscopic examination on the fracture surface of failed hex bolts: (a) Sample B (b) Sample D.

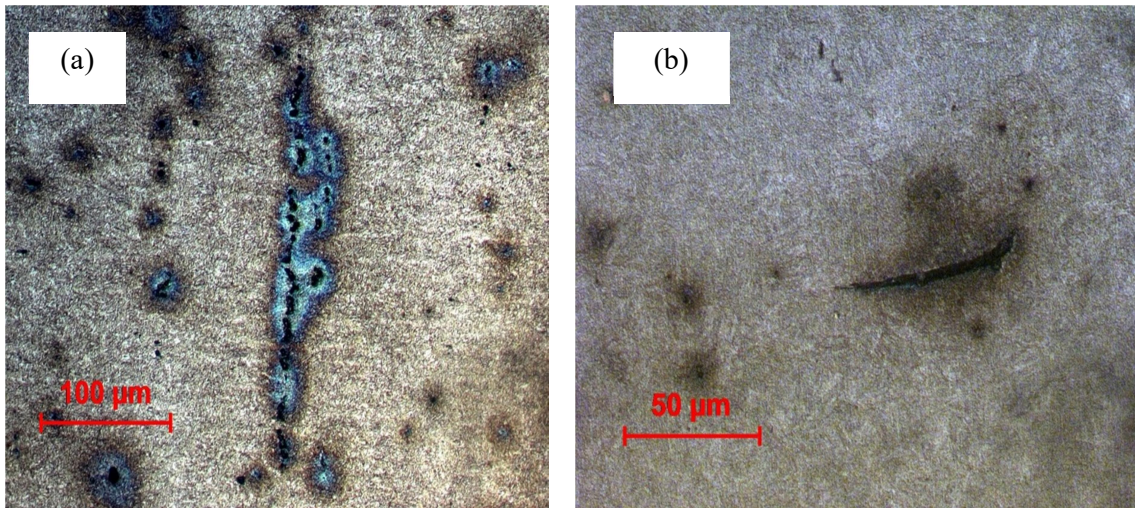
The failed samples were examined under an inverted microscope for metallographic investigation and observation under higher magnification using a SEM. The images of metallography are shown in Figure 5. Observation of the microstructure found that individual and cluster voids with different dimensions are visible on the surface. The cluster voids (Figure 5(a)) with elongated and rounded shapes are approximately 200 μm . Figure 5(b) shows that elongated voids of approximately 60 μm in length. Further examination was carried out under higher magnification using the SEM to determine the location of voids in the microstructure. Based on SEM analysis (Figure 6), the voids occurred on the intergranular that can be observed on the grain boundary associated with the secondary crack, which is the effect of crack propagation from the intergranular. This intergranular cracking in the microstructure indicates the possibility of being caused by corrosion or hydrogen embrittlement (Sanchez *et al.*, 2015; Le *et al.*, 2018).

Figure 5: Images of microstructures of the failed samples: (a) A cluster of voids (b) Elongated void.

Further investigations of the failed samples were carried out using microscopic examinations, which included metallographic analysis and SEM observation. On the flat regions of the failed samples, cluster and individual microvoids were clearly visible. These voids are believed to be manufacturing defects of the hex bolts. The rounded and elongated voids on the microstructure are the source of high stress concentration. This was widely assumed to be the cause of the failure. These voids exhibit as a crack initiation point and propagate when stress is applied during operation. Under high magnification using SEM, these voids are found between the boundaries of material grains. According to Amit (2017), this phenomenon is categorised as intergranular induced cracking, which occurs in the microstructure of hex bolts due to corrosion and hydrogen embrittlement. Sandeep & Manisah (2019) reported that hydrogen embrittlement can be attacked on the structure or mechanical system when these three factors exist, which are mechanical loading, high strength materials and external environment. The chemical composition in Table 1 indicates that the hex bolt is low alloy steel. The hardness values of the samples are above 30 HRC, indicating that this alloy steel is high strength material. Low alloy steel associated with high strength hardness is among susceptible materials to hydrogen embrittlement as well as nickel and titanium alloys (Motomichi *et al.*, 2017; Enyinnaya & Ubong, 2018).

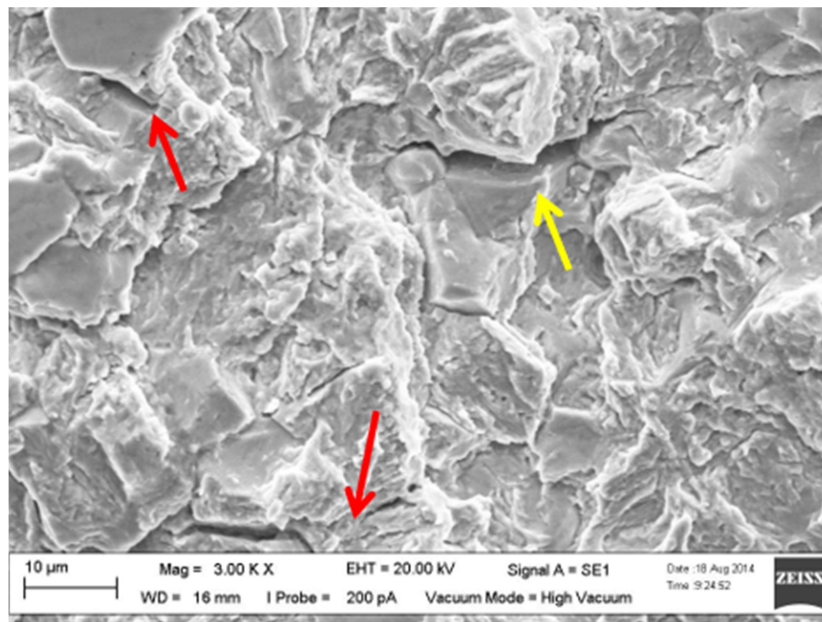
Figure 6: SEM image of the voids. The intergranular cracks are indicated by the red arrows while the yellow arrow indicates a secondary crack.

The hydrogen concentration was then measured, with Sample E having the highest value of 1.42 ppm. According to Murakami *et al.*, (2010), hydrogen embrittlement can occur at a concentration greater than 1 ppm because hydrogen atoms can diffuse inside a material under atmospheric pressure. Hydrogen is diffused on the tip of voids in this case, which can reduce a material's cohesive strength and ductility.

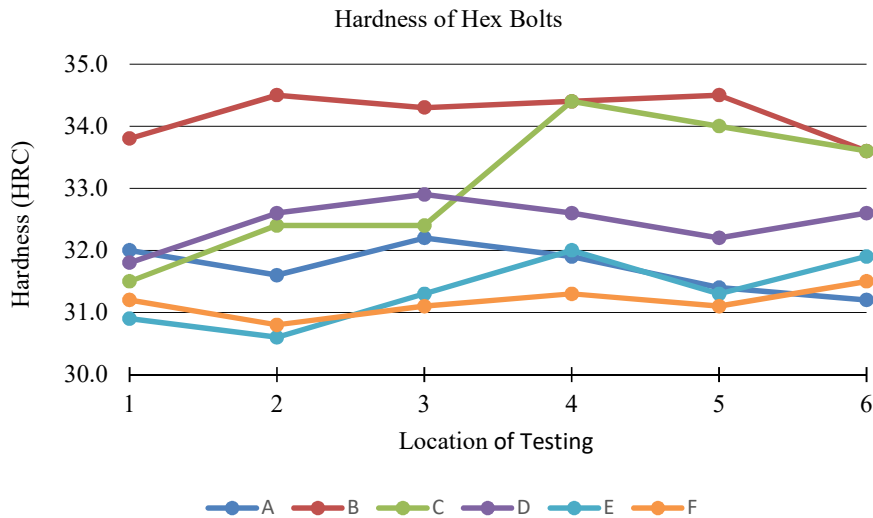
The hardness of the failed hex bolts was measured by using a Wilson 2000 Series Rockwell hardness tester. The hardness test was carried out in six different locations, with the results presented in Figure 7. The range of hardness obtained is 30 to 35 HRC. All the failed bolts show evenly distributed values of hardness except for Sample C, where the values are higher when close to the threaded region (Locations 4 to 6). The highest value of hardness is obtained for Sample B.

Figure 7: Graph of hardness testing results.
