# **TREATMENT EFFICACY OF KAUMA WASTEWATER TREATMENT WORKS IN LILONGWE, MALAWI FOR POLLUTION CONTROL AND WASTEWATER REUSE**

**Principal Mdolo  
(NRC)**

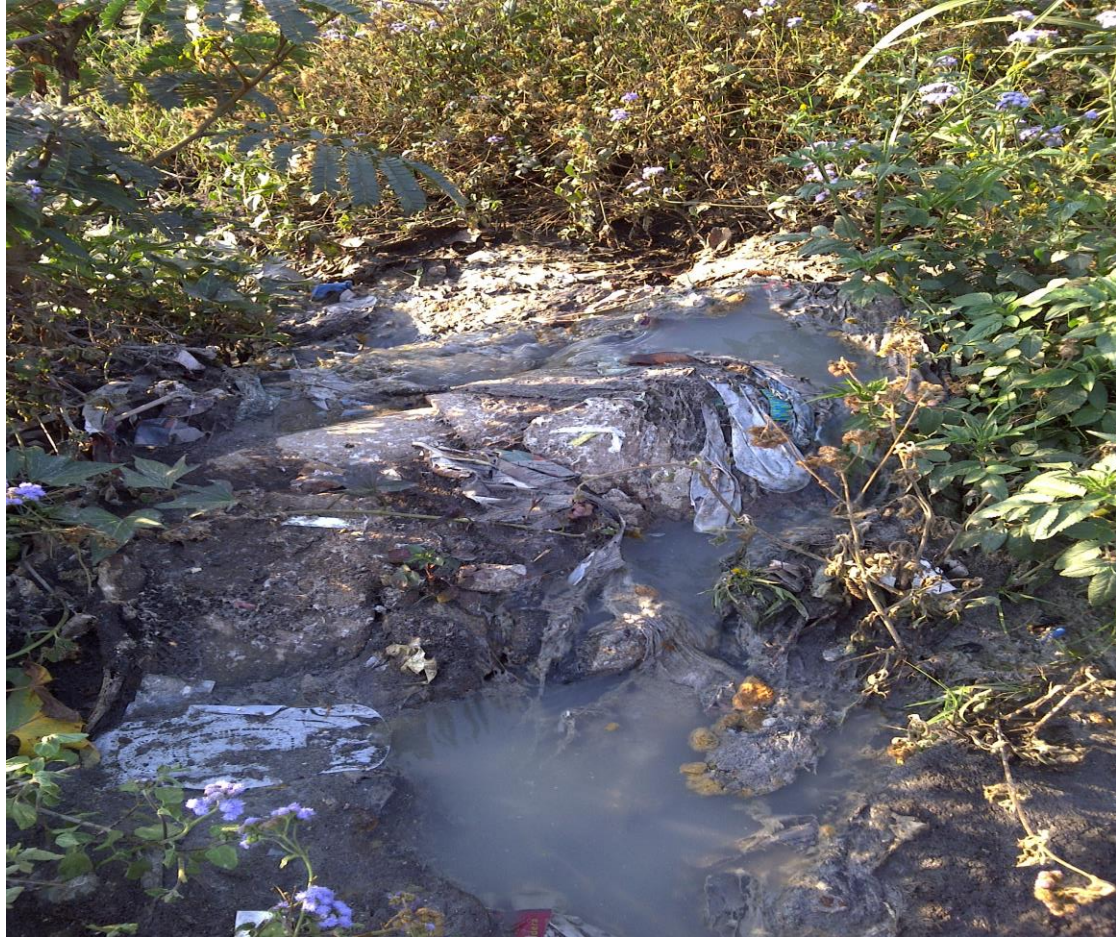
Blantyre (Mdolo 2013)

Discharge of poor quality effluent causes pollution

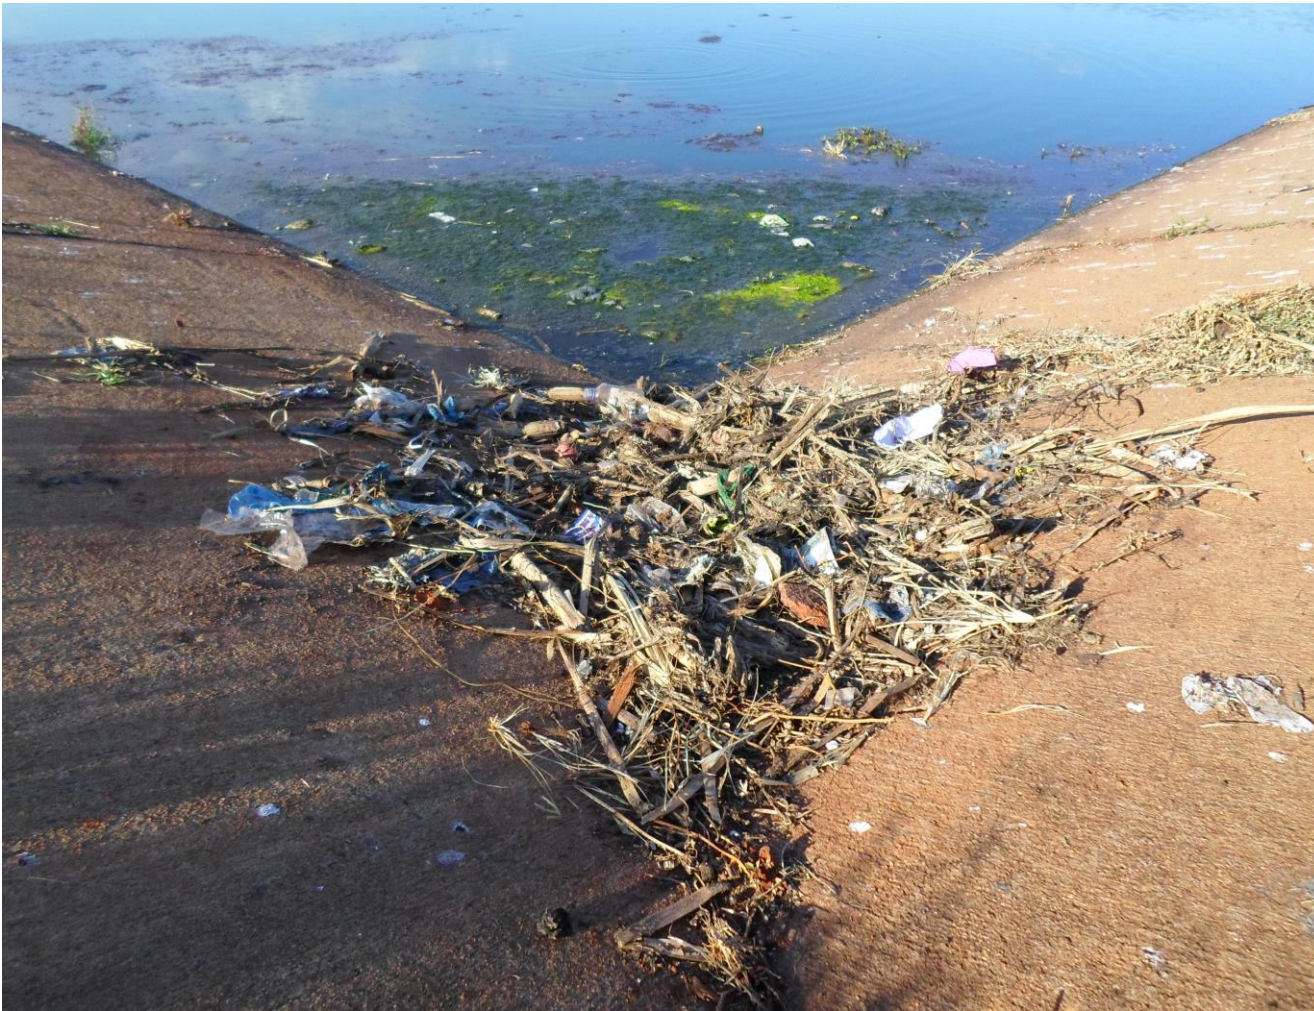
- Inspection of the whole sewer line and cleaning of bar screens were adequately carried
- Grit chambers and distribution chambers were cleaned less frequently than desired
- Effluent discharge pipes were not cleaned at all
- Greasing of gate valves and movable weir spindle shafts was not done
- Monitoring of effluent quality was not done

- All broken and blocked pipes be repaired
- Effluent quality be monitored regularly
- An O & M plan be developed and followed
- Records of all O & M activities be maintained

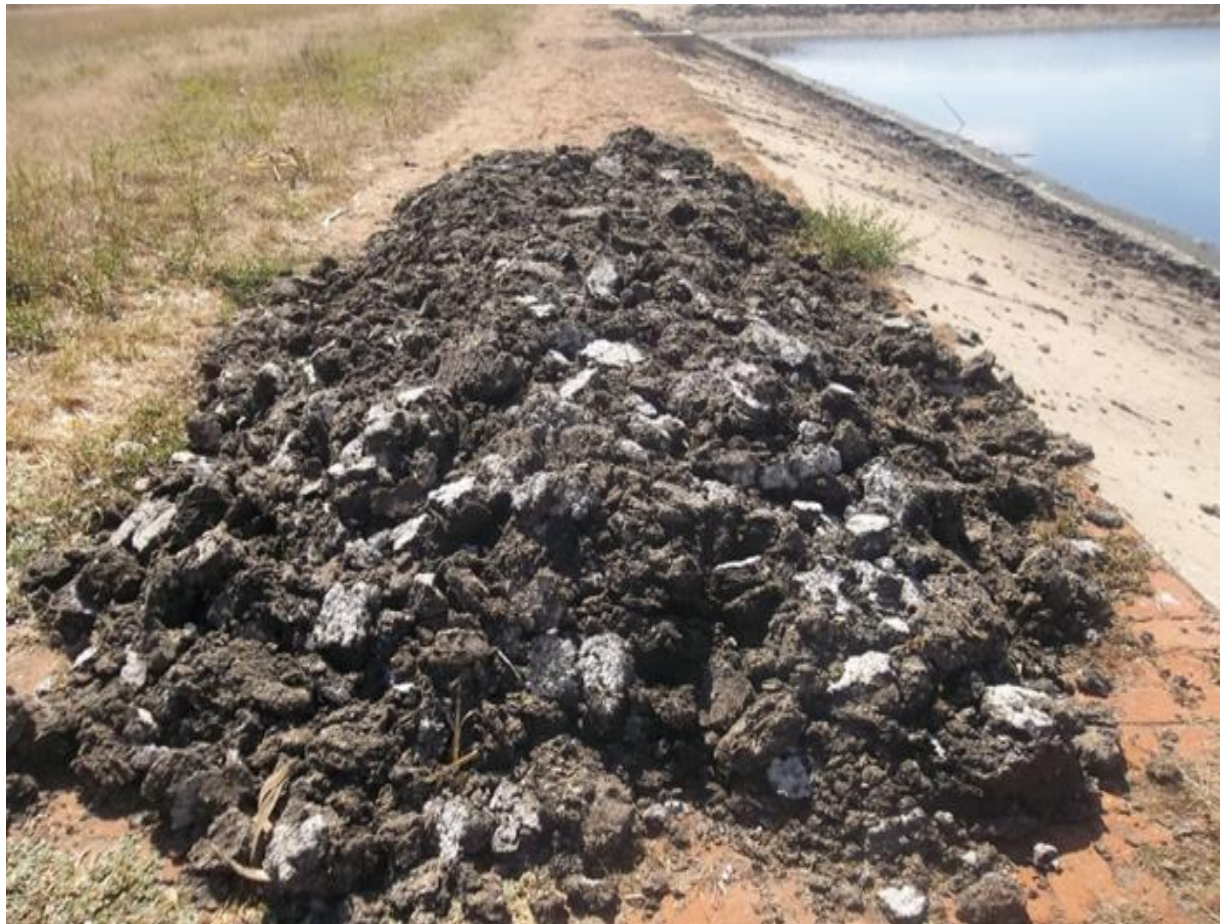
Maintenance of pond embankments, cutting of grass on site, clearing roads and footpaths were done as required

- Desludging of anaerobic ponds was done once every two years
- Filling of a pond maintenance record sheet was not done
- Equipment and materials for O & M works were reported not working
- Lack of resources was reported as the main cause for not carrying out some O & M activities
