Full-Scale Structural and Nonstructural Building System Performance during Earthquakes: Part II – NCS Damage States

CHARACTERIZING NCS DAMAGE STATES

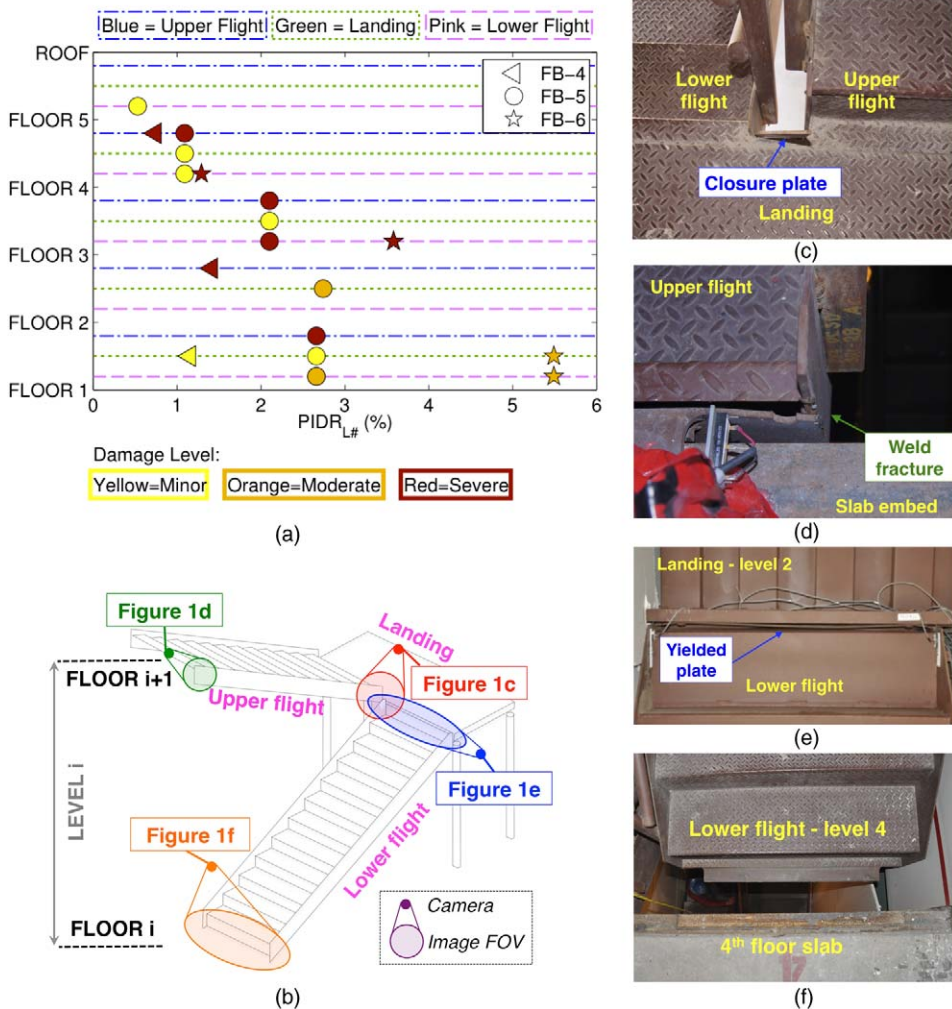
The onset of damage first occurred during test FB-4. This included one instance of *minor* damage in the form of detachment of a steel closure plate at level one (Figure 1c) and two cases of *severe* damage at levels two and four ($PIDR_{L4} \sim 0.8\%$) in the form of fracture of the vertical weld at the connection between the upper flight stringer and the reduced area angle (Figure 1d; see also Figure 4c in Chen et al. 2016). Although the stair flight detached from the reduced area angle, it remained resting on the slab. Nonetheless, this damage state was deemed *severe* since even minor horizontal motion, for example due to occupant loading, may result in complete collapse of the flight and cause life-safety hazards for building occupants. This damage was repaired by welding steel plates between the upper flight stringer and the slab embed at the second level and re-welding of the reduced area angle to the upper flight stringer at the fourth level.

Test FB-5 resulted in numerous instances of *minor*, *moderate* and *severe* damage. Handrail fracture (*minor* damage) was observed at several levels. *Moderate* damage at the first level consisted of yielding of the washers in the lower flight to slab connection. At the second level moderate damage happened in the form of plastic deformation of the connection plate in the lower flight to landing connection (Figure 1e). *Severe* damage included the fracture of welds in the lower flight to slab connection and upper flight to slab connection at several levels.

Figure 1. Damage to the steel stairs: (a) damage state versus $PIDR_{L\#}$ during the final three seismic input motions, (b) schematic showing the location of elements shown in photos c through f with respect to flights and landing (FOV = Field of View), (c) closure plate of the landing at the first level, (d) weld fracture at the upper flight to slab connection as observed at floor three after test FB-4, (e) yielding of the lower flight to landing plate after test FB-5 (view from bottom), (f) complete detachment of the lower flight from the slab at the fourth level as observed after test FB-6 (view from top).

During test FB-6, numerous instances of *moderate* and *severe* damage were distributed throughout the stair system. Two cases of *moderate* damage observed at level one consisted of continued yielding of the washers at the lower flight to slab connection and plastic deformation of the steel plate connecting the lower flight to landing. *Severe* damage at level three and four consisted of the complete detachment of the lower flight

Physical inspection performed during building demolition provided access to view steel posts supporting the stair landings. At this time, the landing posts to slab embed welds were noted to have completely fractured at the three lower levels. These damage states are not incorporated in Figure 1a since the test that caused these failures is uncertain.

from the structure due to the fracture of the lower flight to slab welds (Figure 1f). This damage was repaired by jacking the lower flight back into place and re-welding it to the slab embed.

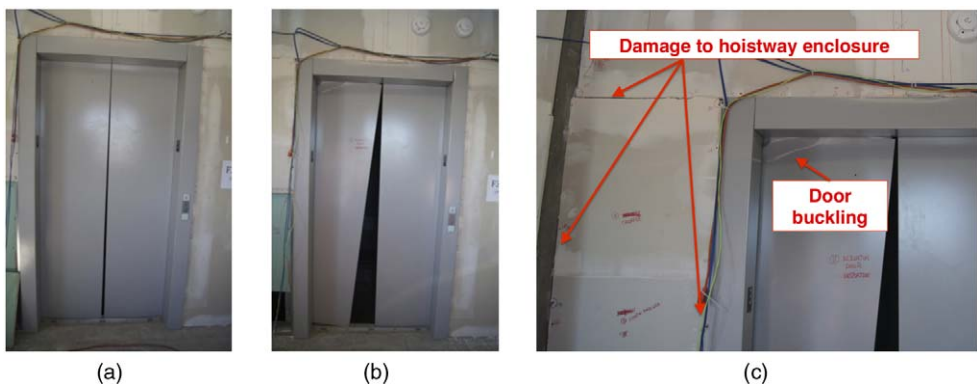
Functionality of the elevator was evaluated following each test by attempting to move the elevator from its test position up and down and operate the doors at each floor level. Visual inspections were also conducted on the cabin doors, the cabin interior, and along the interior shaft with particular focus on evaluating the state of the rail and its anchor attachment points. No damage was recorded in the elevator prior to test FB-5. Inspection after FB-5 ($PIDR_{L2} \sim 2.7\%$, $PIDR_{L3} \sim 2.1\%$) revealed the formation of a small gap (<25 mm) between the cabin doors at levels two and three (Figure 2a) and minor crushing at the top corners of the cabin doors. This damage was classified as *minor* since it did not impair the functionality of the elevator. However, during test FB-6 ($PIDR_{L2} \sim 6\%$, $PIDR_{L3} \sim 3.6\%$), crushing of the elevator doors with the surrounding partition walls continued and the gap between the doors at their base enlarged, with a residual of 200 mm measured at levels two and three (Figure 2b). This damage to the cabin doors eventually resulted in the inoperability of the elevator following this test (*severe* damage).

Figure 2. Damage to the elevator: (a) gap between the cabin doors at level three after test FB-5, (b) gap between the cabin doors at level three after test FB-6, (c) damage to the upper west corner of the door and hoistway enclosure at the third level after test FB-6.

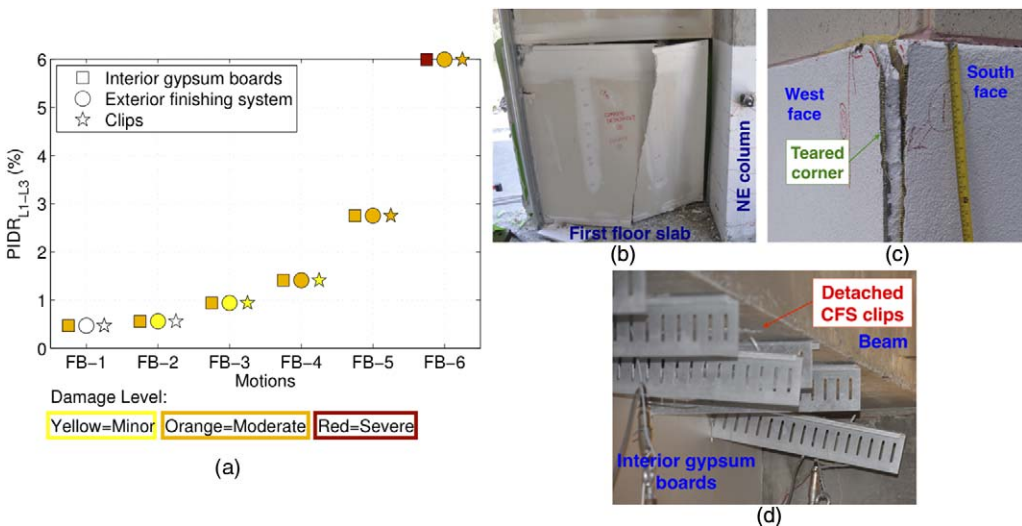
Damage to the interior gypsum boards, which was *minor* during the BI tests, increased as the intensity of the seismic input motions increased. *Moderate* damage during the FB tests included extensive cracking of corner joints, numerous instances of screw pull-out, fracture and partial detachment of the gypsum panels (Figure 3b). The exterior finishing system at the

Figure 3. Damage to the balloon framing: (a) summary of damage level for the three primary visible components of the balloon framing (sides moving in-plane), example of *moderate* damage to: (b) interior gypsum boards (NE = northeast), (c) exterior finishing system, (d) interior connecting clips. (b–d were taken following test FB-6).

exterior of the building exhibited *minor* damage in the form of bulging of the stucco during tests FB-1 and FB-2. During tests FB-3 and FB-4, the stucco continued to bulge and started to show cracks (*minor* damage). During the last two seismic input motions, complete tearing of the corners where the in-plane and out-of-plane walls intersect was observed at several locations. This type and extent of damage was classified as *moderate* (Figure 3c). The CFS angle clips connecting the structural slab to the CFS balloon framed studs did not undergo any damage prior to test FB-3. Less than 15% of the clips observed failure in the form of detachment from either the metal studs or the structural elements during tests FB-3 and FB-4. It should be noted that these detachments were concentrated in the plastic hinge region of the beams, where large local structural deformations are expected. Damage in this case was still classified as *minor*, as a high level of redundancy exists with the relatively tightly spaced clip connections. During tests FB-5 and FB-6, a larger number of clips, ~30% and ~80%, respectively, failed, and for this reason the damage was classified as *moderate*.

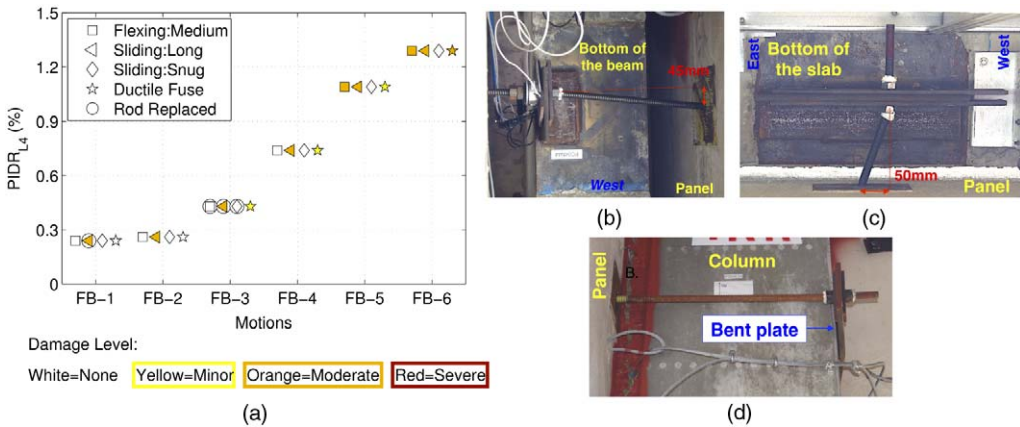
Flexing rod connections underwent *moderate* damage, corresponding to yielding and permanent bending of the connection rod only during the last two tests (Figure 4b). In contrast, the sliding connections with long rods observed *moderate* damage in the form of plastic

Figure 4. Damage to precast concrete cladding panels: (a) summary of the damage level for final five seismic input motions and three of the connection typologies installed at the fourth level, (b) example of *moderate* damage to the flexing rod connection with medium length rod (view from bottom), (c) example of *moderate* damage to a sliding connection with long rod (view from bottom) and (d) example of *moderate* damage to the ductile fuse (lateral view).

deformation of the rod (Figure 4c) at the onset of the FB test phase, behavior that was expected due to the extreme length of the rod. The snug sliding rod connections remained undamaged throughout testing. The push-pull connections with a ductile fuse attained *minor* damage for the first time during test FB-3 in the form of small cracking of the panel close to the connection embed. *Minor* damage to the ductile fuse connection in the form of slight permanent bending of the connecting plate, was also observed after test FB-5. The damage level to the ductile fuse connections was elevated to *moderate* only during test FB-6: in some cases damage corresponded to larger cracks (≥ 0.5 mm) in the panel close to the ductile fuse connection embed, while in some other cases it consisted of considerable (≥ 20 mm) plastic bending of the plate, see Figure 4d.

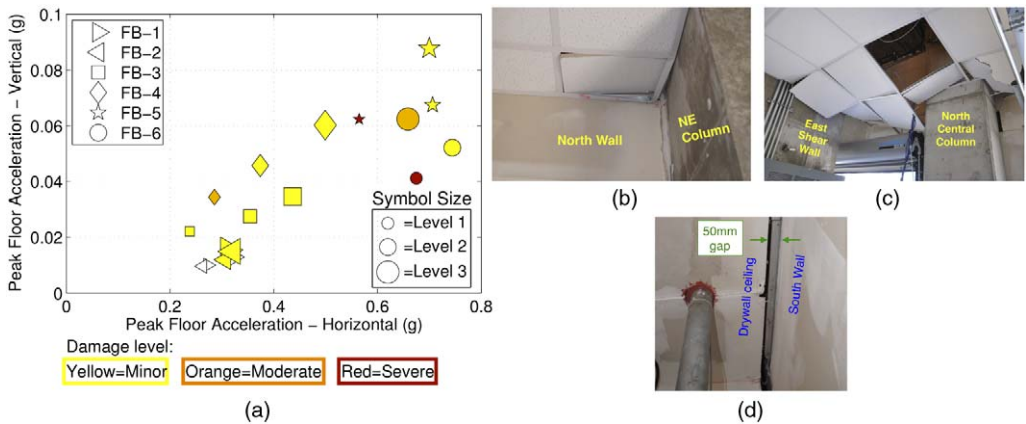
Figure 5. Damage to the ceiling at the three lower levels: (a) summary of damage states, (b) moderate damage at level one after test FB-4, (c) severe damage at level one after test FB-6, and (d) gap between drywall ceiling and balloon framing at level three (moderate damage) after test FB-6 (view from bottom). NE = northeast.

Ceilings at the first level were the most vulnerable to seismic damage since they lacked seismic bracing. The first minor damage to the ceiling at level one occurred during test FB-3. This damage corresponded to small buckling of the tees at two locations near the perimeter. During test FB-4, the damage at this level was elevated to moderate due to increased buckling of supporting tees near the perimeter and the incipient falling of a corner tile (Figure 5b). During the last two tests, the damage was classified as severe and involved collapse of approximately 20% of the ceiling tiles (Figure 5c). These failures were concentrated close to the corner areas.

location during test FB-2 (*minor* damage). This gap continued to widen during subsequent tests. After test FB-6, two locations presented this type of horizontal gap, with a maximum width of 50 mm (Figure 5d). The latter was classified as *moderate* damage due to the large width of the gap. It should be underlined that this gapping was a manifestation of the interaction between the ceilings and the balloon framing and it was classified as ceiling damage since it created a disruption of the horizontal plane of the ceiling.

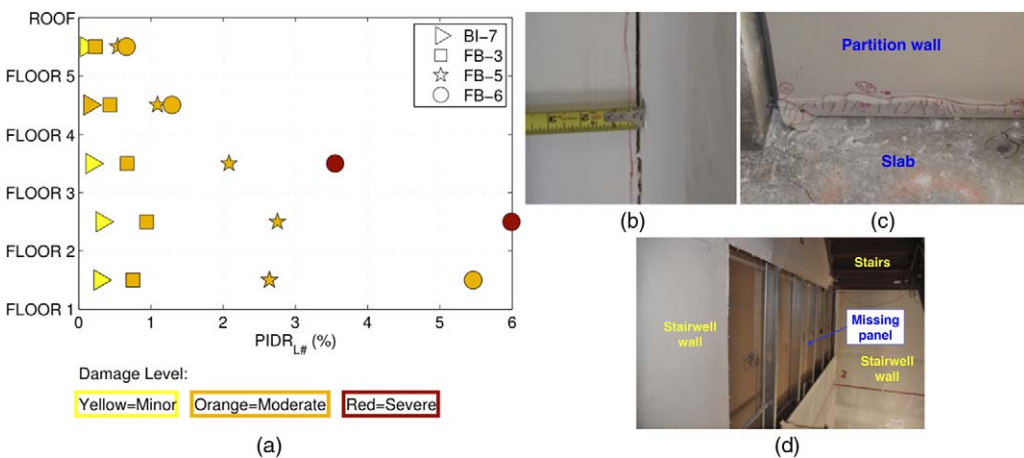
This data shows that during the final BI test, mostly *minor* damage was observed at every level, particularly in the form of joint tape cracking. In addition, gypsum board crushing and damage to the screws around the bottom track (*moderate* damage) were initiated at the fourth level. During test FB-3, the damage state was elevated to *moderate* at each floor. Damage included extensive crushing of the gypsum boards and gap opening between gypsum panels (Figure 6b), especially in regions where interaction of the partition walls with other components was imminent, such as at the south side of the stairs, where pounding with the stair landing occurred. During test FB-5, cases of *moderate* damage (e.g., gypsum crushing

Figure 6. Damage to the partition walls: (a) summary of damage level for select seismic input motions, (b) opening of the gap between panels (*moderate* damage) after test FB-4, (c) gypsum board corner crushing (*moderate* damage) after test FB-5, and (d) fallen gypsum board in the stairwell (*severe* damage) after test FB-6.

at the bottom boundary, see Figure 6c) and *severe* damage in the form of pull through failure of the screws that caused separation of the CFS studs and gypsum boards were observed. During the last test, *severe* damage to the partition walls was observed at every level except for the fifth, where damage remained *moderate*. *Severe* damage included several instances of complete detachment of the gypsum boards from the CFS studs (Figure 6d).

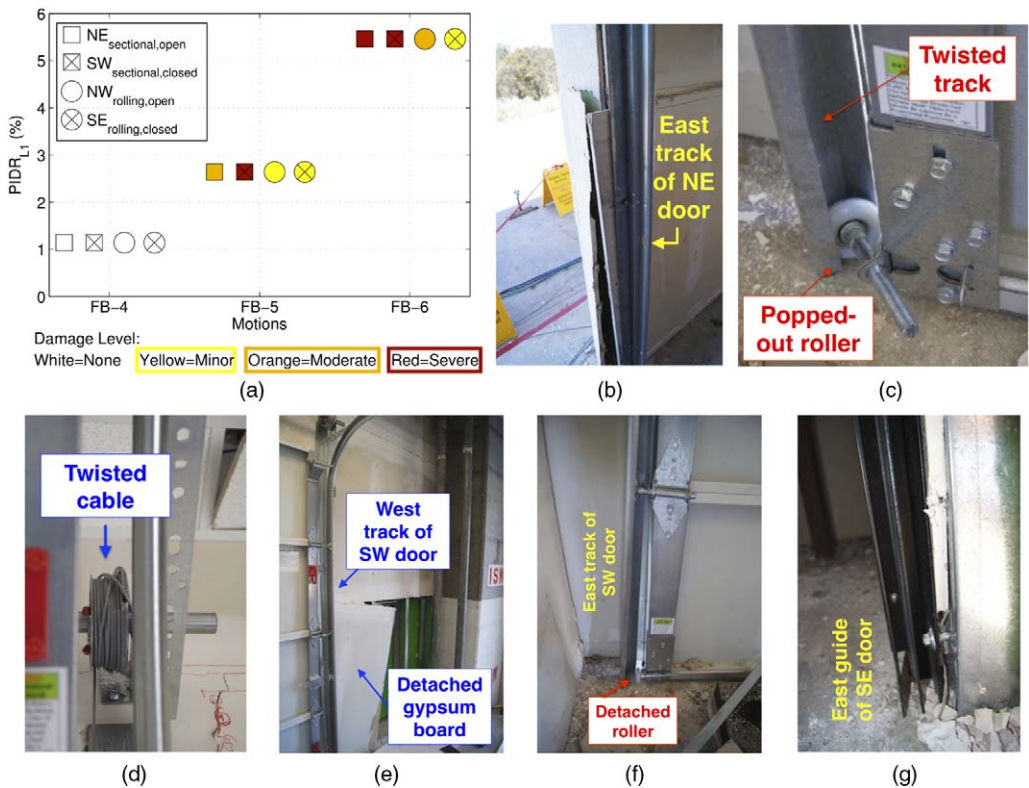
Figure 7. Damage to the doors at level one: (a) summary of damage level for the four doors, (b) east side of NE door jamb after test FB-5, (c) east track of SW door with twisted roller after test FB-5 (d) twisted cable on east side of NE door after test FB-6 (e) south wall at SW door after test FB-6, (f) east track of SW door after test FB-6, (g) east guide of SE door after test FB-6. NE = northeast, SW = southwest, NW = northwest, and SE = southeast.

During test FB-5, all four doors were damaged to varying degrees primarily due to their interaction with the interior gypsum panels of the balloon framing. The north-east sectional garage door that was staged open during testing ($NE_{\text{sectional,open}}$) suffered *moderate* damage: the track shifted due to the interaction with the gypsum boards and because of this the door was not able to operate smoothly anymore (Figure 7b). The north-west steel rolling door staged open during testing ($NW_{\text{rolling,open}}$) and south-east rolling door staged closed ($SE_{\text{rolling,closed}}$) underwent *minor* damage in the form of widening of the guide rails at the bottom ($\sim 10\text{--}20\text{ mm}$). The south-west sectional garage door staged closed ($SW_{\text{sectional,closed}}$) suffered *severe* damage and was inoperable due to twisting of its track and pop-out of its bottom roller (Figure 7c).

During the most intense test FB-6, both the NE and SW sectional doors were *severely* damaged and no longer operational. Damage to these doors manifested in the forms of twisting of the pulley cable (Figure 7d), loosening of the support anchors, detachment of the door track from the gypsum board (Figure 7e), and lower roller detachment (Figure 7f). Damage to the opened NW rolling door was *moderate* in the form of compression of the guiderails due to detachment of panels of the balloon framing. The closed SE roll-up door suffered only *minor* damage in the form of $\sim 10\text{ mm}$ narrowing of the track at bottom and remained operational (Figure 7g). Severity of damage was more intense for the sectional garage doors and less impacted by the status of the door (fully opened versus closed).

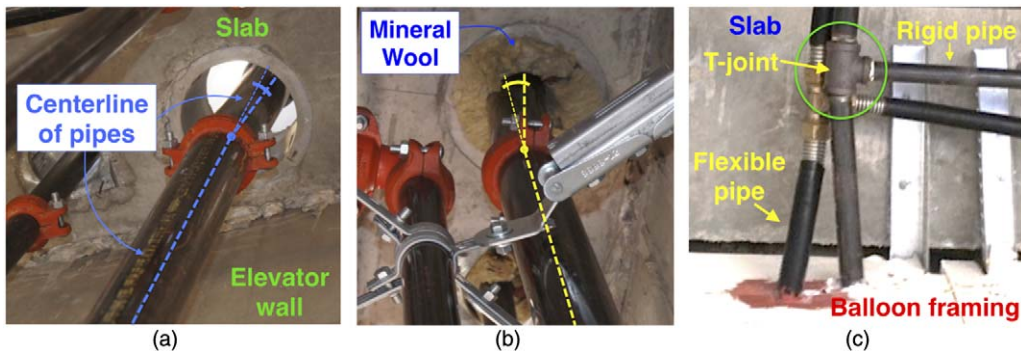
Figure 8. Damage to services (view from bottom): (a) rotation of the riser at junction after test FB-1, (b) nominal loss of the mineral wool at penetration after test FB-2, and (c) permanent bending of the steel pipe at level one after test FB-6.

- *Electrical Distribution System*: Remained functional throughout testing at all levels.
- *Fire Sprinkler System*: No drop in hydrostatic water pressure was observed during testing, indicating that no leaks occurred. *Minor* damage in the form of loosening of the vertical riser during test FB-1 (Figure 8a and b) and displacement of the mineral wool at penetration locations during test FB-2 were observed (Figure 8b).

- *Gas piping*: No pressure drop or damage to either of the two gas pipes was observed prior to test FB-6. Following this final test, pressure in the rigid gas pipe dropped to zero, while pressure within the flexible pipe remained at its pre-test value. The pressure drop was attributed to the fracture at the connection between the T-joint and the rigid pipe at level one ($PIDR_{L1} \sim 5.5\%$) (Figure 8c).

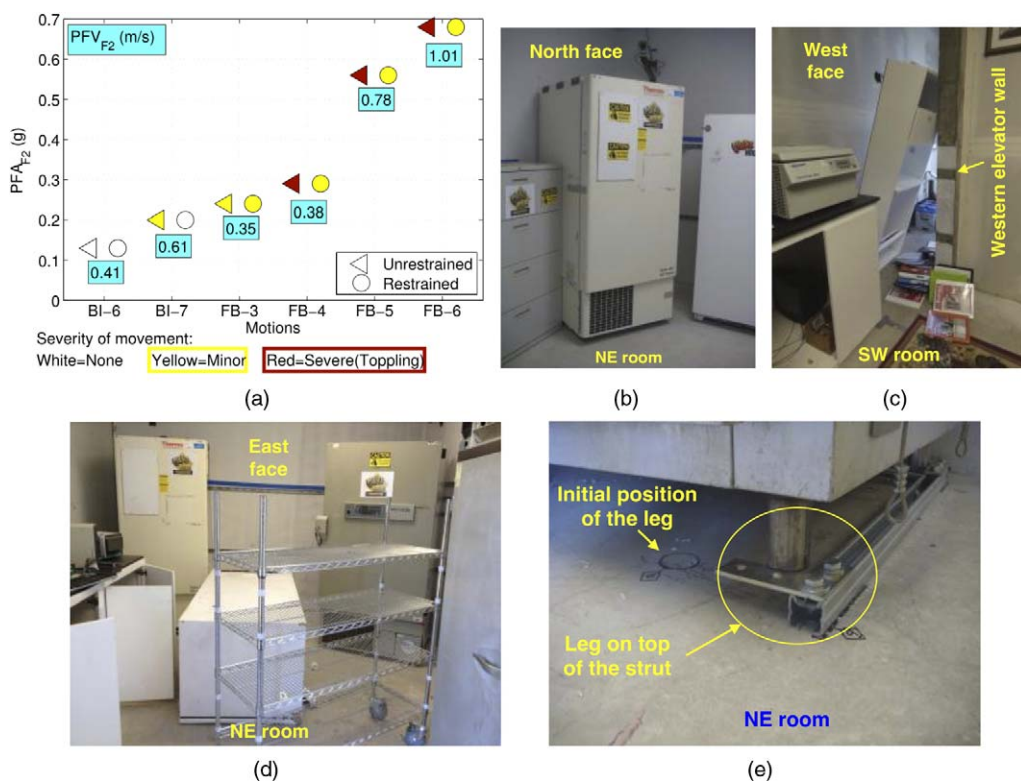
Figure 9. Damage to the second floor equipment and nonstructural contents: (a) summary of severity of movement for restrained and unrestrained items, (b) movement of the unrestrained refrigerator after test BI-7, (c) toppling of a bookshelf after test FB-4, (d) toppling of an unrestrained refrigerator after test FB-6 (excessive rotation of the unrestrained refrigerator can be seen in the right side background), and (e) leg of a piece of equipment on top of the restraining strut after test FB-6.

During each inspection phase, permanent displacement of the equipment installed at level two was monitored and subsequently all the content was reorganized to the initial position. Figure 9a correlates the damage state of the restrained or unrestrained items to PFA_{F2} and indicates also the peak floor velocity at the second floor (PFV_{F2}). This figure shows that no movement of the items installed at the second level was observed prior to test BI-7. During this test, an unsecured refrigerator in the northeast room displaced permanently ~ 150 mm. The restrained items did not move substantially up to this point. During the low level FB tests, restrained and unrestrained items underwent only small movements (<30 mm).

During test FB-4, the movement of the restrained items remained within the limits imposed by the restraints. The unrestrained bookshelf in the southwest room, however, tipped over (Figure 9c). Test FB-5 caused substantial dynamic and permanent movement of the unrestrained items (<120 mm) including toppling of a large refrigerator. During the final FB-6 test, permanent horizontal displacement of the unrestrained items were as large as 0.3 m and two of the items toppled, namely a bookshelf and refrigerator (Figure 9d). In contrast, during both tests FB-5 and FB-6, restrained items moved only within their limits, and failure of restraints was not observed. In one case, the legs of a large restrained piece of equipment jumped over its slab restraining strut (Figure 9e).

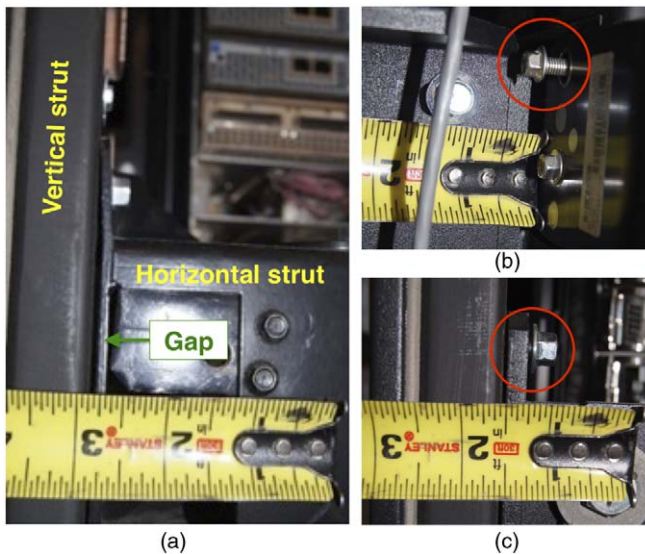
Figure 10. Damage to the non-functional computer server at level three: (a) yielding of the end plate of the horizontal strut during test FB-4, (b) and (c) screw pullout during test FB-5. (Note that the measuring tape indicates inches and not millimeters.)

The non-functional unit, whose longitudinal direction was perpendicular to the primary direction of shaking, remained undamaged up to test FB-3 ($PFA_{F3} \sim 0.35$ g). Inspection performed following test FB-4 ($PFA_{F3} \sim 0.37$ g) revealed plastic yielding of the end plate of the horizontal connection strut (Figure 10a). During test FB-5, ($PFA_{F3} \sim 0.71$ g) screw pullout occurred at two locations (Figure 10b and c). Both types of damage can be classified as *minor*. The functional unit, placed with its longitudinal axis parallel with the direction shaking, experienced no damage throughout testing. In addition, although two errors in data transfer occurred during test FB-5, the unit was able to recover immediately; therefore run-time functionality was not compromised.

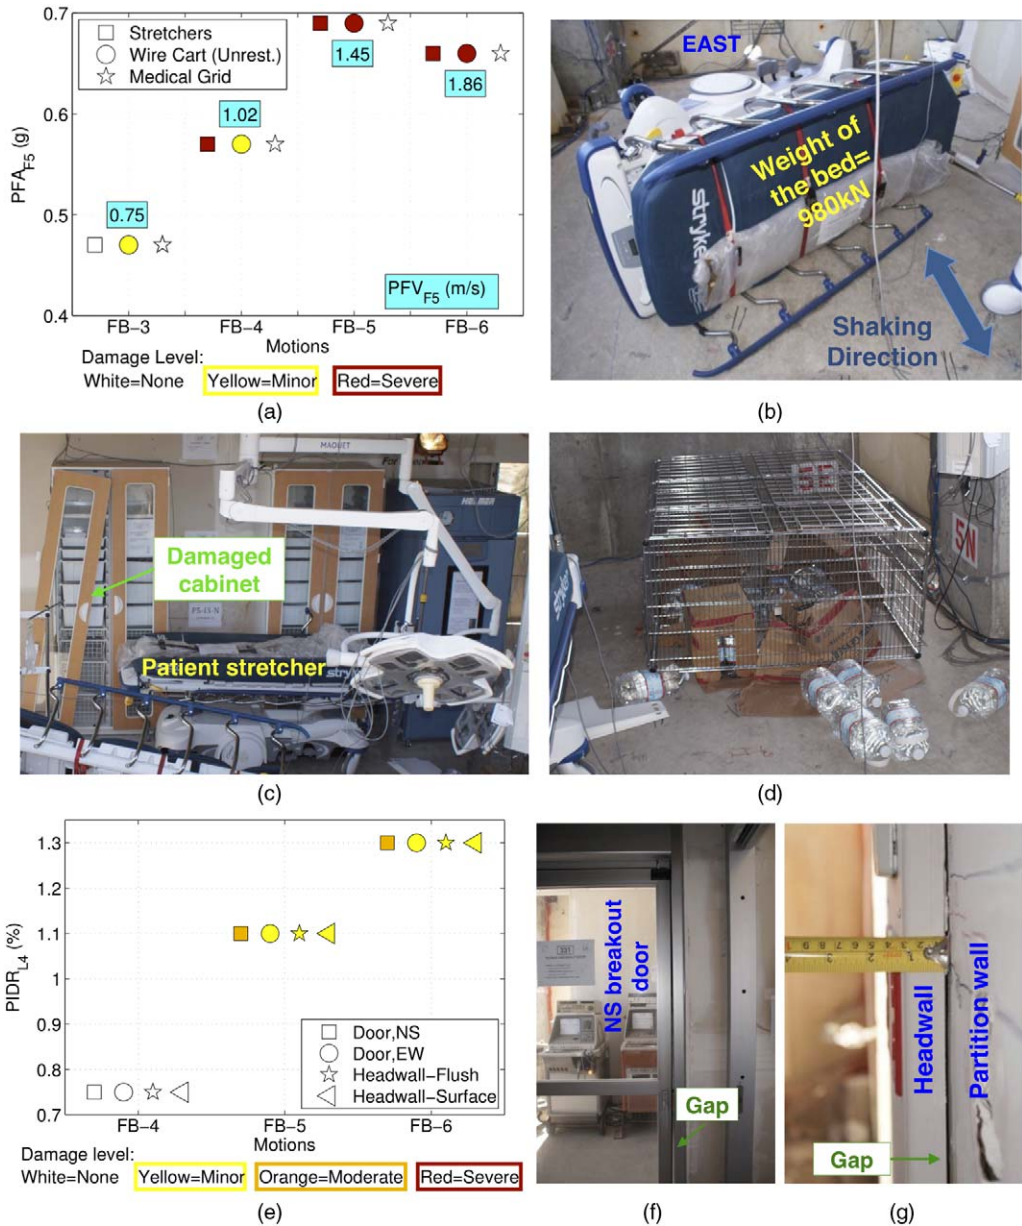
- *Patient care beds and stretchers:* Two beds were installed at each of the upper stories. At each level, the bed parallel to the direction of shaking was left unlocked before testing while the one perpendicular to it was staged locked. The locked patient bed positioned perpendicular to the direction of motion at the fourth level did not observe significant permanent displacement (larger $PFA_{F4} \sim 0.7$ g, larger $PFV_{F4} \sim 1.65$ m/s), while the stretcher installed in this fashion on the fifth level toppled during each of the final three tests (Figure 11b). The unlocked units positioned parallel to the direction of shaking rolled during testing, with the amplitude of movement increasing from test to test. During the last two seismic input motions, their movement was so violent that it caused damage to other items. For instance, the impact of the rolling patient bed with a partition wall at the fourth level left a significant hole in the wall, while at the fifth level the patient bed impacted a wall mounted cabinet, damaging its door (Figure 11c).

Figure 11. Damage to the medical equipment: (a) damage state versus peak floor acceleration (acceleration sensitive items on level five), (b) toppling of the patient bed at level five during test FB-4, (c) damage to the cabinet door caused by movement of the patient bed during test FB-6, (d) toppling of the wire shelving unit at level four after test FB-5, (e) damage state versus inters-tory drift (drift sensitive items on level four), (f) gap between the NS door and the door jamb observed during test FB-6, (g) gap between the headwall and the partition wall observed after test FB-6. NS = north-south and EW = east-west.

wheels placed on the fourth level exhibited movement from the first BI seismic input motion, with the range of its displacements increasing from a few centimeters to several meters during the final test. Movement of the unrestrained unit not on wheels placed on the fifth level was observed from test BI-6 ($PFA_{F5} \sim 0.15 g$, $PFV_{F5} \sim 0.42 m/s$). Subsequently, this item toppled during the last two seismic input motions (Figure 11d).
