Experimental assessment of post-earthquake retrofitted reinforced concrete frame partially infilled with fly-ash brick

Keywords: captive column effect; epoxy injection grouting; fly-ash infill; full-scale experiment; partial infill wall; retrofitting; steel jacketing

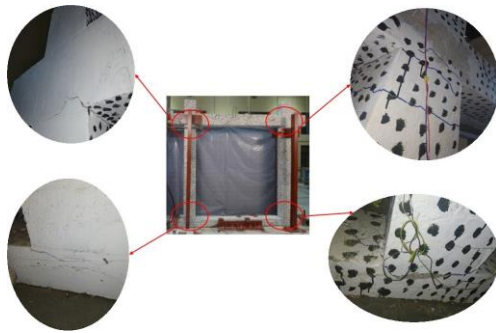
Fig. 2 RC non-ductile bare frame subjected to slow-cyclic loading (Kaushik *et al.* 2018)

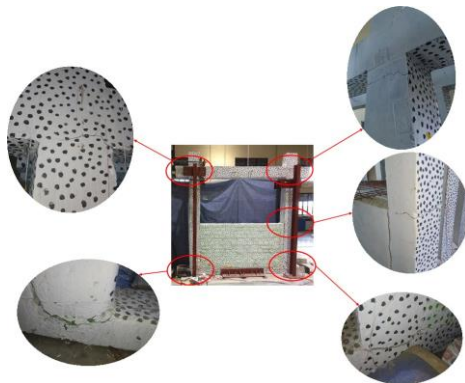
Fig. 3 Damages to RC partial infill frame subjected to slow-cyclic loading (Kaushik *et al.* 2018)

(Fig. 3). The ultimate lateral strength of the bare frame (BF) and partially infilled frame (PIF) was 33.3 kN and 72.7 kN, respectively, whereas the secant stiffness (corresponding to 75% of the ultimate load (Park 1989)) of the frames is 2.17 kN/mm and 3.77 kN/mm in case of the BF and PIF, respectively.

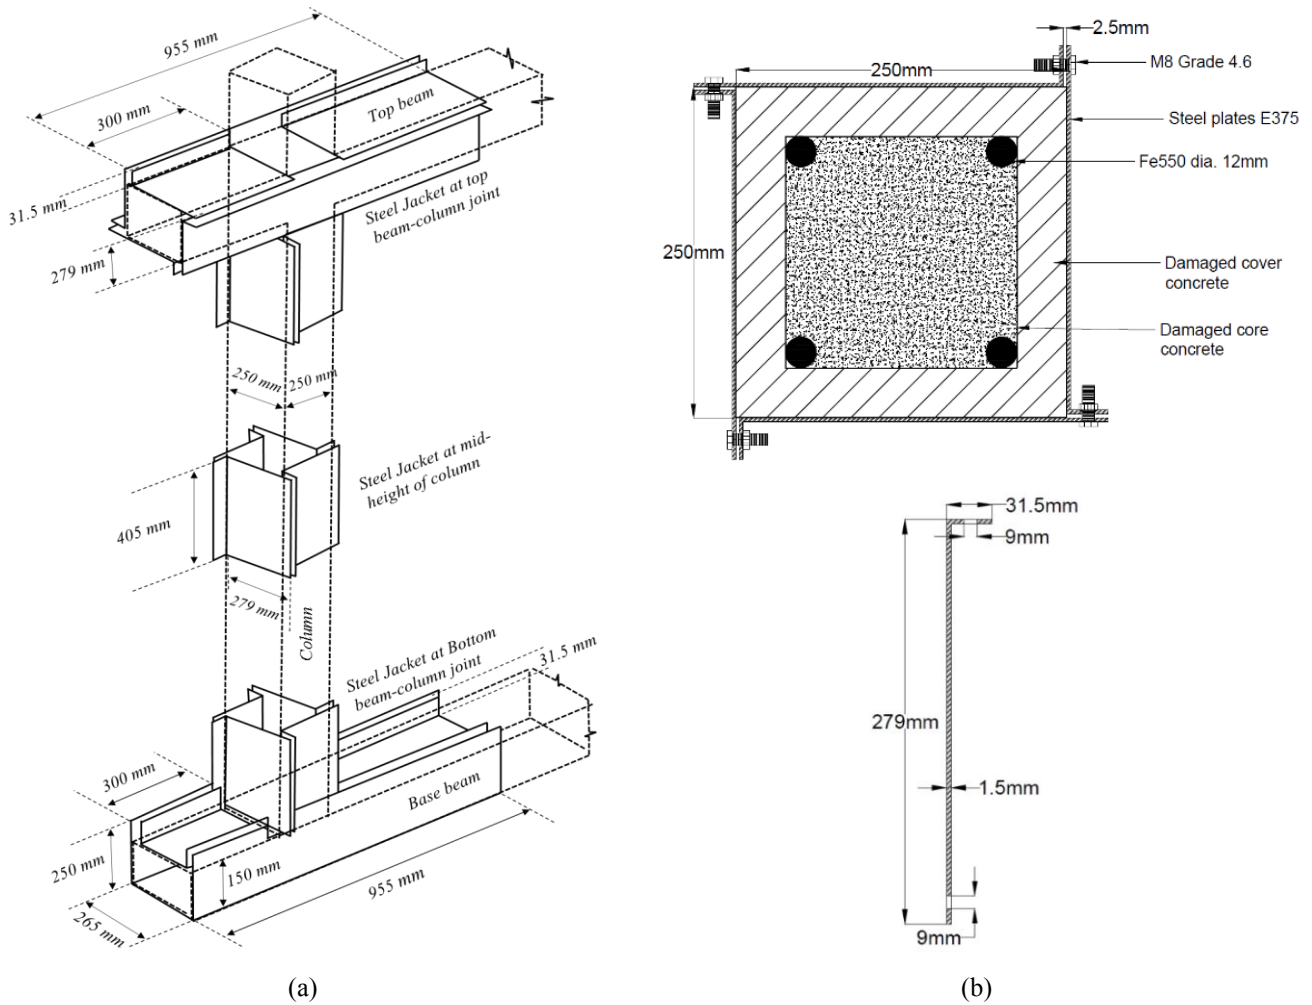
Fig. 4 (a) Schematic diagram of steel jacking of DPIFR-GS frame (b) Four side bolting of L-plates

without any slippage between the two. For this purpose, four L-shaped plates were attached at the surfaces of damaged locations by using the epoxy adhesive and immediately bolted (before the curing was done) with each other by using M8 bolts to confine the concrete as shown in Fig. 4(b). A gap of 2.5 mm was kept initially between the short and the long legs of the adjacent L-shaped plates (Fig. 4(b)), so that the plates can confine the concrete cross-section when the bolts were tightened, by bending around its corner. The diameter of the bolt hole, the pitch and the edge distance of all the steel plates were maintained as 9 mm, 105 mm and 45 mm, respectively. However, the L-shaped plate arrangement was practically not viable for the tie beam. Hence, U-shaped plates were used, as shown in Fig. 4(a) for the tie beam. The U-shaped plate at the bottom beam was welded with the plates at the bottom of the column. Fig. 4(a) also shows the arrangement of plates at the top beam-column joint and at the top of the masonry infill wall, respectively. After the application of steel plates, the partial infill wall was constructed using fly-ash bricks used previously in the case of PIF, and the captivity in the columns was also kept same by constructing the wall in 50% of the opening area. The wall was thus cured for a period of 28 days thereafter. Fig. 5 shows the steel-jacketed partially infilled RC frame.

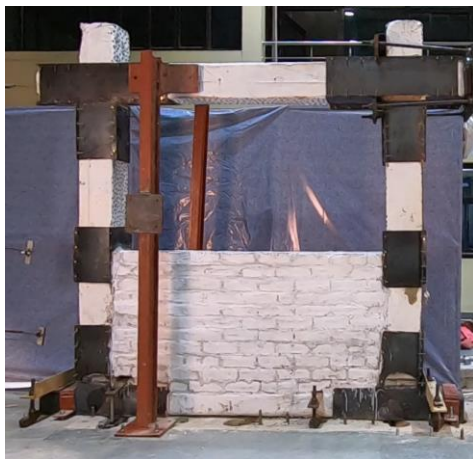
Fig. 5 Retrofitted partially infilled frame (DPIFR-GS)

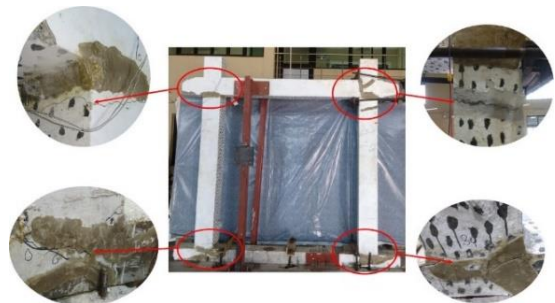
Fig. 10 Failure cracks in epoxy retrofitted bare frame (DBFR-G)

(Table 2). Therefore, the damages were shifted from the beam-column joint to the top of the column, as shown in Fig. 10. In the 75 mm cycle of loading (3% drift), the formation of hinges took place in the tie beam at the same locations (i.e., at bottom beam-column joint) as it was observed in BF by Kaushik *et al.* (2018). In the final cycle of 100 mm (4% drift), the cracks in the tie beam and column were enlarged, and the frame was no longer able to resist the further load. Similar failure was observed in the case of the bare frame tested by (Kumbasaroglu *et al.* 2017 and Basha *et al.* 2016), where the failure took place mainly due to the formation of hinges at the top beam-column joint and the bottom of the column.

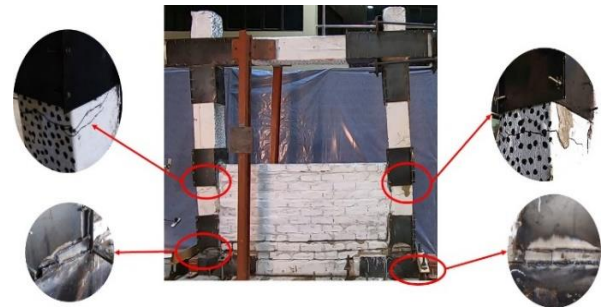
Fig. 14 Failure cracks in DPIFR-GS

plates of the column was ruptured and entirely separated in the windward column (Fig. 14), which led to the formation of hinges at the base beam-column joint thereby reducing the lateral strength of the frame drastically. Fig. 15 shows the comparative hysteresis curve of the partially infilled frame before and after retrofitting for 3.2% of drift value. Both PIF and DPIFR-GS showed symmetric behaviour in the push and the pull cycle.

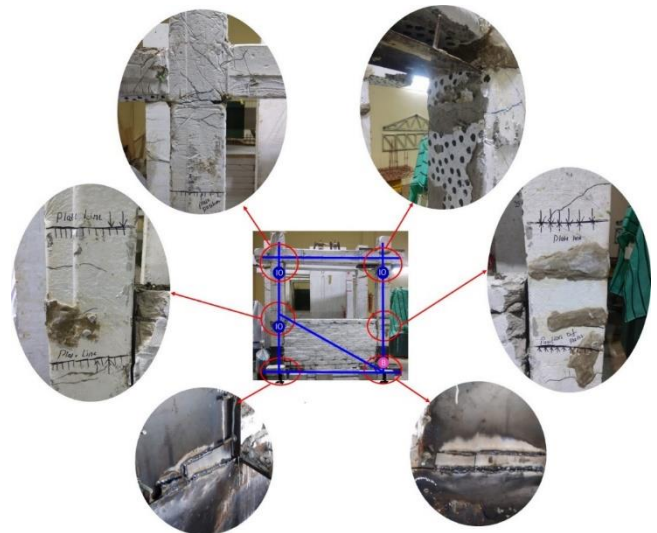
The visual inspection of the retrofitted partially infilled reinforced concrete frame (DPIFR-GS) indicated only a few minor cracks at the exposed surface of the structure (the region without steel plates) except at the places just below the mid-height of the column (where the steel plate ends).

Fig. 25. Damages in DPIFR-GS

The steel plates also appeared to be undamaged. The extent of the damage in the concrete beneath the steel plates was checked after removing the steel plates. The formation of cracks took place at the mid-height of the column beneath the steel plates due to the captive column effect. However, due to the confinement provided by the steel plates, the cracks were unable to propagate fully. This leads to the shifting of captive column failure in the region where the steel plates end, as shown in Fig. 25 (below the top of masonry infill).

The top beam-column joint (on the leeward side) has also developed many cracks under the steel plates. The diagonal pattern of the cracks is an indication of shear failure at the joints. The cracks were formed at the top of the windward column without affecting the joint region much, as shown in Fig. 25. All of these observations show that the steel plates were effective in sharing the load even after the concrete cracked.

The location and the extent of damage in DPIFR-GS are compared with the location and the state of hinges in the numerical model, as shown in Fig. 25. The shifting of the captive column failure below the top of the masonry infill in the undamaged concrete portion was synonymous with the formation of immediate occupancy hinge below the equivalent diagonal strut in the numerical model. Also, the formation of the immediate occupancy hinge at the top columns are indications of damages in the experimental frame.
