Post-Earthquake Assessment and Strengthening of a Cultural-Heritage Residential Masonry Building after the 2020 Zagreb Earthquake

3. Case Study-Building in the Street Ribnjak

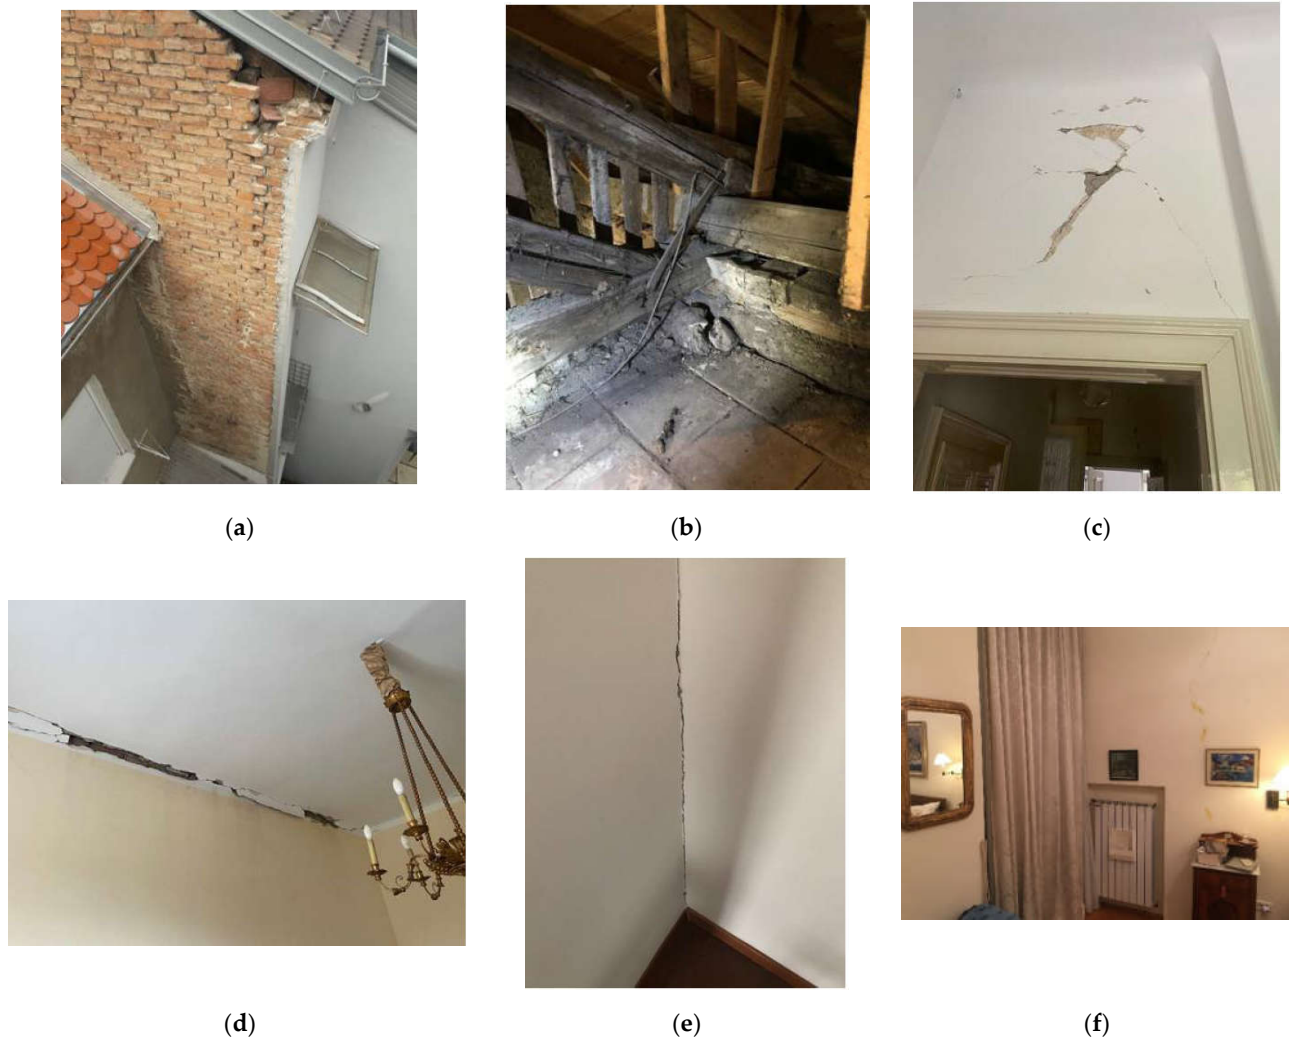
A detailed visual inspection of the building was performed on 28 June 2021. During the inspection, minor to moderate damage was noted. There was no damage observed in the basement. The most pronounced damage to the structure was observed at a gable wall, as it partially collapsed (Figure 7a). On the roof, the rotation of the purlins towards the outer part of the wall was observed. This is visible in several purlins where the rotation of the purlin located at the corner is minimal, whereas the maximum rotation is observed on the seventh purlin (Figure 7b). The chimney collapsed and immediately after the earthquake the roofing has been rehabilitated.

Figure 7. (a) Partial collapse of a gable wall; (b) oration of purlin's; (c) damage in the spandrels; (d) cracks at the contact of the ceiling; (e) vertical crack at the contact of two walls; (f) vertical crack along the wall [32]. Reproduced with permission from Projekt na kvadrat d.o.o., 2022.

The interpretation of the crack pattern can be of substantial assistance in understanding the structure's state of damage, its possible causes, and the type of survey to be performed [33]. Cracks were observed on the largest number of lintels, both vertical and diagonal in one direction and cross (diagonal) cracks (Figure 7c). Moreover, minor diagonal and X-pattern cracks are visible in the walls at the lintels (above the doors) and parapets between the windows on the façade. These are minor cracks that indicate that there has been an exceedance of the shear strength, but since the width of the cracks is small, it

enables the transfer of forces through friction. Additionally, vertical cracks were observed on the lintels near the openings. These are mostly minor cracks that are located at the top and bottom of the walls. The appearance of these smaller cracks in most cases is caused by arch action and indicates that the tensile strength has been exceeded. This represents characteristic damage to such structures. Some of the cracks were repaired after the earthquake. In any case, it is necessary to determine the exact width of the cracks and, depending on the degree of damage, the decision will be made regarding an appropriate rehabilitation method (injection of crack or installation of spiral reinforcement bars). The observed horizontal cracks, which were recorded at the bottom and top of the walls between the openings, occur mainly due to stress concentration along the corners of the opening. These are mostly minor cracks that can be rehabilitated with the injection process.

The floors of the ground and first floor of this URM building are made of light and flexible timber so the appearance of cracks in the ceiling structure was expected, as most probably there is no good connection between the floors and the wall and between the walls (Figure 7d,e). This is an additional parameter that makes these structures vulnerable to earthquakes. More severe damage was noted in wooden ceilings, load-bearing walls, and connection between the load-bearing walls and the ceiling. The cracks extend throughout the entire height of the wall at the connection of the two walls Figure 7e and along the height of the wall Figure 7f.

In this case, as the floor is flexible, the loads on the walls are transferred in relation to their surface, and not as per their stiffness as in the case of the structures with rigid floors which exhibit a “box” behavior [21]. The appearance of horizontal cracks located at the level of the floors and the gable wall was also observed. Generally, when it comes to very small movements (which is not the case here) sliding occurs on the surfaces between the wall and the floor structures, and in this case, it is a damage of a minor degree. In case the cracks are followed by dislocations in the value of several mm, it is a serious slip between the floor structure and the wall. In this case, it is necessary to carry out appropriate rehabilitation strengthening of the floor structure, and appropriate connection of the floor and the walls.

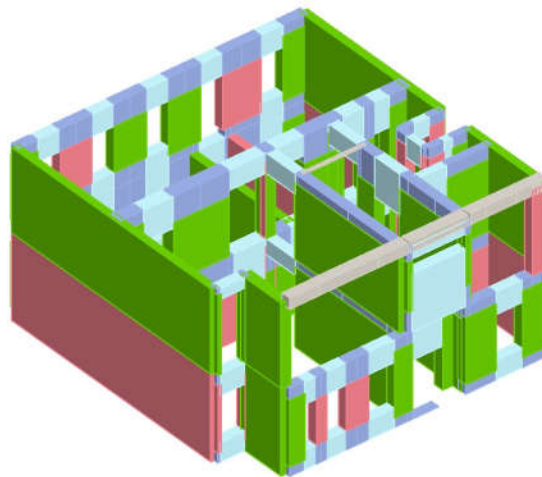
As in any calculations, first of all, static analyses are conducted. Due to very low masonry characteristics, many of the elements had already bending damage and did not possess adequate capacity to take over the gravity loads as indicated in Figure 12. According to the calculation, 32 out of 75 elements did not possess adequate vertical load resistance. This had a direct effect on the seismic capacity of the walls.

Figure 12. Damage stated due to static loads.

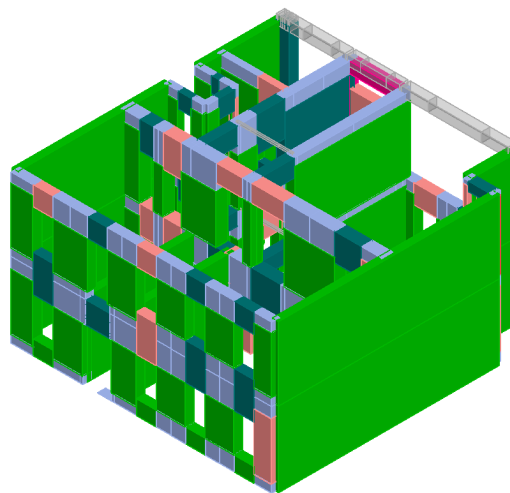
The type of damage at the maximum displacement capacity for X and Y directions is presented in Figures 14 and 15a. The predominant damage in the walls is caused by bending (pink). A rather similar situation is observed in the Y direction; however, additionally, one of the walls experienced shear failures (orange color) and bending failure (red color) (Figure 15b). The bending damage above the windows in the lintels is clearly observed on the façade wall (Figure 15c) and the visible cracks on the walls due to bending have been presented in Figure 7f.

Figure 14. Damage at maximum displacement capacity for pushover in the X direction.

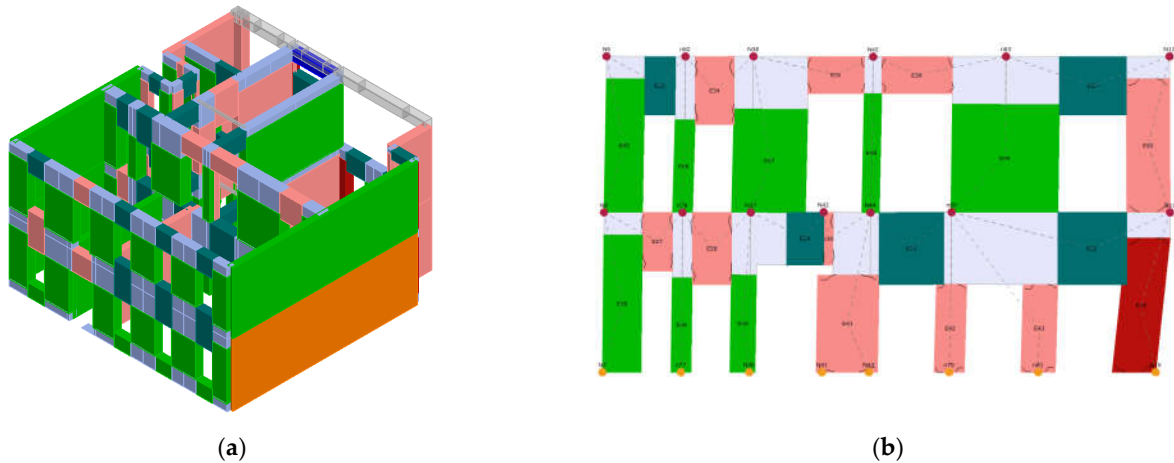
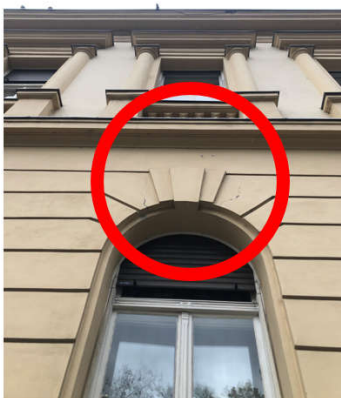
Figure 15. Damage at maximum displacement capacity for pushover in the Y direction; (a) shear failure of the wall; (b) bending failure of the wall; (c) bending damage above the windows in the lintels

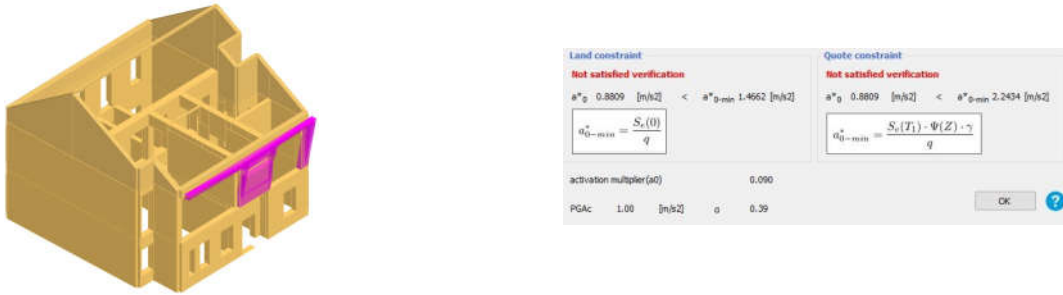
Besides checking the global in-plane behavior of masonry structures, it is as well necessary to check the out-of-plane behavior which is basically the first mode of failure in traditional URM structures, especially the ones with flexible diaphragms. The timber floors are usually not well connected to the walls and the connection of the walls is not constructed in a proper way, not providing a “box” behavior of the structure and leading to out-of-plane failures. As expected, the façade wall looking at the courtyard did not pass the out-of-plane verification (Figure 16). The failure mode is consistent with the 1st eigenfrequency mode.

Figure 16. Local mechanism out-of-plane failure of the façade wall.
