RISK ASSESSMENT OF MOULD EXPOSURE IN MINE SITE ACCOMMODATION BUILDINGS

The buildings are colloquially known as “Singlemens Quarters” or ”Dongas” and were located in the Pilbara Region of North-West Australia. Initial inspections were initiated by a flooding event; however, the investigation of the affected rooms identified several areas of existing mould damage. The main causes of the mould damage were refurbishments of wet bathroom areas into accommodation units and condensation from constant air-conditioning, which resulted in interior finishing’s & materials being below the dew point temperature. Extensive

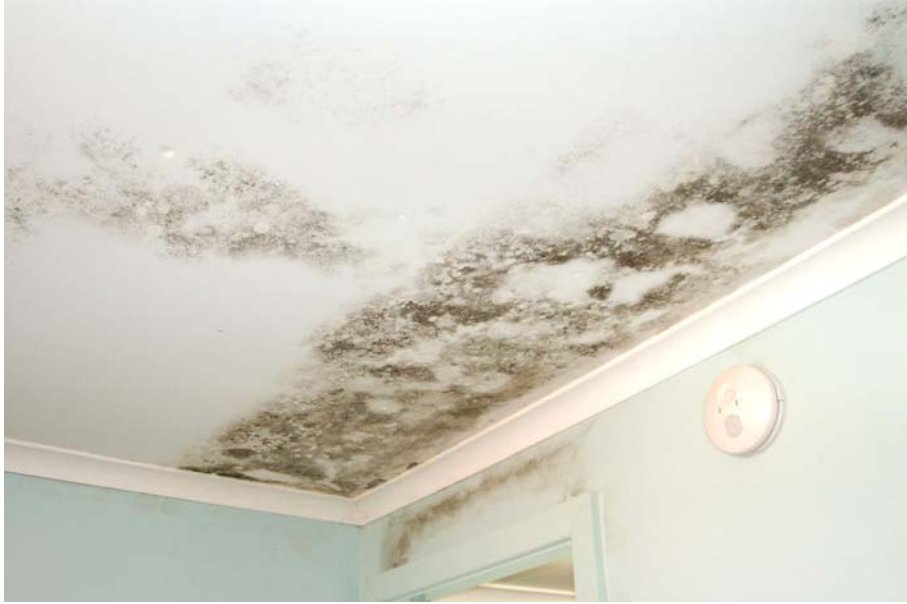
The initial inspection of the accommodation buildings revealed extensive visible mould growth throughout the gyprock ceiling and walls in the accommodation rooms. There was significant condensation and dew point problems on bulkheads and in the built in wardrobes caused by a combination of incorrect setting of air conditioning systems, lack of insulation and wide temperature range between the outside air and dead air spaces. The split system air conditioners were visibly mouldy with cooling coils, fins and fan cowling showing extensive mould growth.

Figure 1 Grade 4 Mould contamination on ceilings

- Patch up , gyprock walls and panels: Ensure appropriate insulation is installed
9. Removal of air- conditioning units
 - Wall Mounted air conditioning units in Grade 4 contaminated rooms removed and disposed off safely

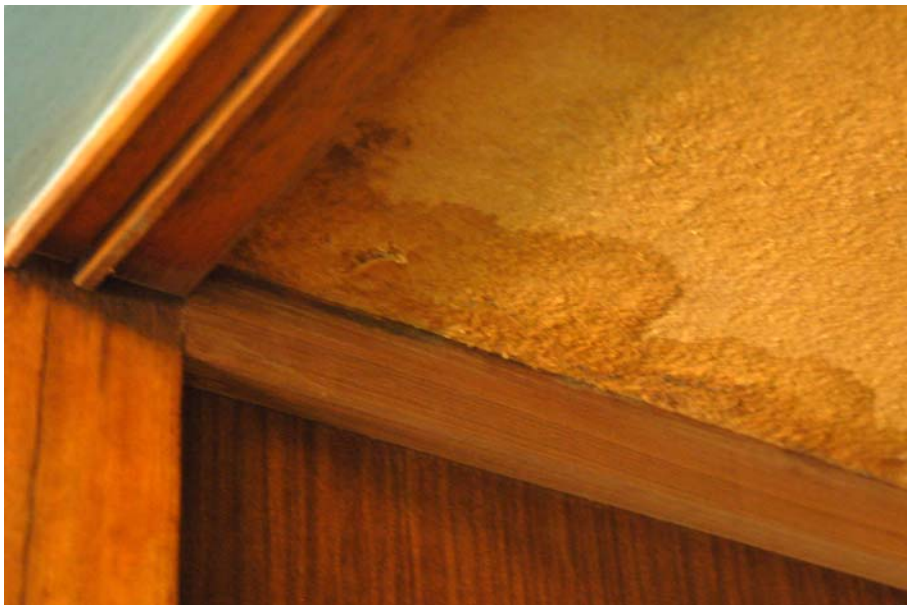
Figure 2 Water staining insides of built in wardrobes

- Lay out drop sheets; no power tools to be used; all waste material carefully placed into bins
5. Cutting out top of built in cupboards and removal of bulkheads

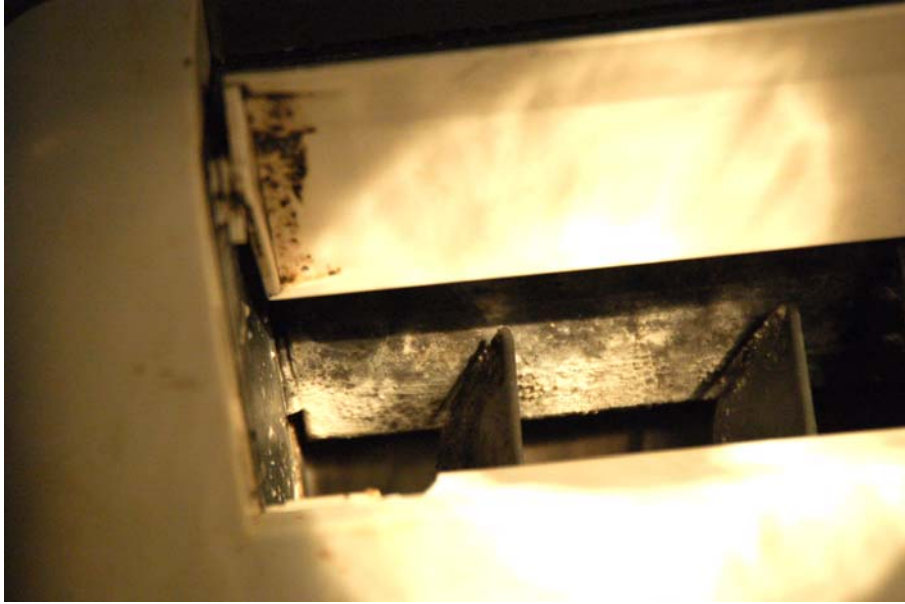
Figure 3 Mould Contaminated air conditioning fins

Surface sampling of the air conditioners tested showed extremely high (> 25,000 CFU/cm²) surface concentrations of fungal (mould) spores. Extremely High concentrations were detected on the air conditioning fins and the fan casing. This indicates that fungal growth was occurring on these surfaces. These results indicate that those surfaces require cleaning to remove mould growth.
