Risk Assessment of the Decay of Asbestos Cement Roofs

Objectives: In an assessment of the risk of asbestos fibres release from asbestos cement materials, an important role is played by the assessment of the surface corrosion and by the disaggregation of asbestos cement. The aim of this work is to evaluate the differences among several methods used for the risk assessment that lead to a specific choice of abatement techniques.

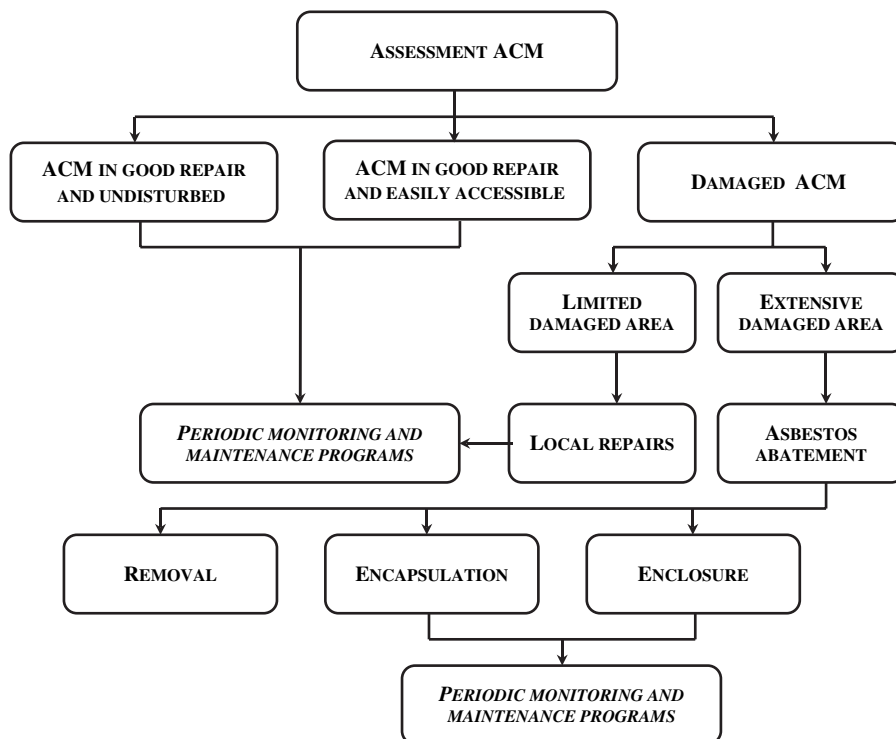
Fig. 1. Flow chart of ACM assessment.

The Ministerial Decree of 1994 identifies the criteria for a thorough assessment of the state of the materials, risks, inspections, maintenance, and abatement, as shown in the flow chart in Fig. 1. These criteria were adopted and integrated into the Ministerial Decree of 1999.

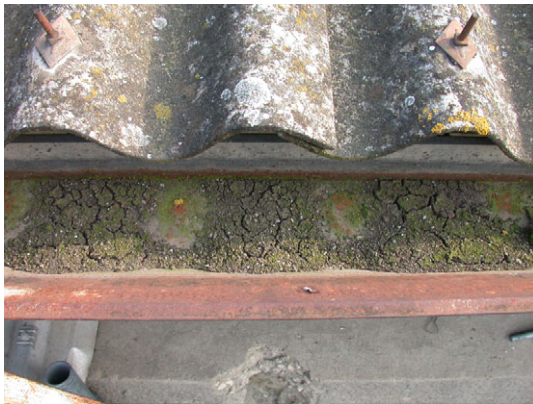
Fig. 2. Friable material in the gutter.

- the friability of the material;
- the state of the surfaces and in particular the presence of zones where asbestos fibres are surfacing;
- crumbling, cracks, or breakages;
- friable or pulverulent material next to eaves, gutters, etc. (Fig. 2);
- the presence of collections of materials forming small stalactites corresponding to seepage points (Fig. 3).

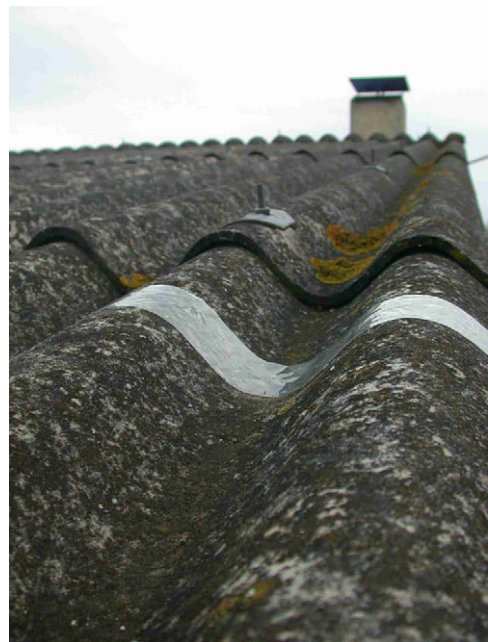
Fig. 4. Example of sampling by pull-up test.

In order to apply the pull-up test, the analysed surfaces must be dry (at least 48 h should have passed since the last episode of rain) and the sheets should not have been subjected to prior cleaning procedures. In the case of sheets that showed notable signs of moss, lichen, or mould, sampling took place in areas free of the latter. For each roof, at least three pieces of

adhesive tape were used. For the flat sheets, the adhesive tape was positioned parallel to one of the two sides for at least 20 cm avoiding overlapping. For the corrugated sheets, the adhesive tape was applied across the curve, for at least two complete curves (Fig. 4). After application, the adhesive tape was pulled delicately and was finally folded again on itself to avoid the loss of the collected material.
