# Occupational Exposure To Polychlorinated Dioxins, Polychlorinated Furans, Polychlorinated Biphenyls, and Biphenylenes after an Electrical Panel and Transformer Accident in an Office Building in Binghamton, NY

by Arnold Schechter\* and Thomas Tiernan†

A polychlorinated biphenyl (PCB) and tri- and tetrachlorinated benzene-containing electrical transformer was involved in an explosion and fire in a modern office building in Binghamton, New York, on February 5, 1981. Because of an unusual system of air shafts the entire building and adjacent garage became contaminated with toxic chemicals. Polychlorinated dioxins, furans, and biphenylenes were formed as pyrolytic by-products. Before the extent of the chemical contamination was appreciated workers were exposed to these chemicals. Four years after the explosion and after the expenditure of over \$22 million for cleaning and other expenses, the building remains closed.

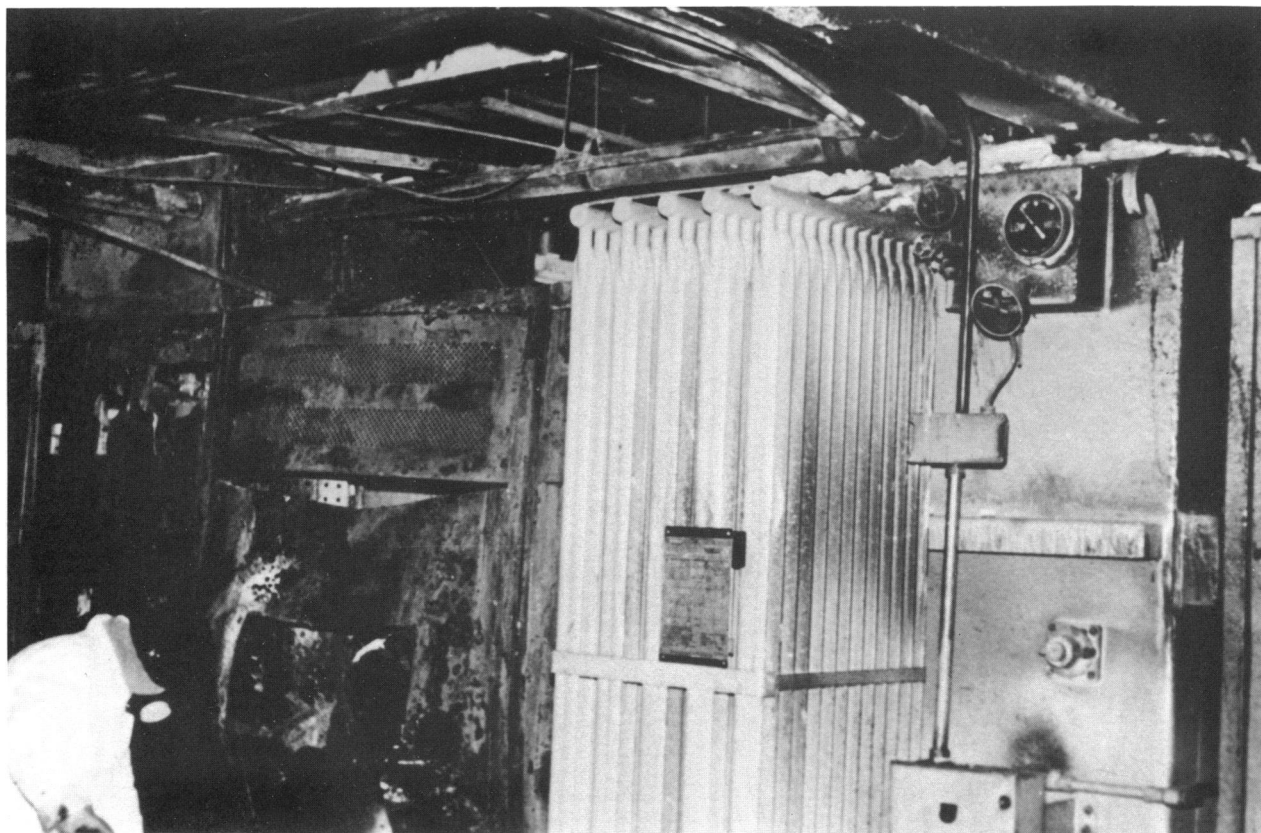
FIGURE 2. The damaged electrical panel is seen on the left behind a clean up worker. The damaged transformer is to the right of the panel. Soot is apparent on the panel and ceiling where burned wires and insulation are seen.

The affected transformer (Fig. 2) was located in the

basement of the Binghamton State Office Building, which is one of four government buildings, including the Broome County Building, Binghamton City Hall and the Binghamton City Council Building, sharing a common basement and subbasement level parking garage. Air

shafts in the ceiling of the transformer room extended to the top of the 18 story Binghamton State Office Building. These shafts ventilated the two bathrooms on each floor of the building and opened to these rooms by a small opening covered by a metal grating. During the

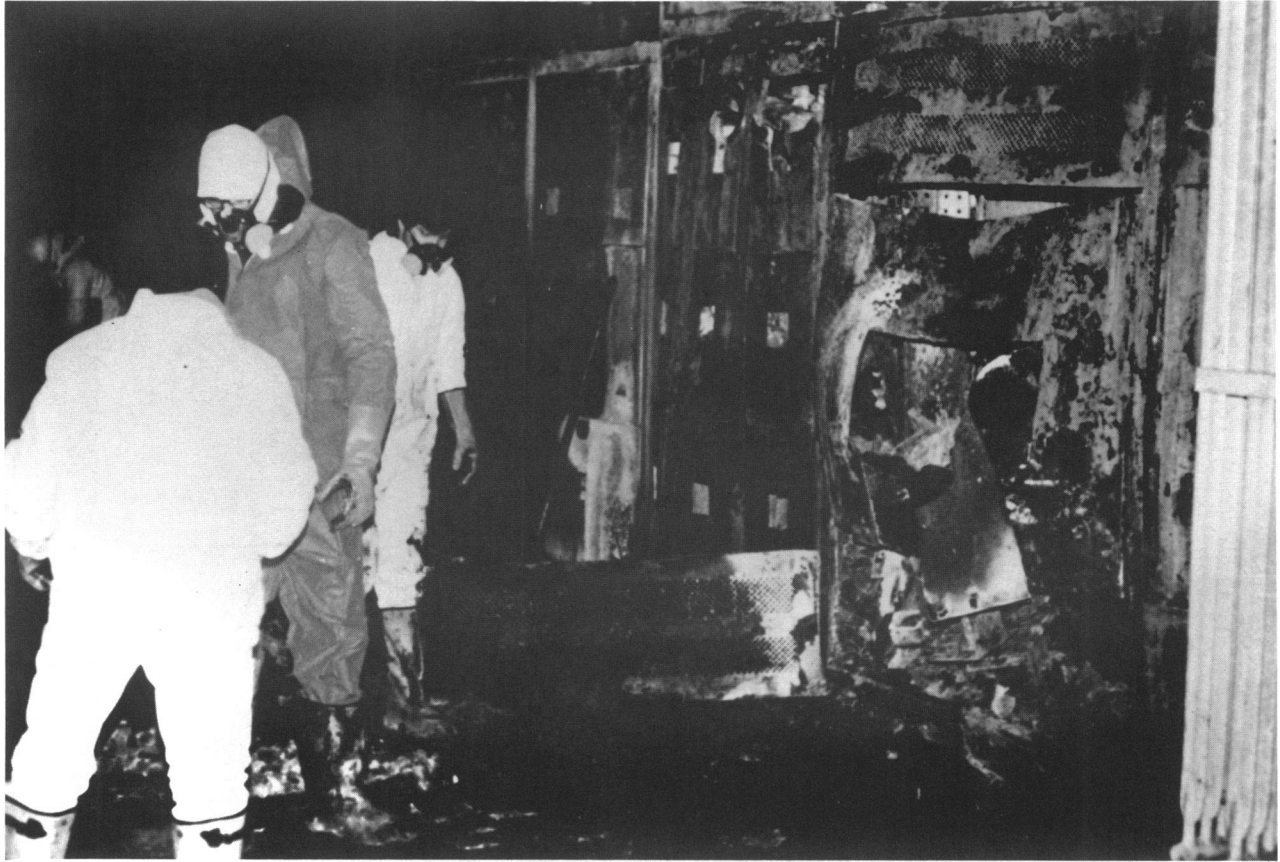
FIGURE 3. This photograph shows the damaged, soot-covered, electrical panel and several workers wearing different sorts of protective clothing over their street clothing. Respirators with cartridges filtering air and particulates are apparently being worn by these workers but full facial protective masks or oxygen breathing apparatus are not being used. These photographs were taken in February 1981.

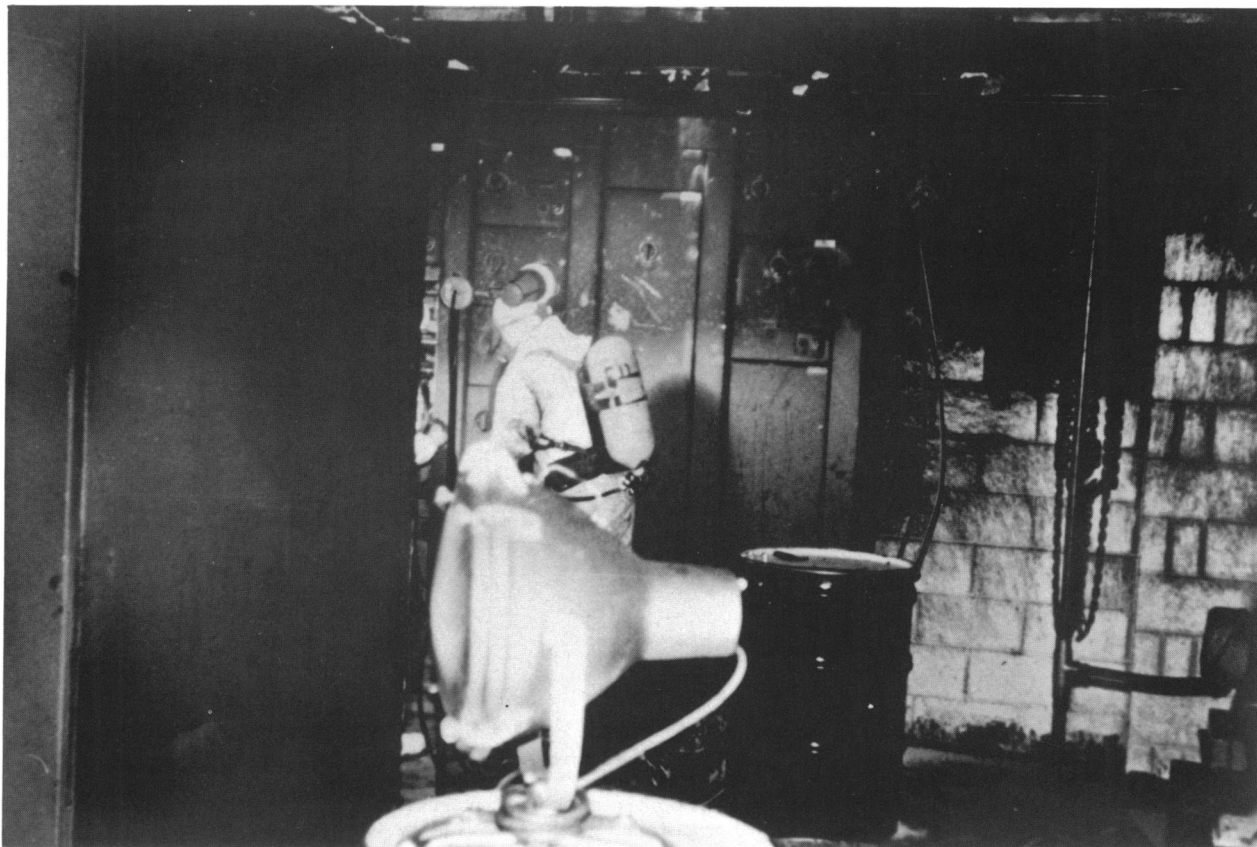
FIGURE 4. A worker wearing full air pack, self-contained breathing apparatus (SCUBA) and full face and body protection is shown working in the transformer room.

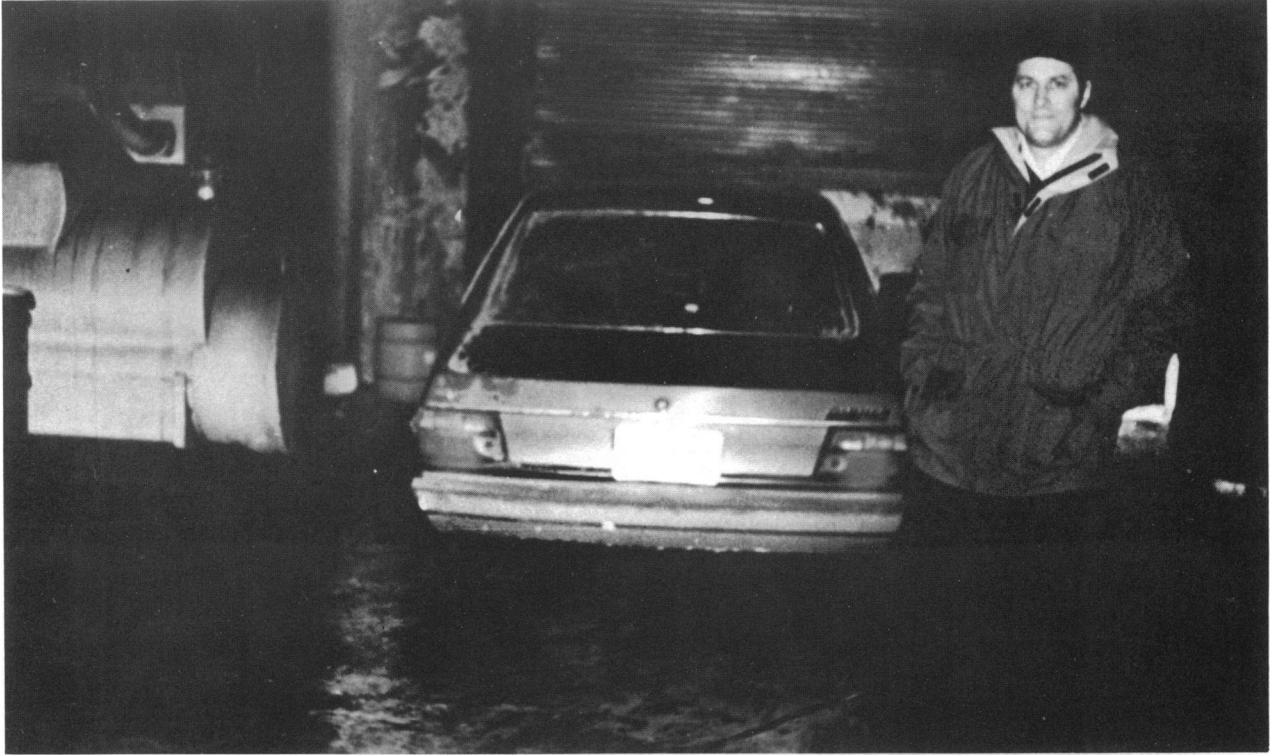
FIGURE 5. An engineer wearing no protective clothing or respirator is shown in a contaminated area. Ingestion of chemical contaminated soot and air is probable through the respiratory, dermal or gastrointestinal routes as is the potential for movement of chemicals to the home via contaminated clothing.

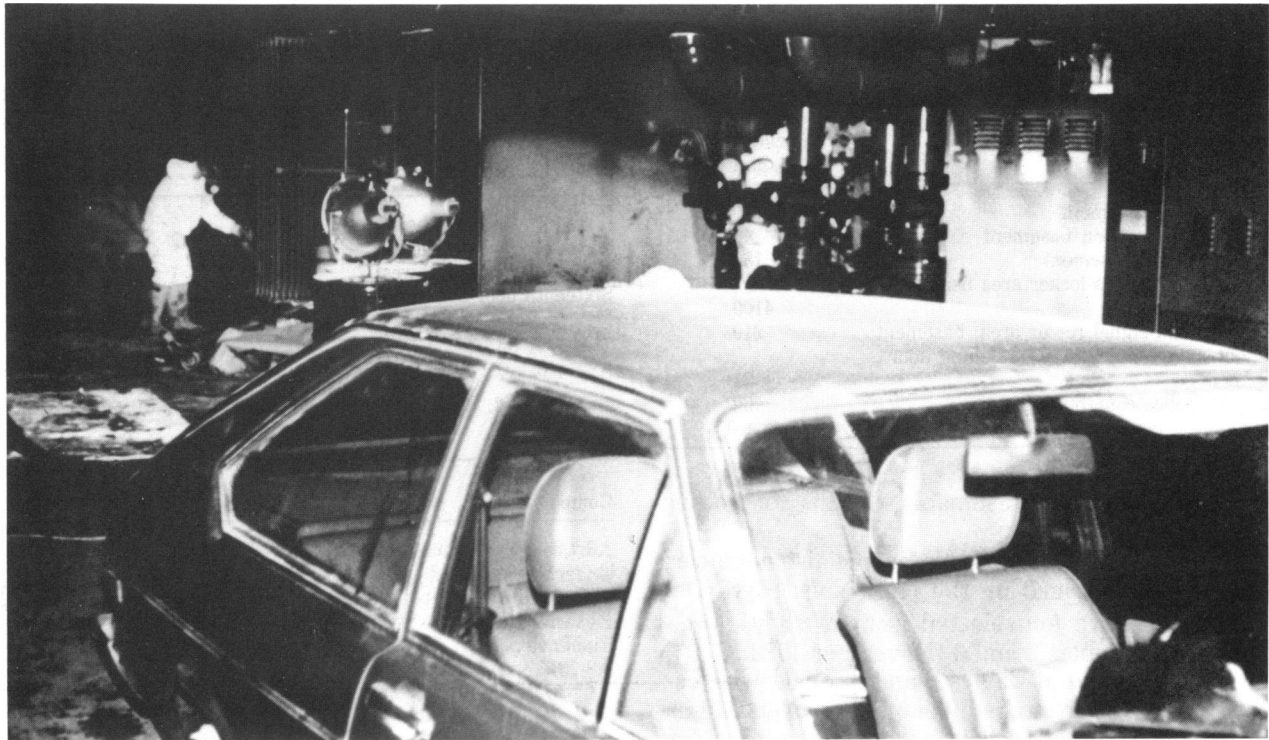
FIGURE 6. A car in the electrical room area was contaminated with PCBs and presumably other chemicals. The PCB contamination which can be visualized on top of the car could not be removed by repeated scrubbing and detergent in steam cleaning. The car was eventually removed to a toxic waste dump.

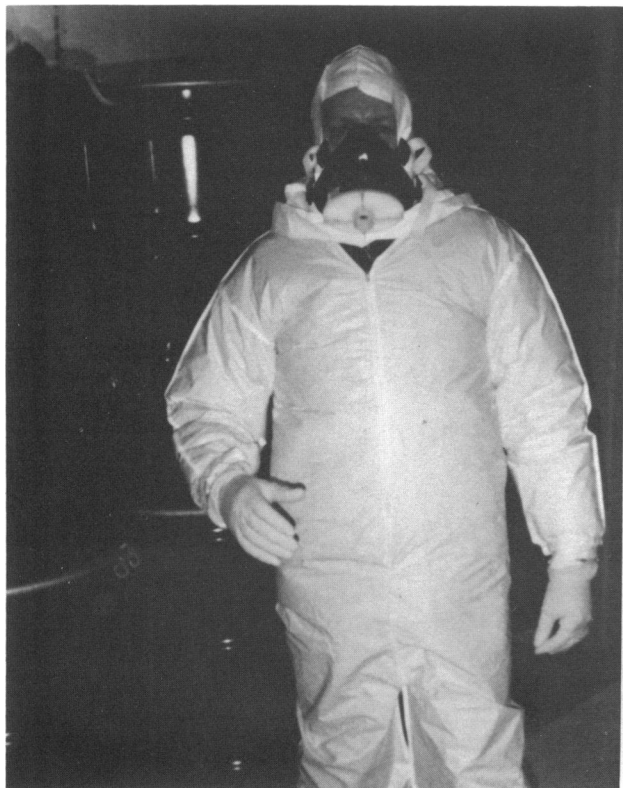
FIGURE 7. Various types of respirators and cartridges were used in the initial clean up during February 1981. Uncovered hair, face and eyes are seen, as is an apparently dust-type respirator as well as partially opened protective clothing over street clothes. Such irregularities document chemical exposure and pose a problem of patient evaluation and medical surveillance for the occupational medicine physician who may be involved afterwards. Direct measures of exposure such as sequential PCB blood or dioxin and furan adipose tissue determination may prove useful to better estimate exposure.

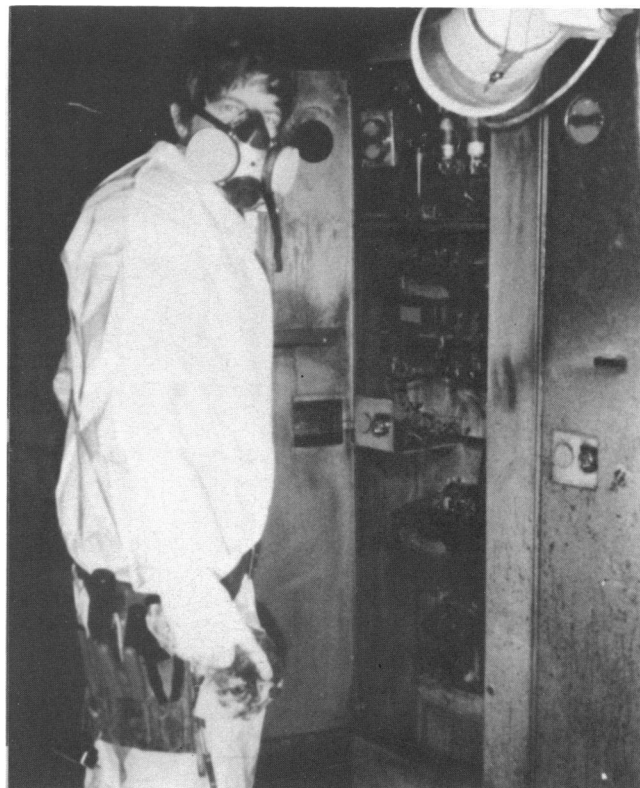
FIGURE 8. Contract electrician wearing street clothes, open protective clothing, a respirator without full face protection and apparently not a NIOSH-approved type of cartridge in his respirator. He later developed skin cancer on an exposed portion of his forehead.

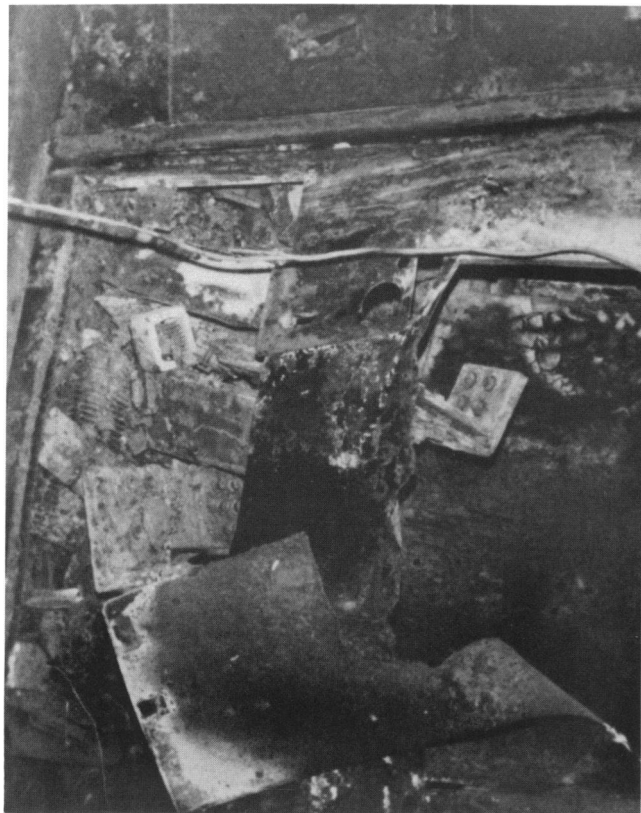
FIGURE 9. Intense heat at the electrical panel produced this damage. Metal panels are destroyed or bent by the heat of the electrical arcing.

rooms) better fuses and circuit breakers, prevention of surges in electricity reaching electrical panels and transformers, rapid methods for extinguishing fires, such as by noncombustible gases now used in some industries, or substitution of non-PCB and nonchlorinated benzene-containing equipment should be considered. The substituted material must also be evaluated for toxicity before replacement of PCB. Last, the health effect of most of these isomers in man is an unknown area, certainly one in which extensive medical research is urgently needed.

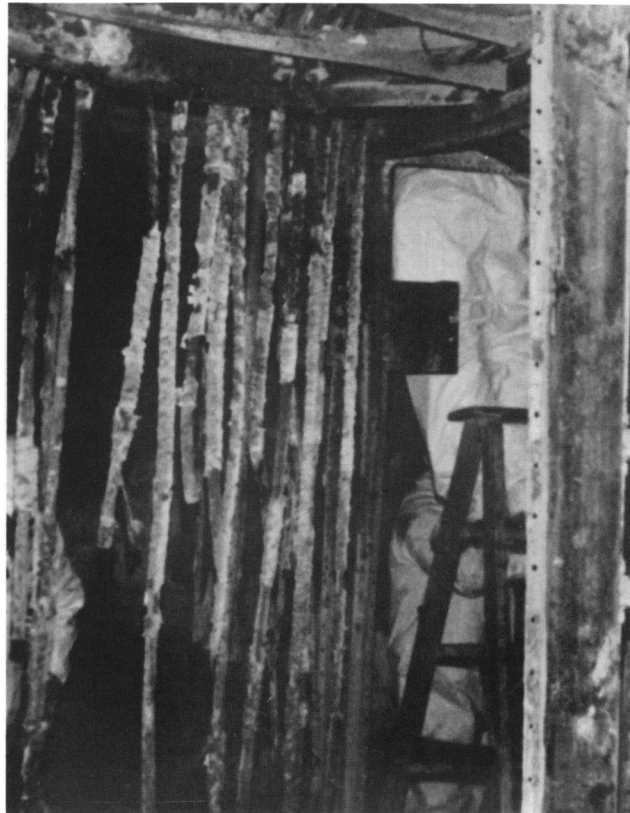
FIGURE 10. The intense heat burned the insulation from these wire cables. This implies other chemicals such as vinyl chloride may have been involved in the initial worker exposure, especially that of firefighters, police and supervisory workers, as well as photographers and other representatives of the press.
