SHEAR STRENGTH AND DEFORMATION MECHANISMS OF COMBINED AND CONFINED MASONRY WALLS SUBJECTED TO CYCLIC LOADING

Arturo Tena-Colunga¹, Artemio Juárez-Ángeles², and Víctor Hugo Salinas-Vallejo³

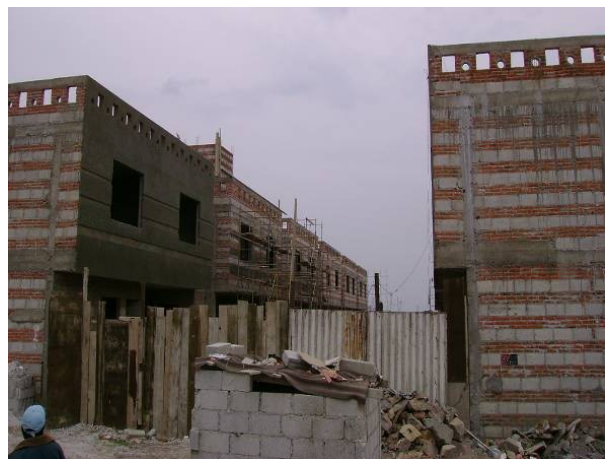
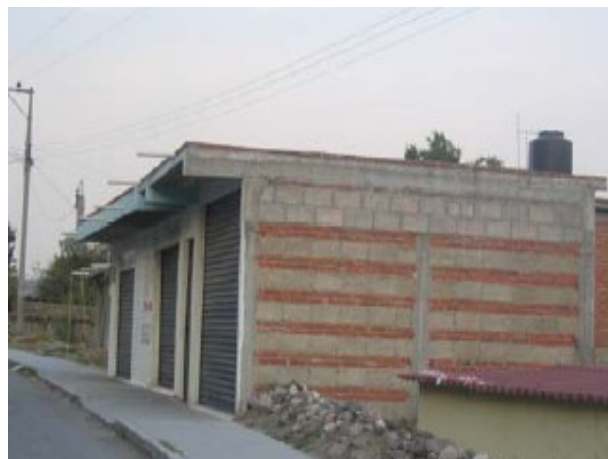
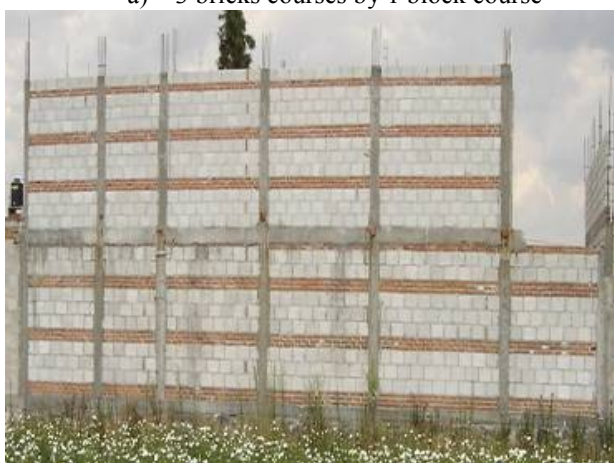
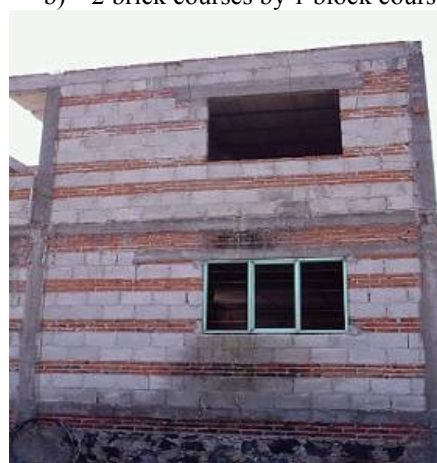
Figure 1. Combined and confined masonry construction

a) 3 bricks courses by 1 block course

b) 2 brick courses by 1 block courses

c) 3 brick courses by 3 block courses

d) 3 brick courses by 2 block courses

This modern version of combined and confined masonry has been being used since early 1990s. Different arrangements to combine and alternate brick courses with block courses have been used [1-4, Figure 1], but the one that it is more commonly used is the one depicted in Figure 1a, where three courses of clay bricks alternate with a course of concrete blocks.

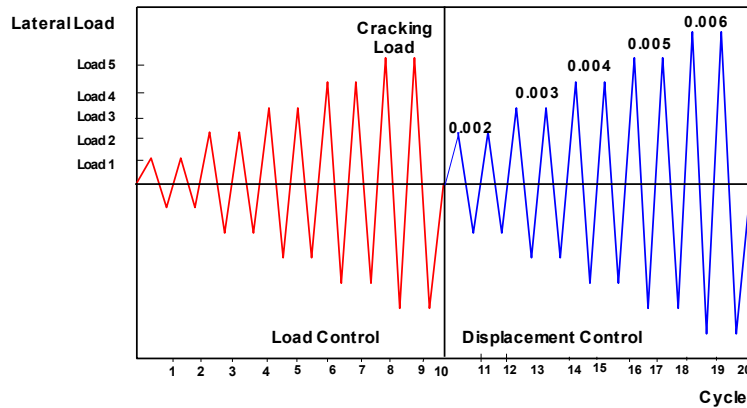
Figure 12. Cyclic testing protocol used

The cyclic testing of the walls was done following the general guidelines of Appendix A of NTCM-2004 [12] required for earthquake-resistant masonry wall systems. According to the testing protocol of reference, masonry walls have to be subjected to repeated cycles of at least 25%, 50% and 100% the estimated cracking load for the walls (load control, Figure 12) and, after the first cracking, walls have to be subjected to repeated cycles of increasing drift ratios of at least 0.2% (displacement control, Figure 12). In this research, both the load and the displacement control were done using additional steps, as schematically illustrated in Figure 12.

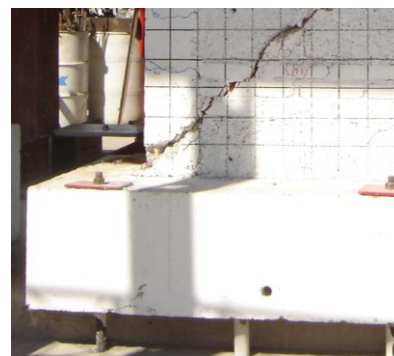
Figure 14. Shear crack penetration of confining RC columns of wall MCC-1 that lead to failure

Instability in the wall response triggered for a drift angle of 0.6% for wall MCC-1 after a major shear crack penetrated the confining column (Figure 14); this last half cycle is marked with a broken red line in Figure 13a.

a) Top right corner

b) Bottom left corner

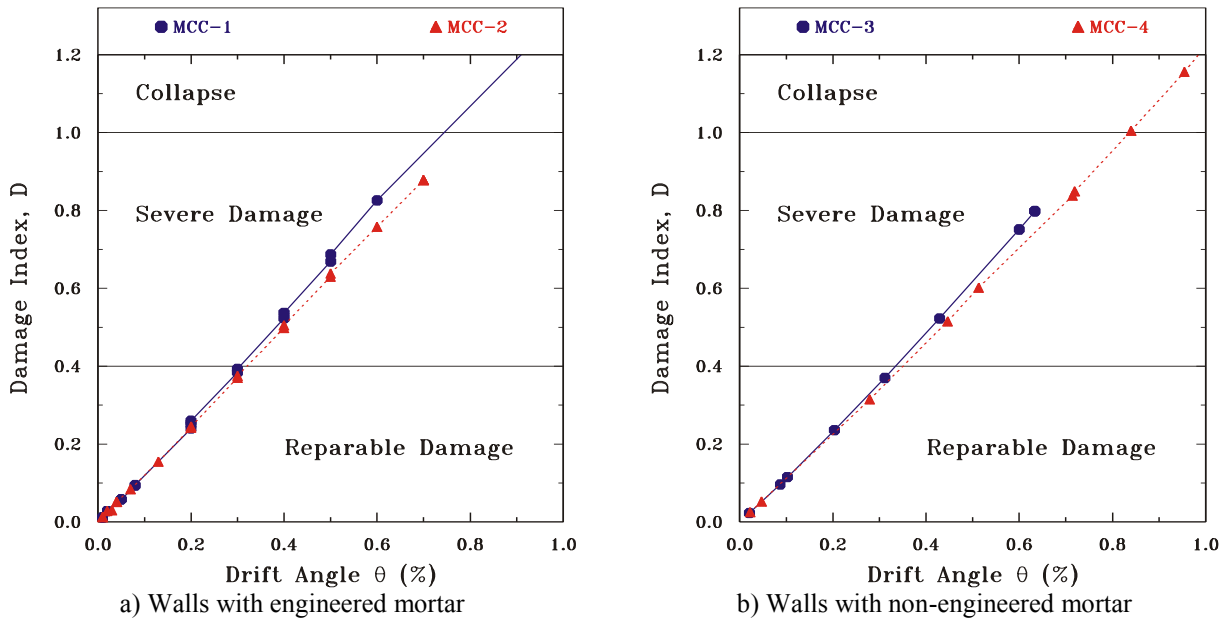
Figure 17. Modified Kwok-Ang damage index vs drift angle for combined and confined masonry walls.

Therefore, from the reduced database of the experiments described here, a preliminary value of $\varepsilon = 0.046$ was obtained for combined and confined masonry walls, as reported elsewhere [1-2]. Also, from the analysis of experimental data that allowed defining the limiting lateral drift ratio $\theta = 0.003$ for earthquake-resistant design purposes [1-3], it was clear that the limiting boundary value between repairable and severe damage should be $D = 0.4$ for combined and confined masonry. Therefore, the proposed damage index scale for combined and confined masonry is: a) No damage: $D = 0$, b) Repairable damage: $0 < D \leq 0.4$, c) Severe damage: $0.4 < D < 1.0$, d) Collapse: $D \geq 1$. The obtained damage index vs. drift ratio curves for the tested combined and confined masonry walls are depicted in Figure 17, where it can be

observed the proposed adjustments for the Kwok-Ang damage index seem reasonable for both the walls jointed with engineered (Figure 17a) and non-engineered (Figure 17b) mortar.
