Artemis Biosolutions
Case Study
School Carpet

Case Study Summary

- An Interface modular tile was presented to Interface Microbiology Services
- The tile was from an independent school system in the mid-west
- The tile had patches of darkened stains

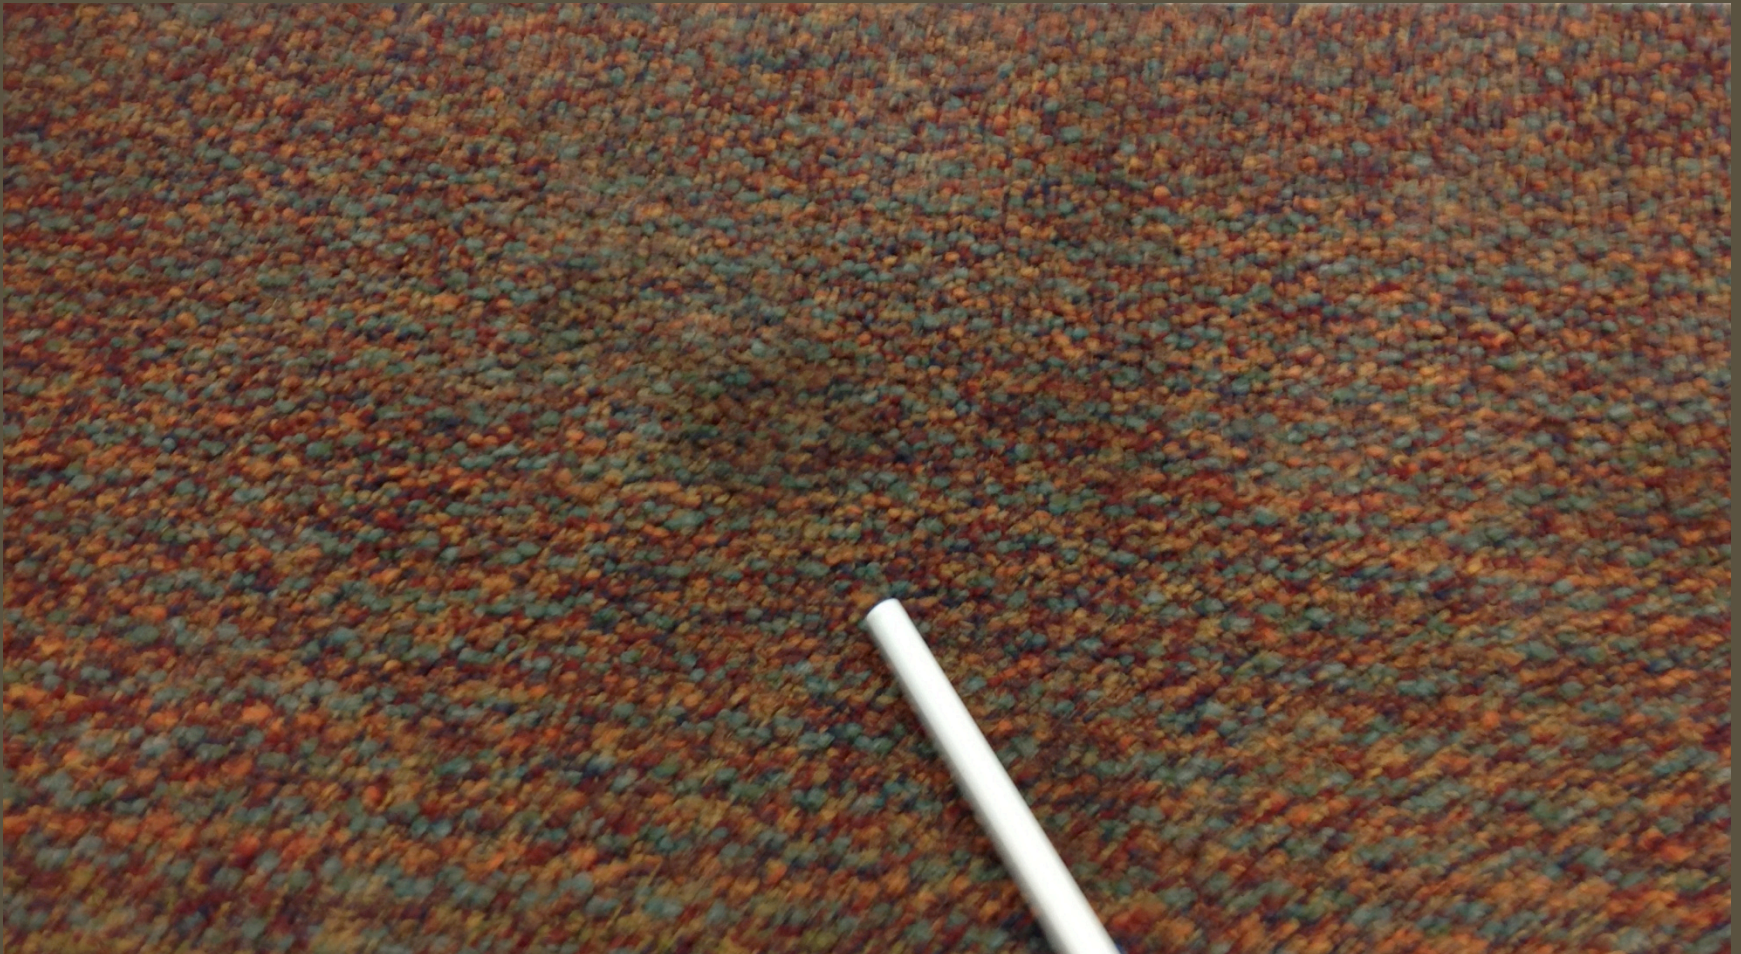
Soiled carpet developed patches of mold

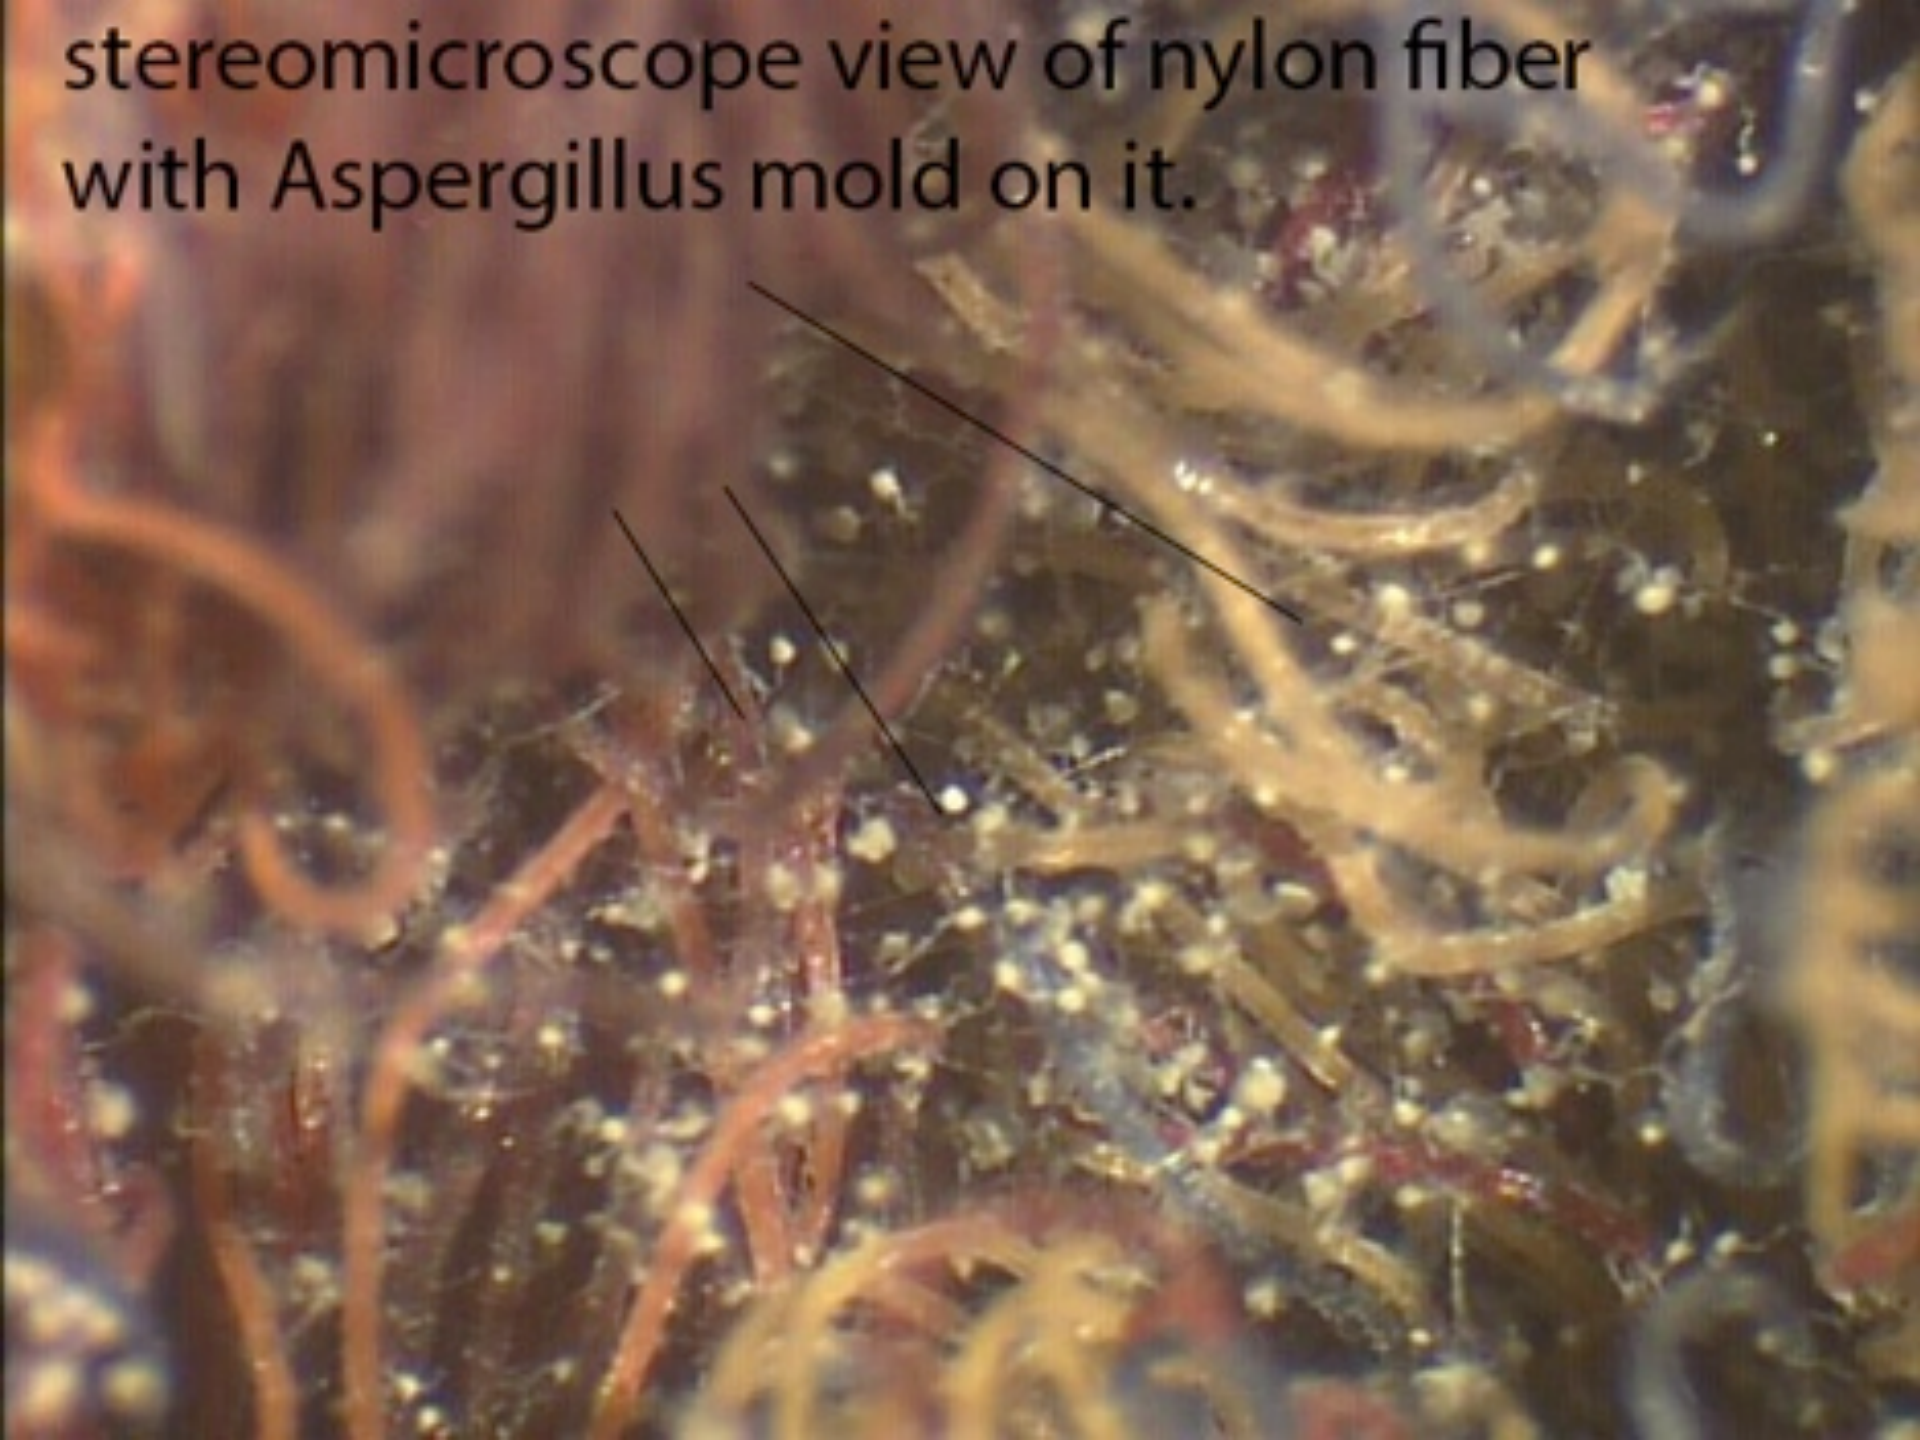
stereomicroscope view of nylon fiber
with *Aspergillus* mold on it.

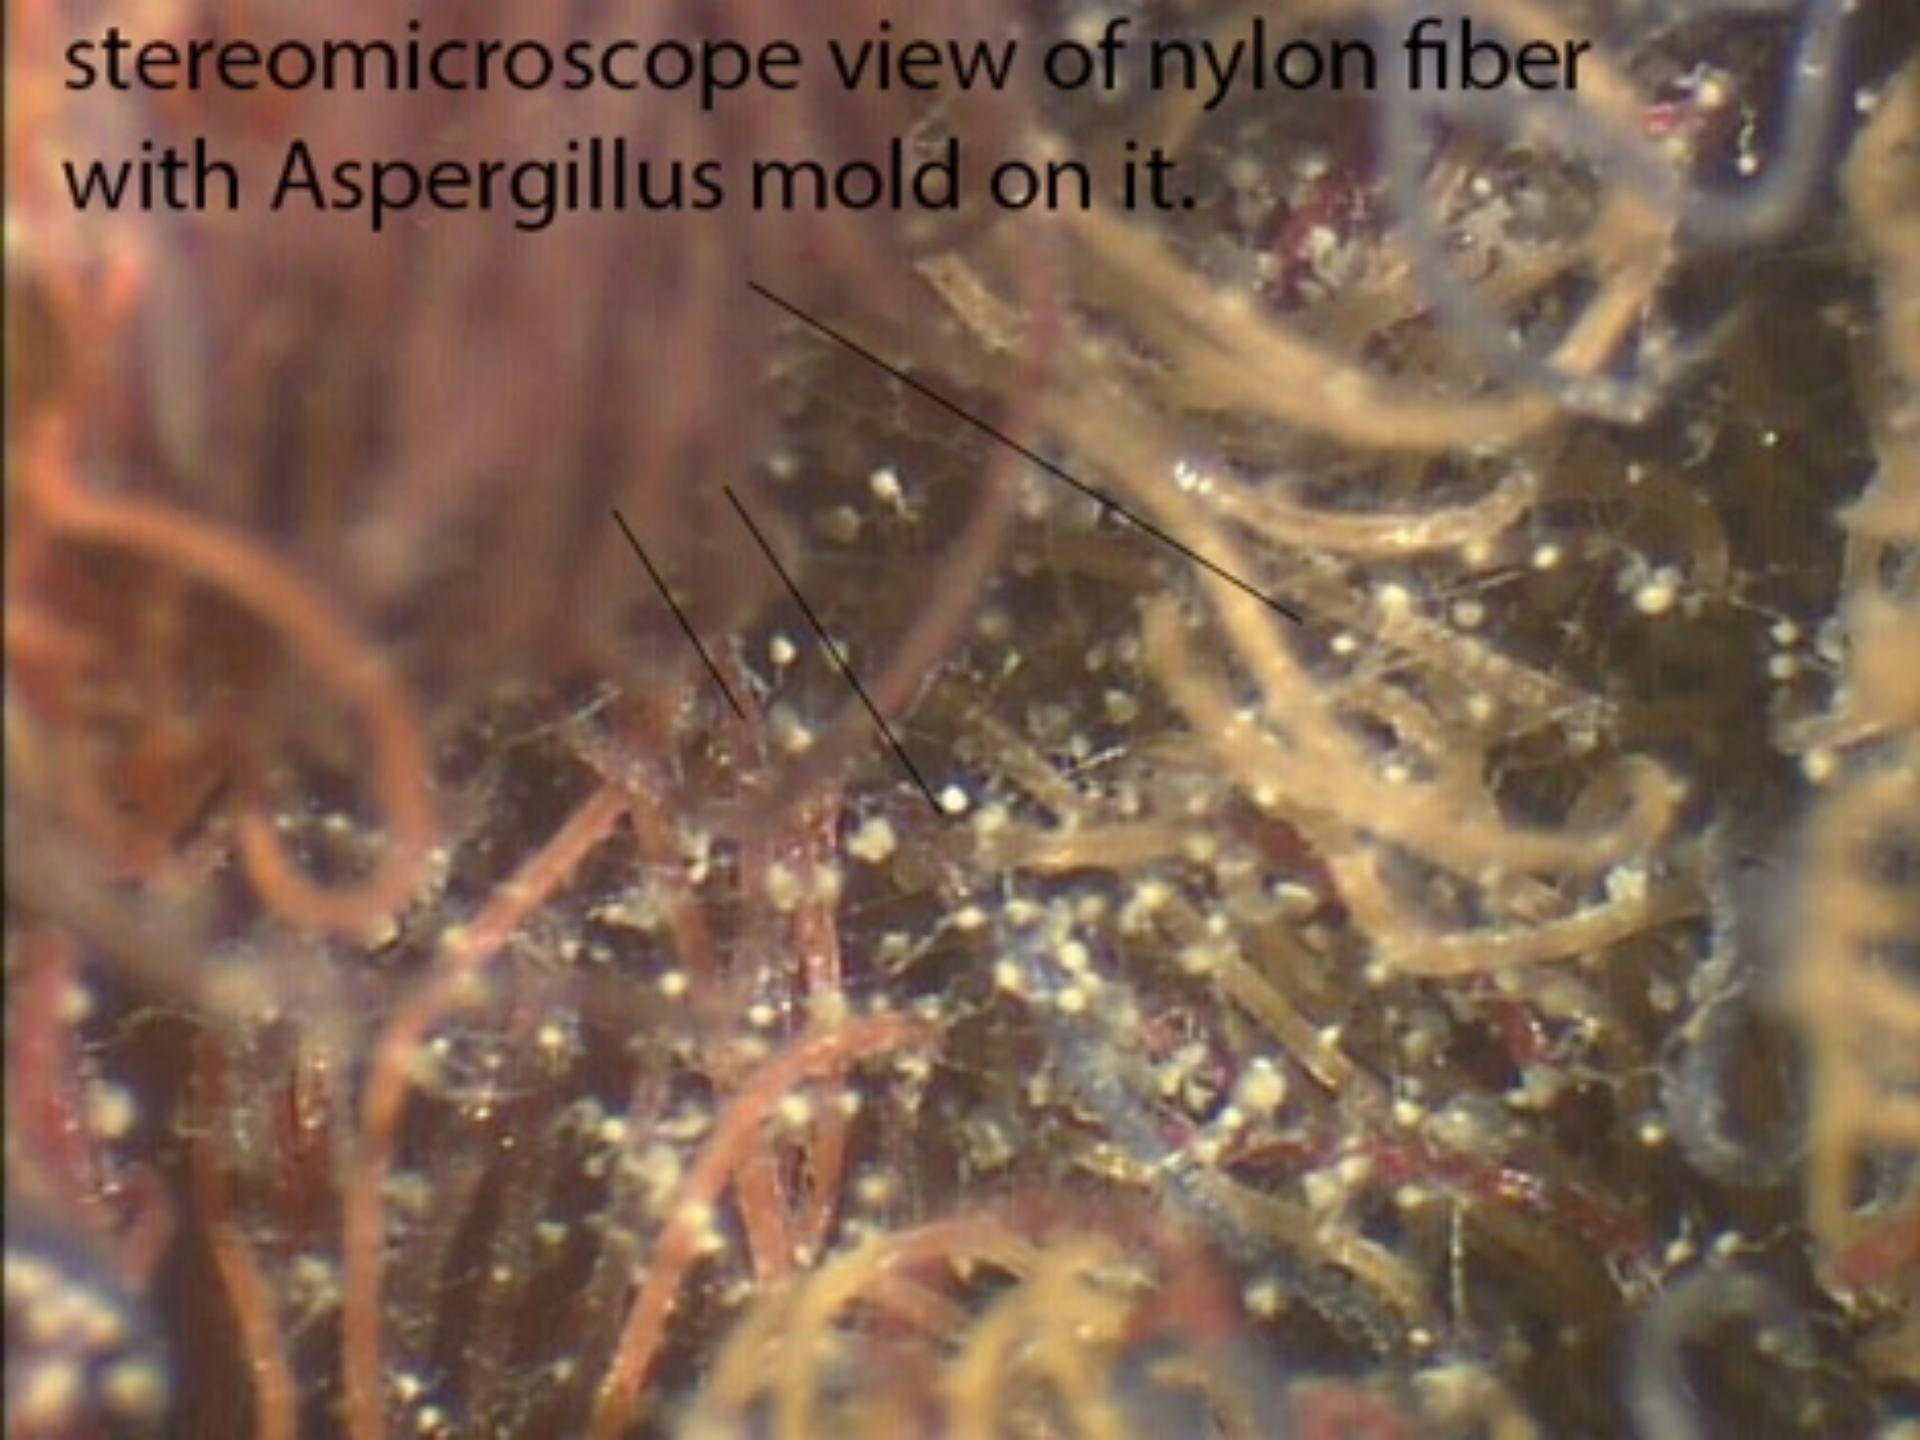
stereomicroscope view of nylon fiber
with *Aspergillus* mold on it.

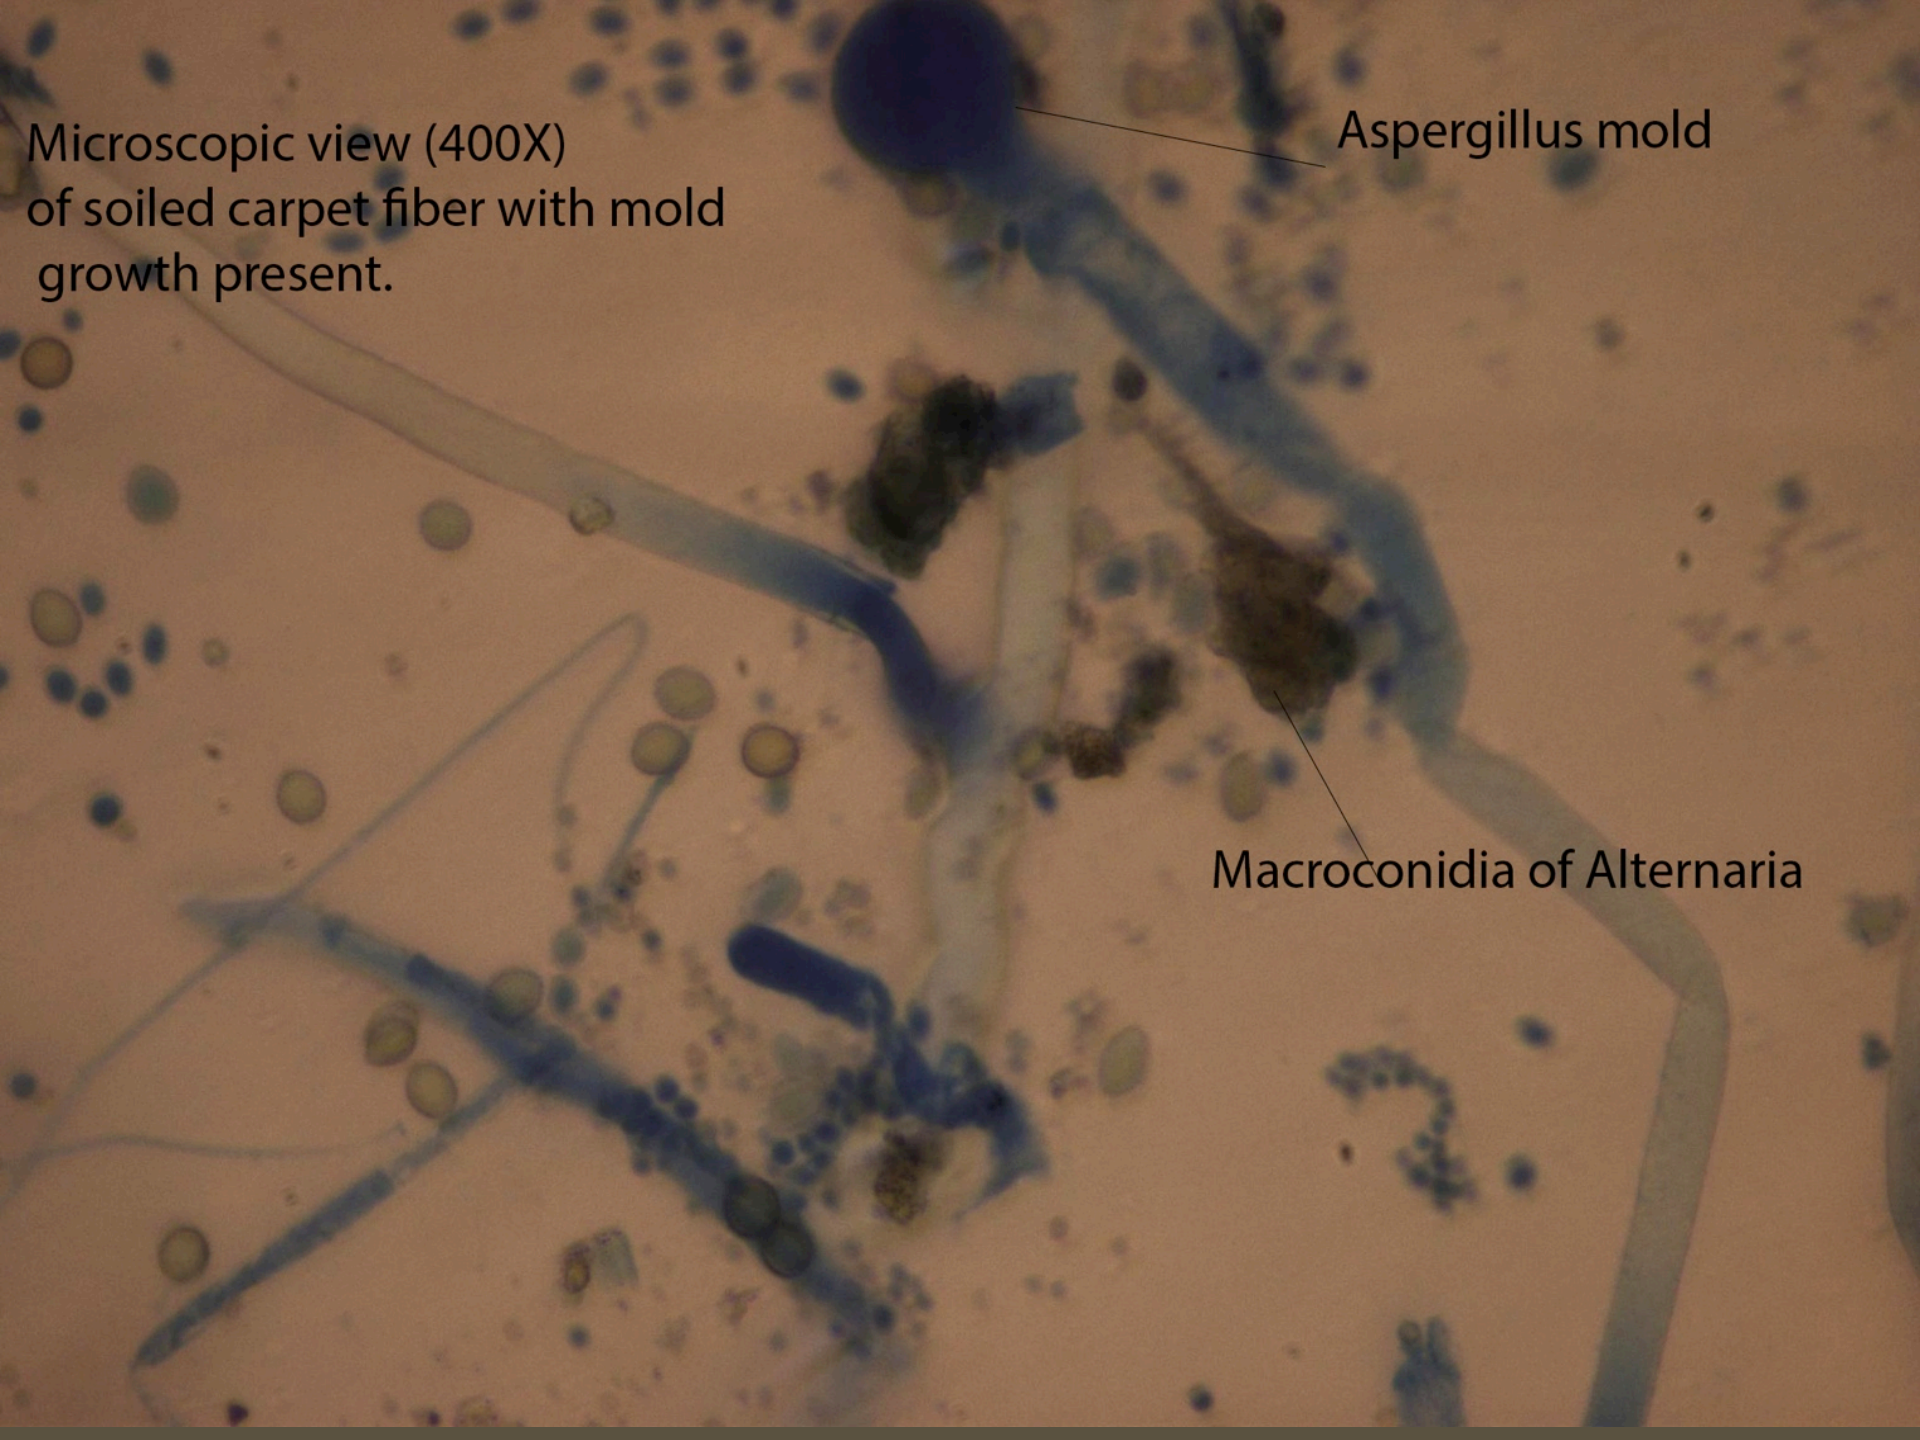
Microscopic view (400X)
of soiled carpet fiber with mold
growth present.

Aspergillus mold

Macroconidia of Alternaria

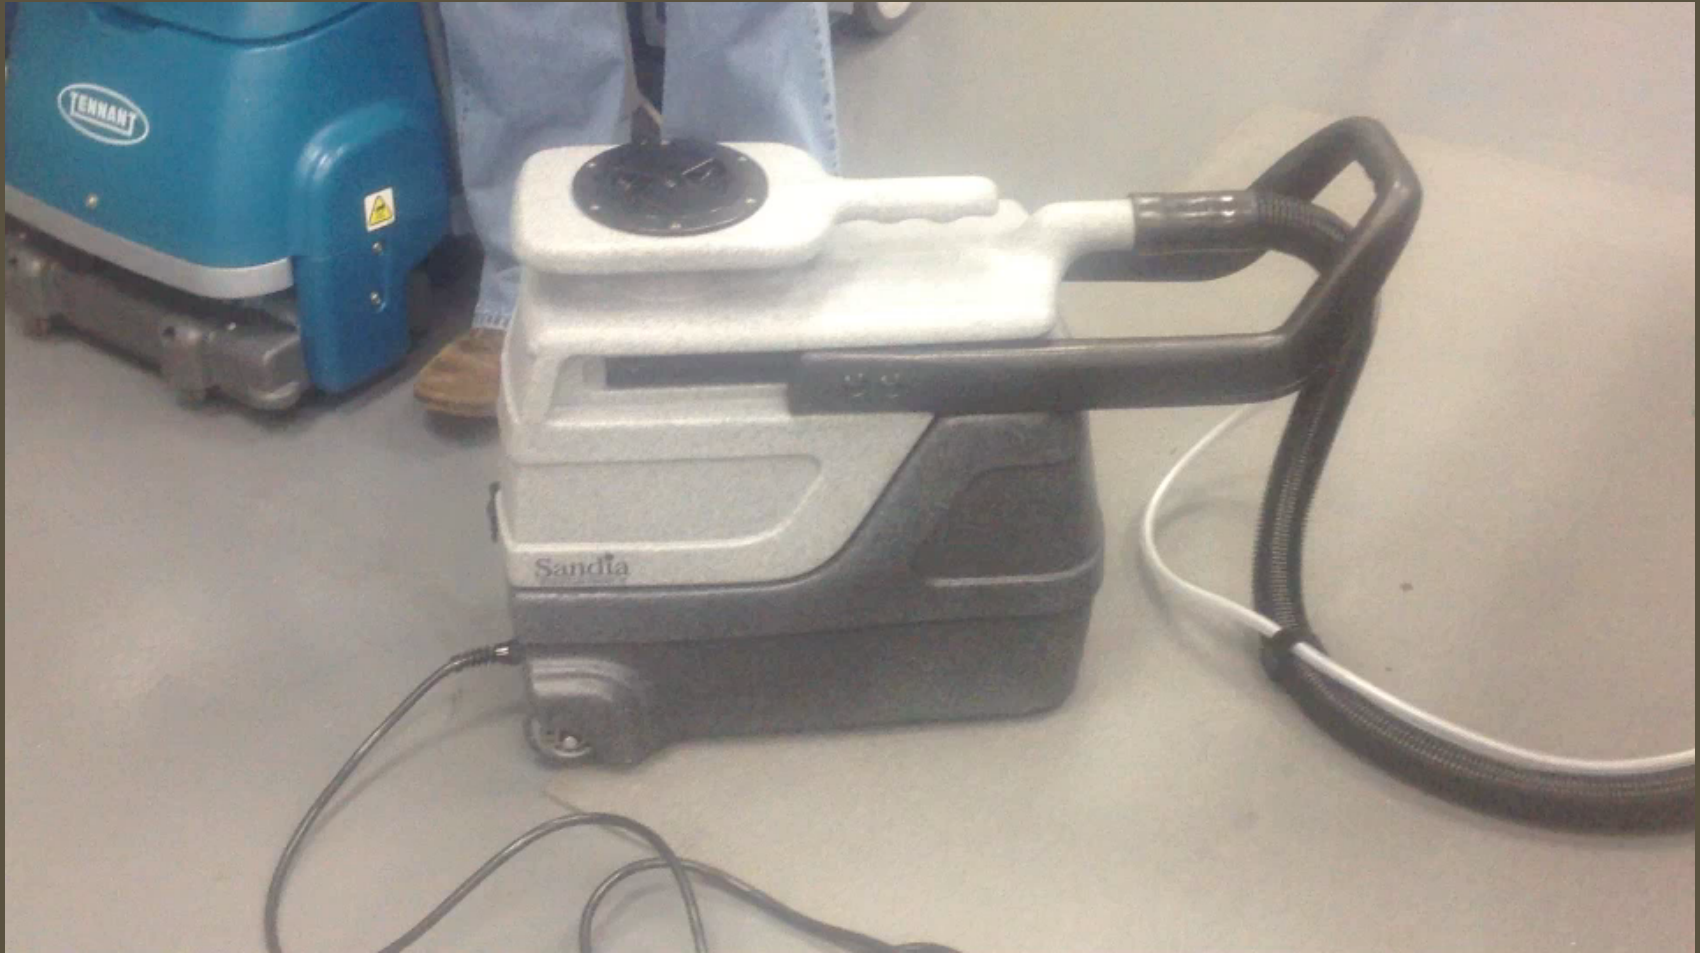
Spot Extraction Sandia 3 Gallon Extractor

- Carpet was pre-spotted with Artemis Biosolutions Carpet (50:50 side A and side B) , brush agitated into the pile, allowed to stand 15 minutes
- A dual motor-3 gallon extractor (Sandia) was used to vacuum extract soil and biocontaminants from the carpet
- The extractor used diluted Artemis Biosolutions product at 2 oz per gallon each (Side A and Side B)
- The pre-spotting and extraction procedure was repeated twice with extra vacuum only passes to remove residual moisture
- Carpet was allowed to air dry 24 hours prior to any further processing

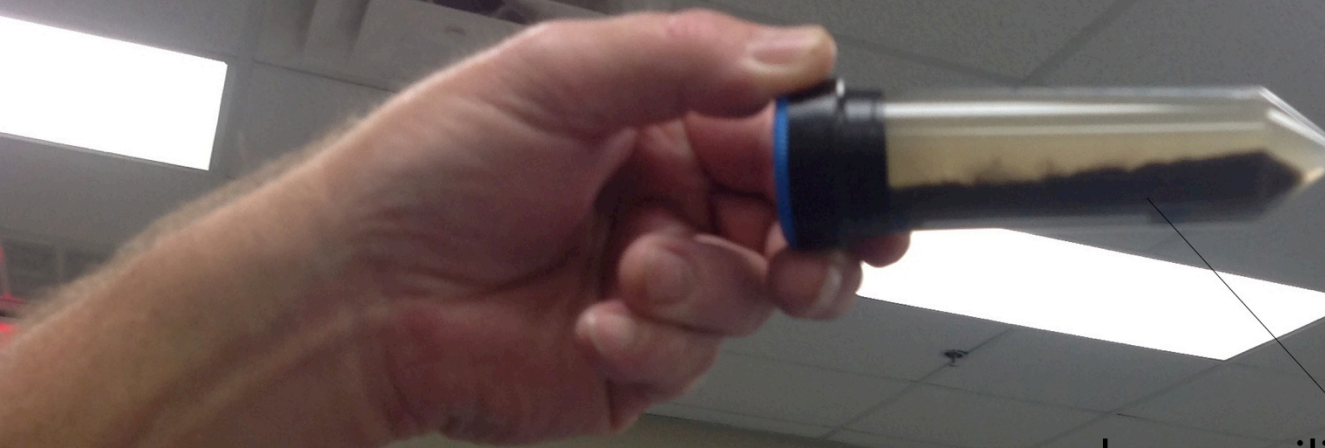
Appearance of extraction recovery water from 1/2 IPS 48 carpet tile

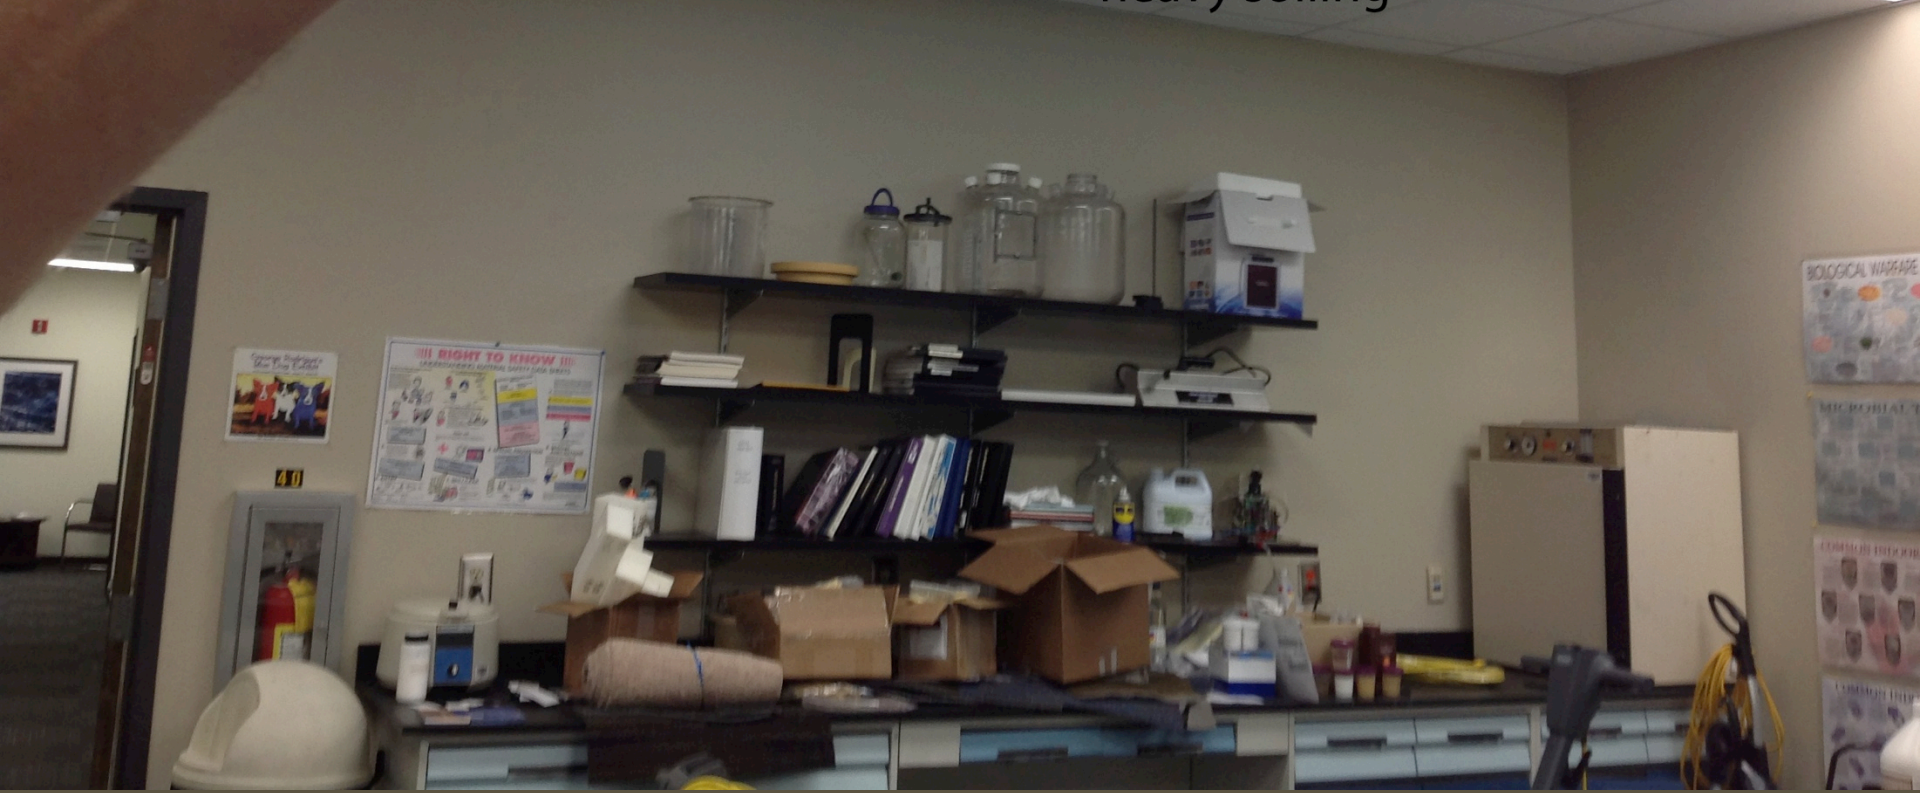
heavy soiling

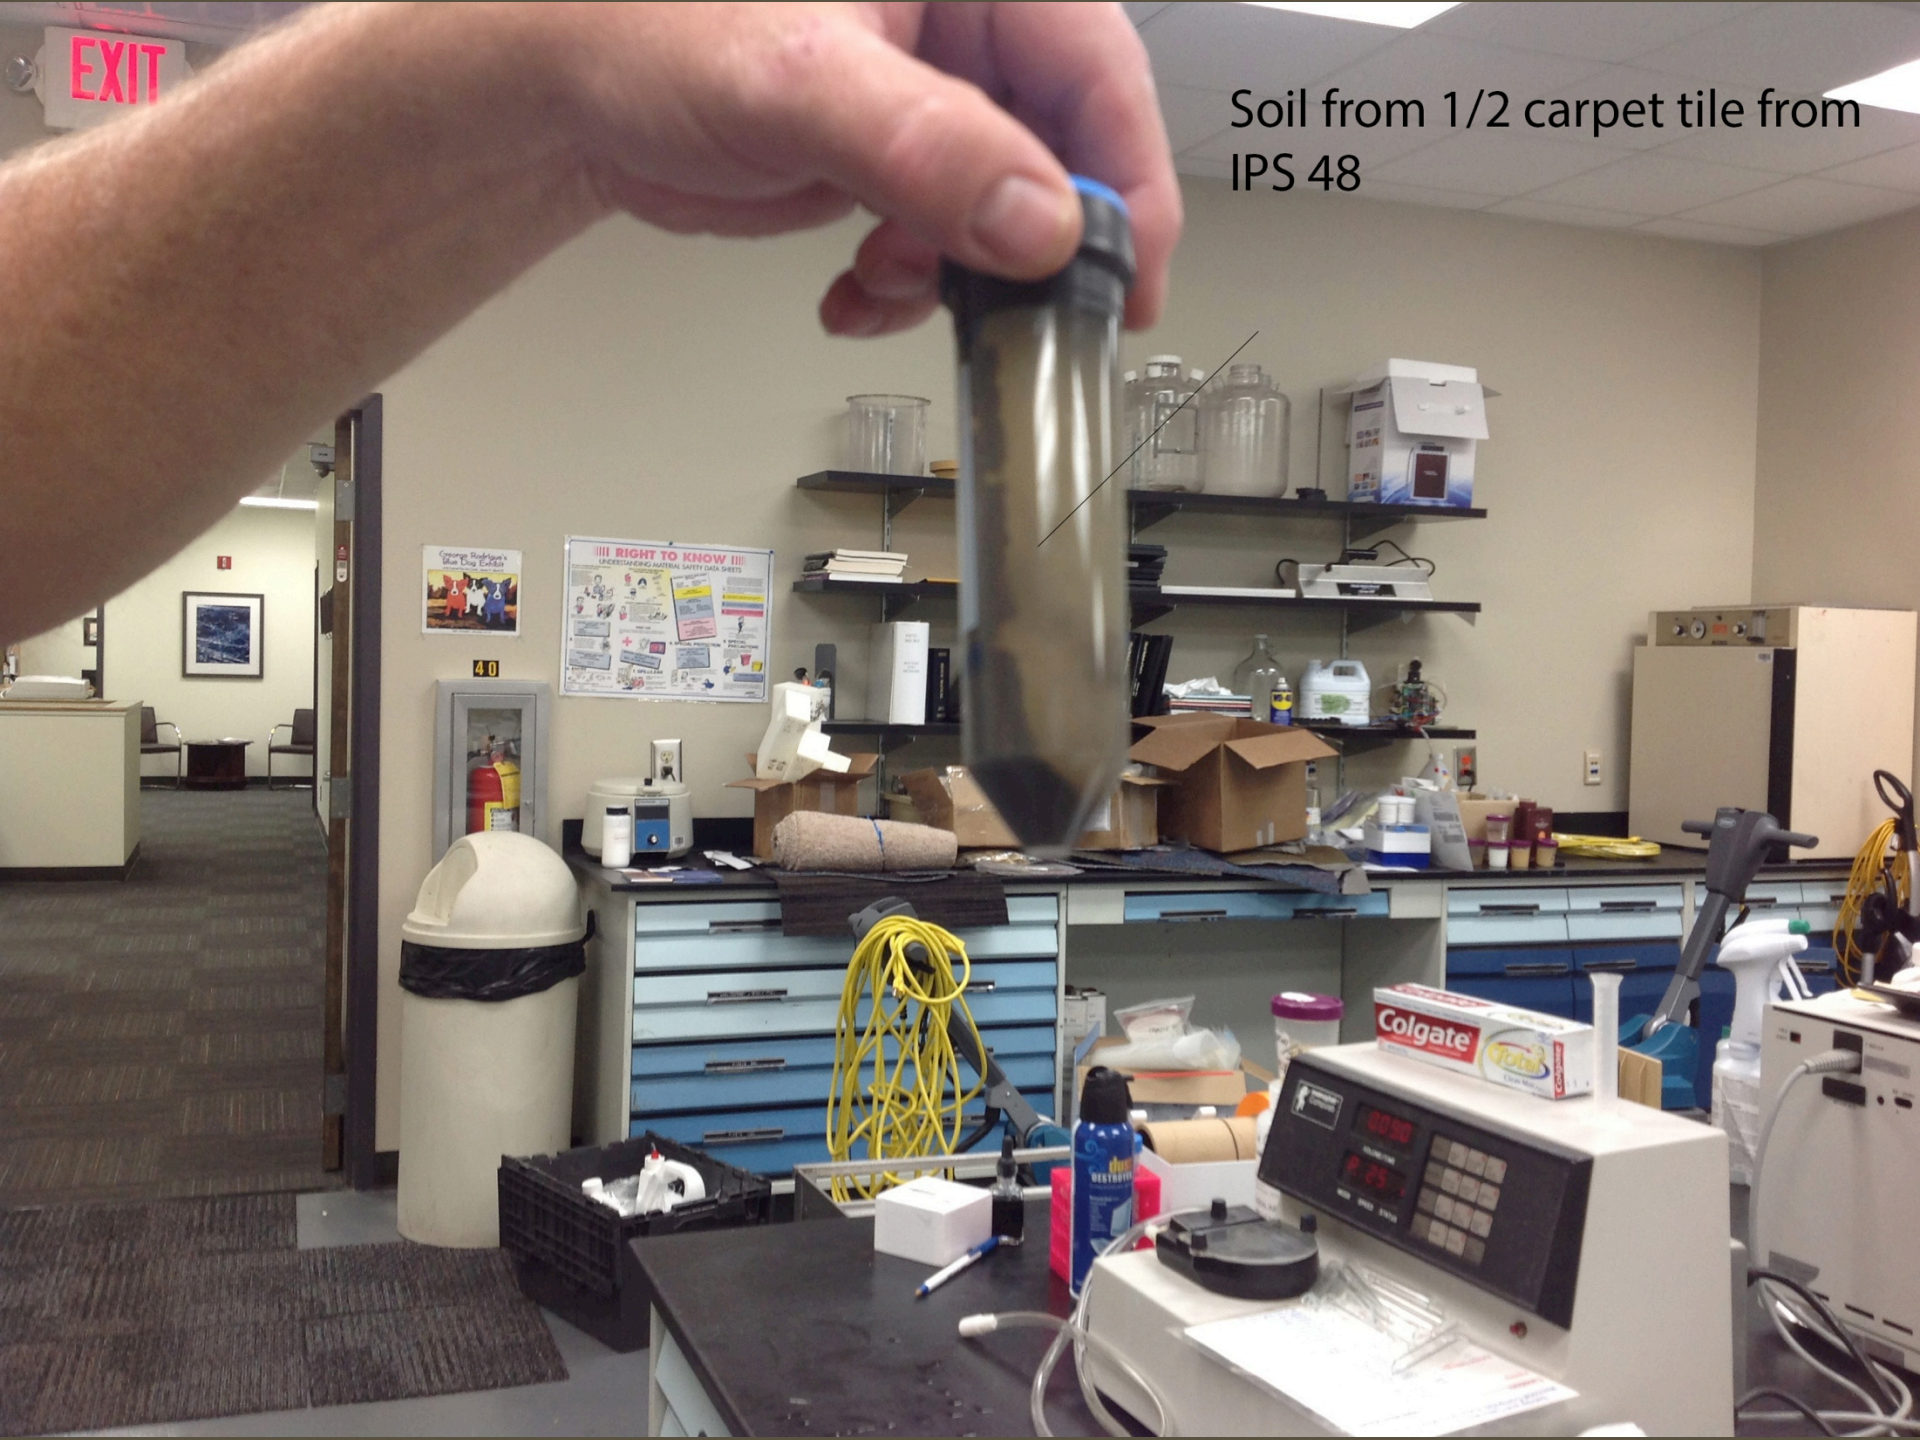
Soil from 1/2 carpet tile from
IPS 48

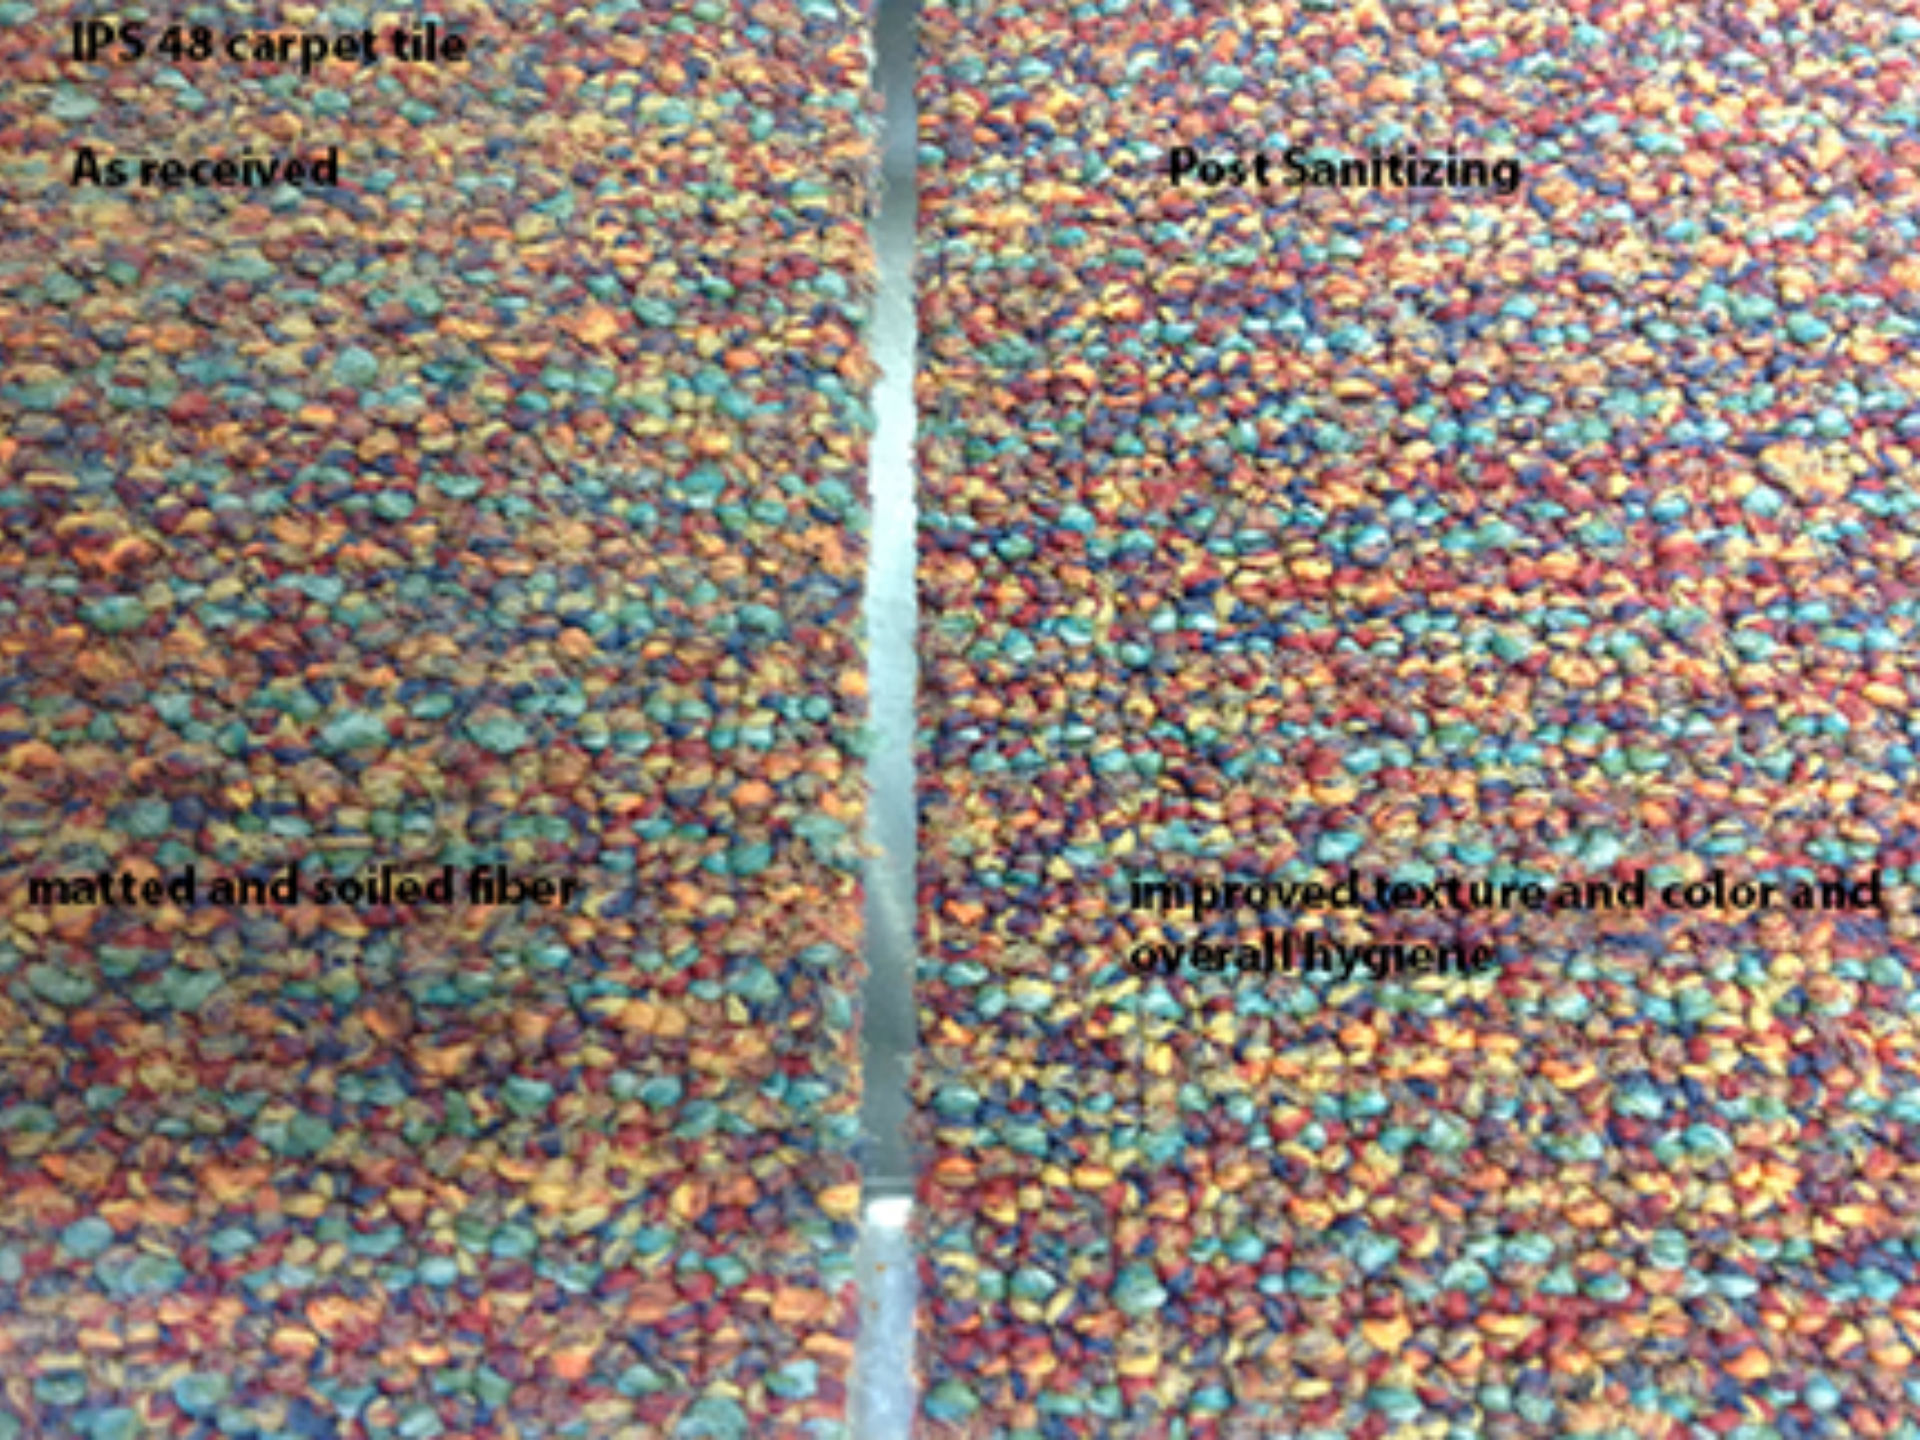
IPS 48 carpet tile

As received

matted and soiled fiber

Post Sanitizing

**improved texture and color and
overall hygiene**

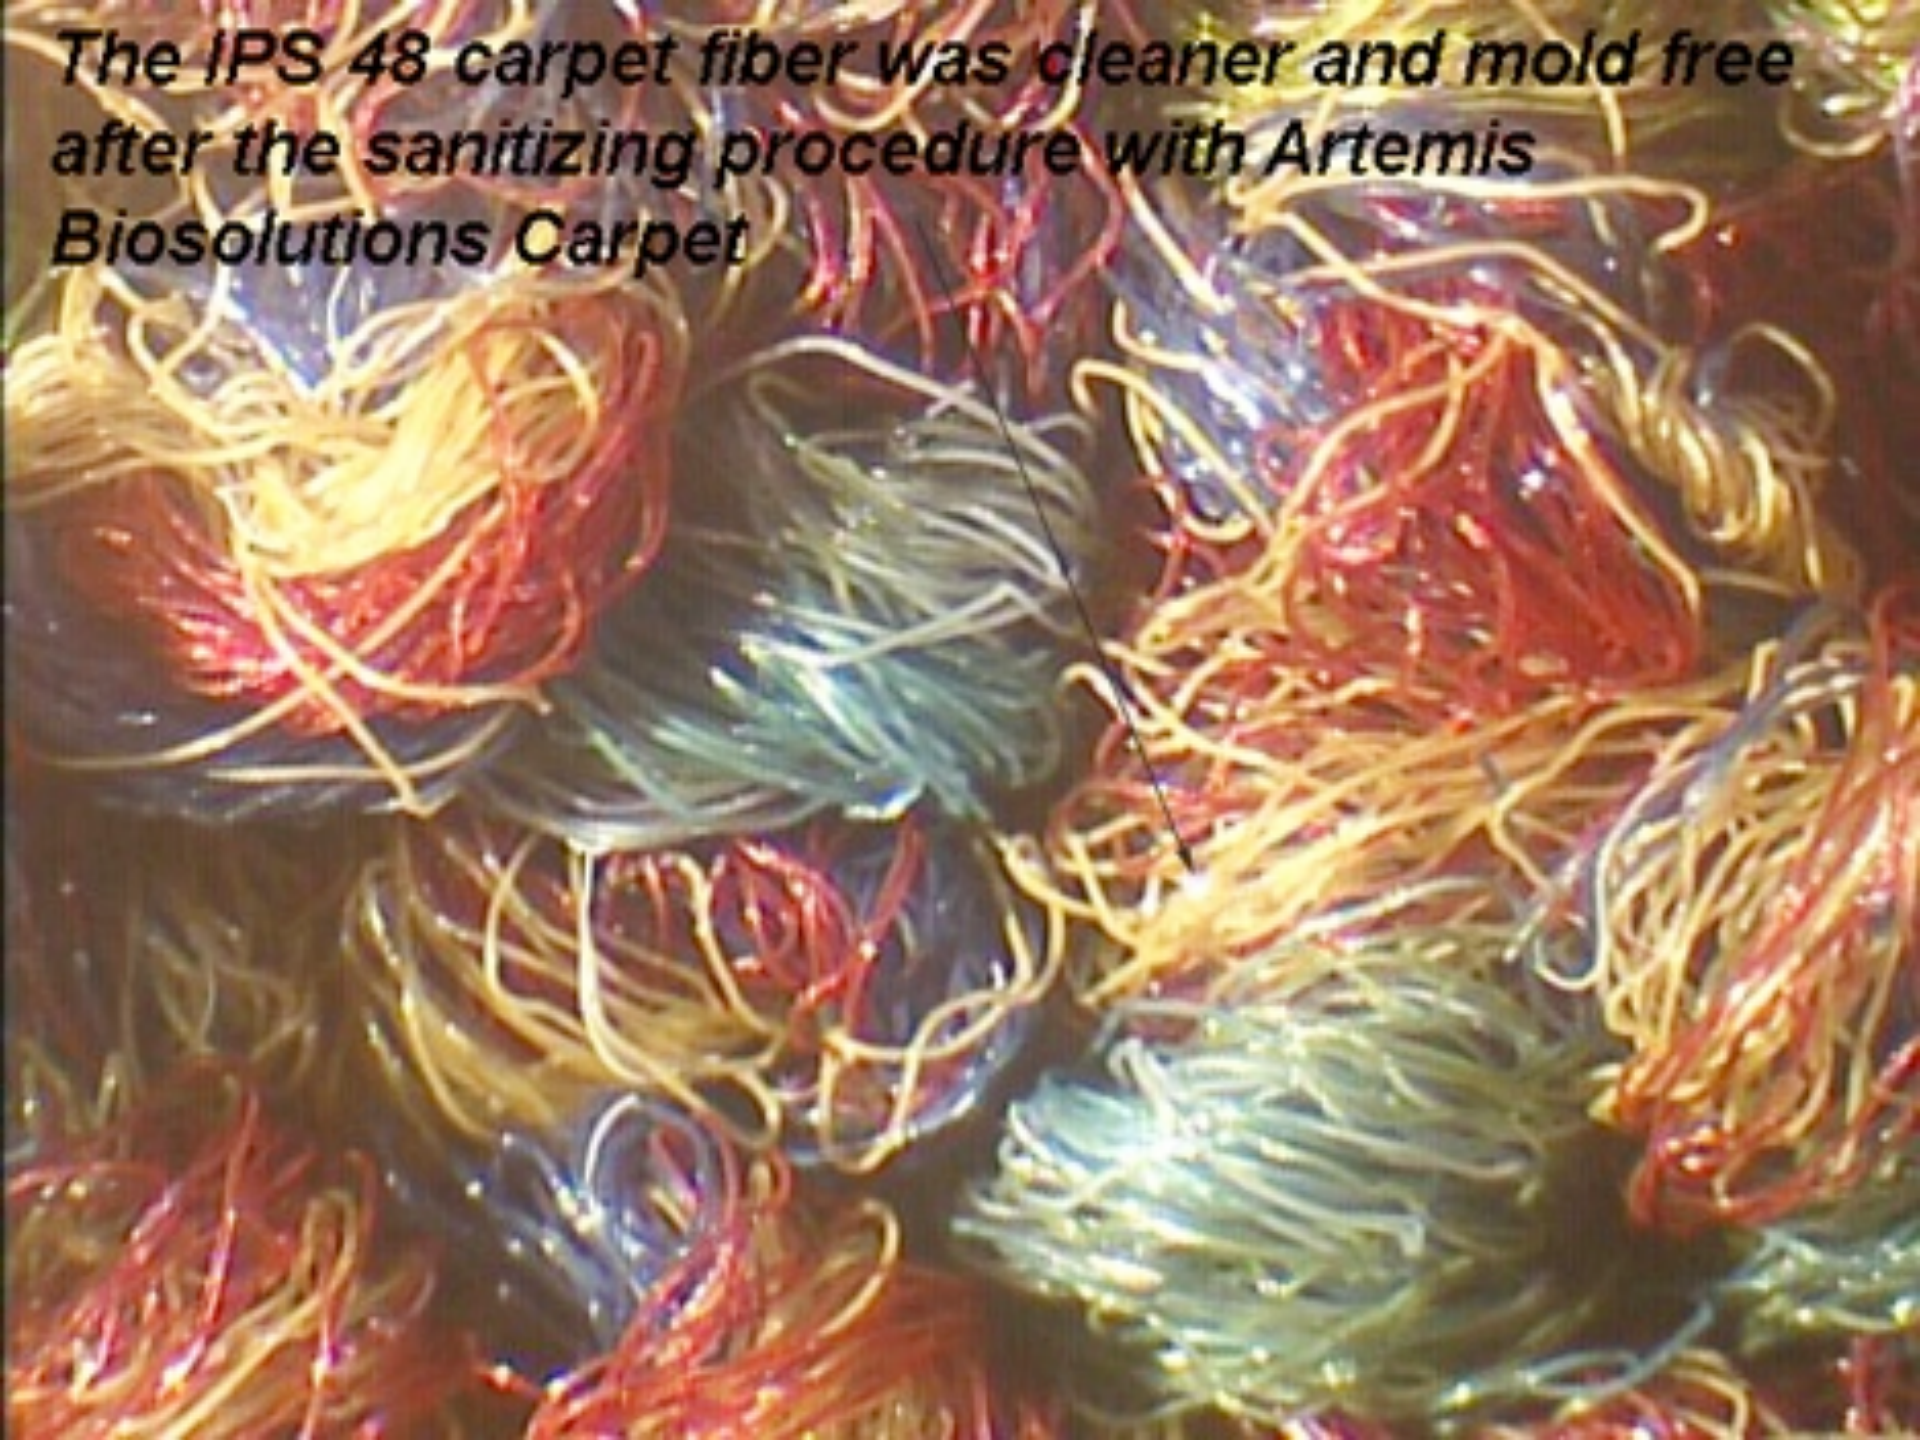
The IPS 48 carpet fiber was cleaner and mold free after the sanitizing procedure with Artemis Biosolutions Carpet
