Artemis Biosolutions
Case Study
School Carpet

Case Study Summary

- An Interface modular tile was presented to Interface Microbiology Services
- The tile was from an independent school system in the mid-west
- The tile had patches of darkened stains

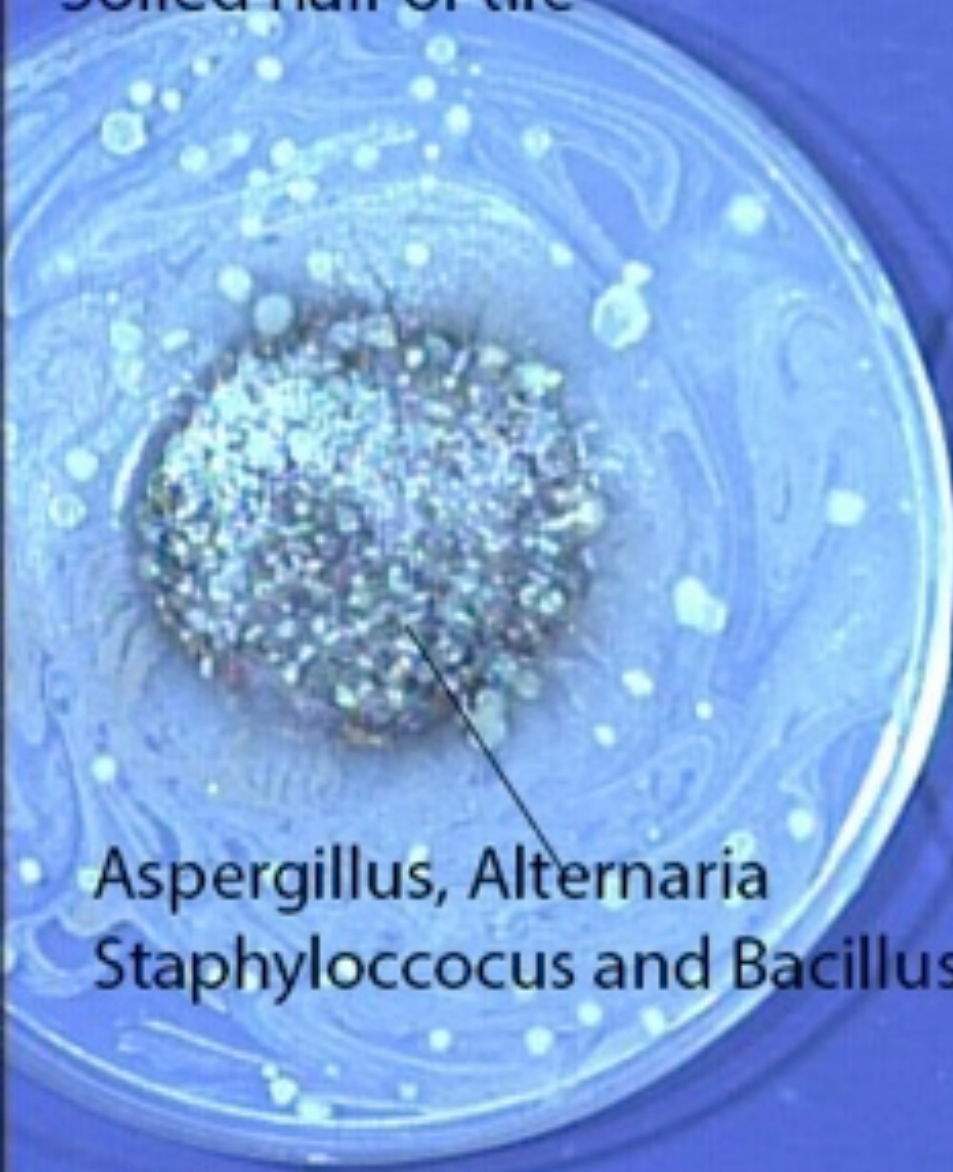
Post-santizing culture of IPS 48 carpet

Soiled half of tile

Aspergillus, Alternaria
Staphylococcus and Bacillus

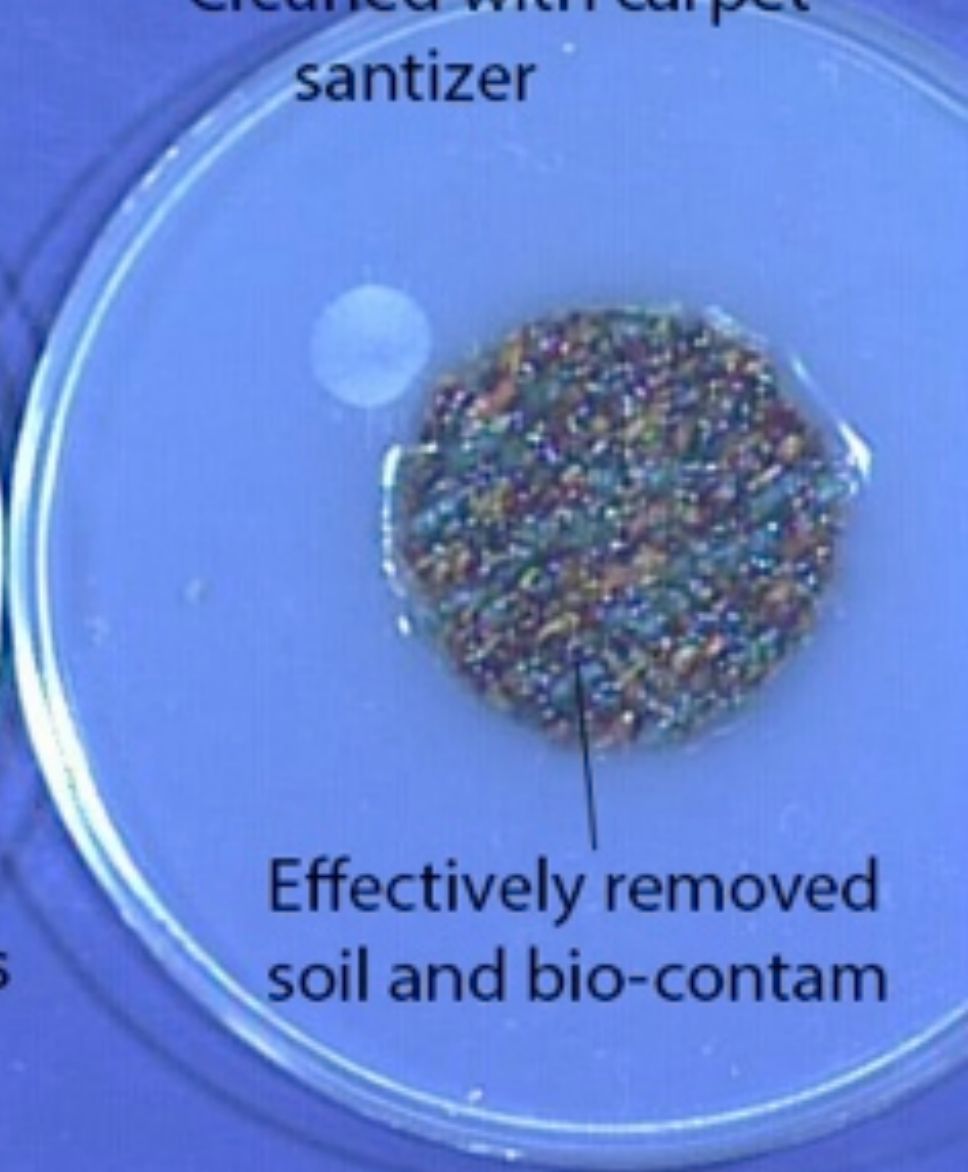
Cleaned with carpet
santizer

Effectively removed
soil and bio-contam

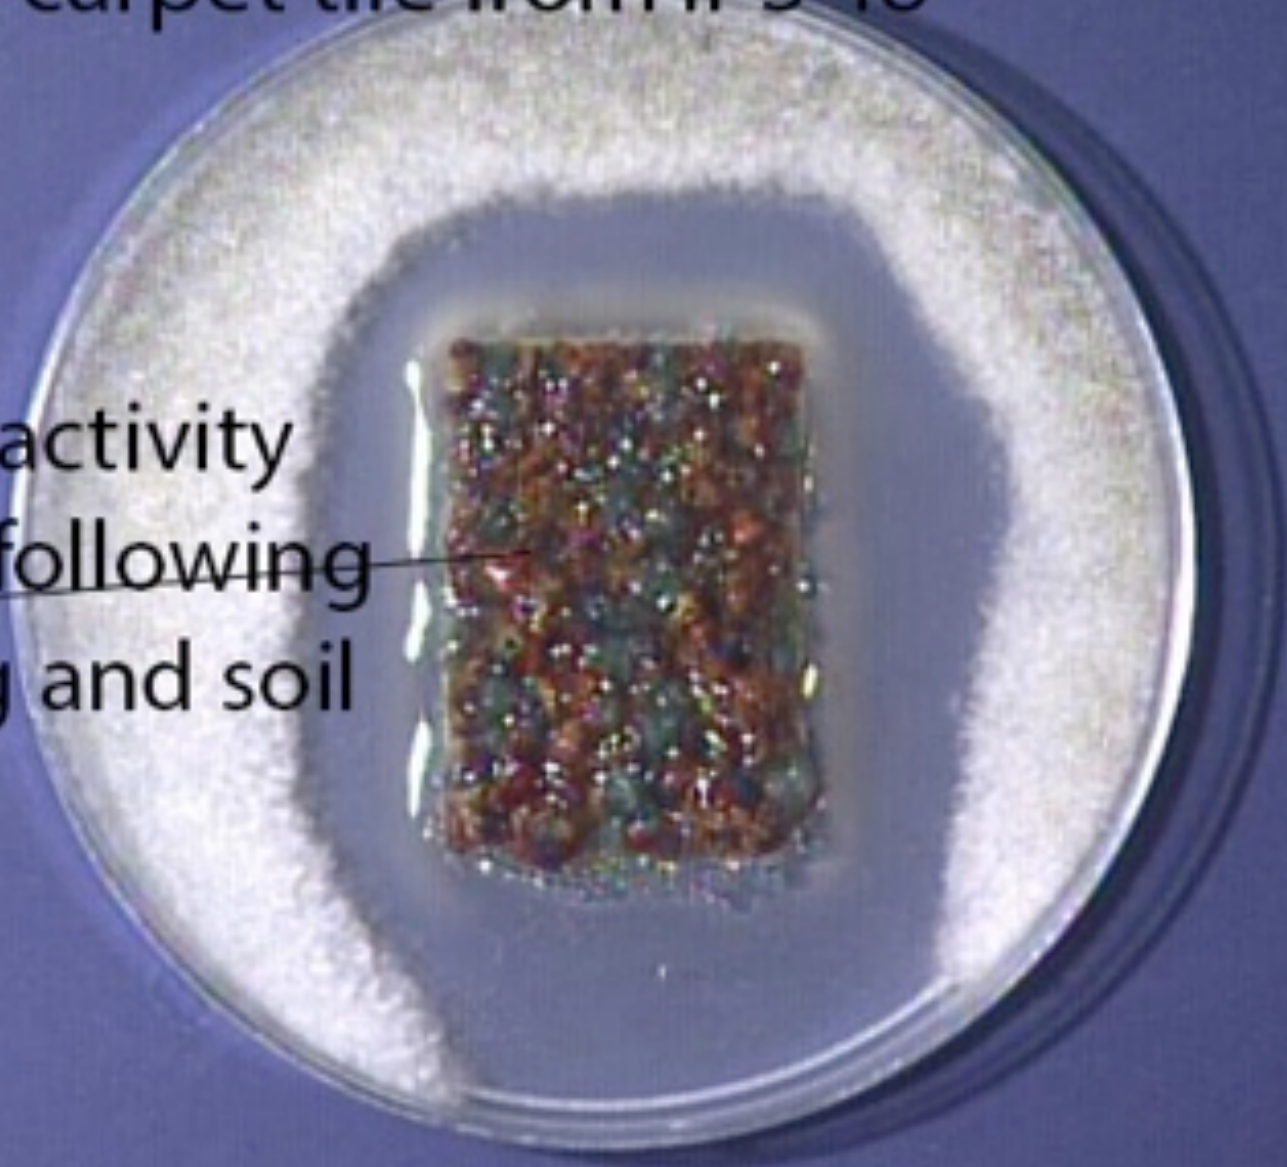
ASTM 2471 mold challenge of sanitized
Interface carpet tile from IPS 48

biostatic activity
restored following
sanitizing and soil
removal
