Elwha nearshore ecosystem restoration: dam removal and shoreline armor removal

Elwha Nearshore Ecosystem Restoration: Dam Removal and Shoreline Armor Removal

Jamie Michel and Anne Shaffer, Coastal Watershed Institute; Chris Byrnes, Washington Department of Fish and Wildlife; Dave Parks, Washington Department of Natural Resources
Salish Sea Ecosystem Conference 2018

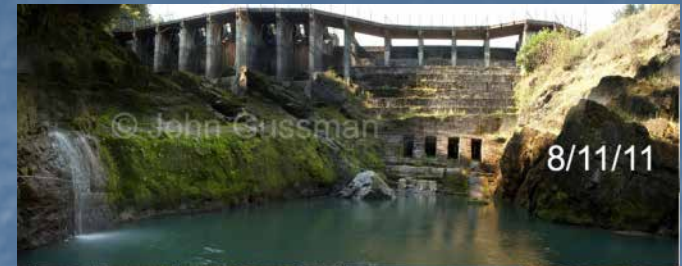
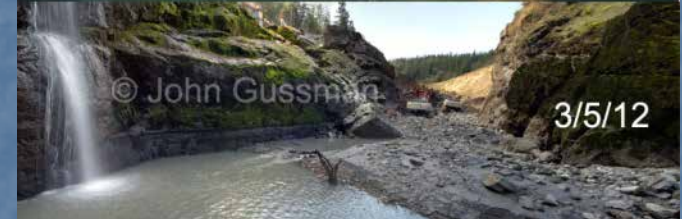
Dams Alter Sediment Supply

Former 105' tall Elwha Dam
Removal Completed August 2012

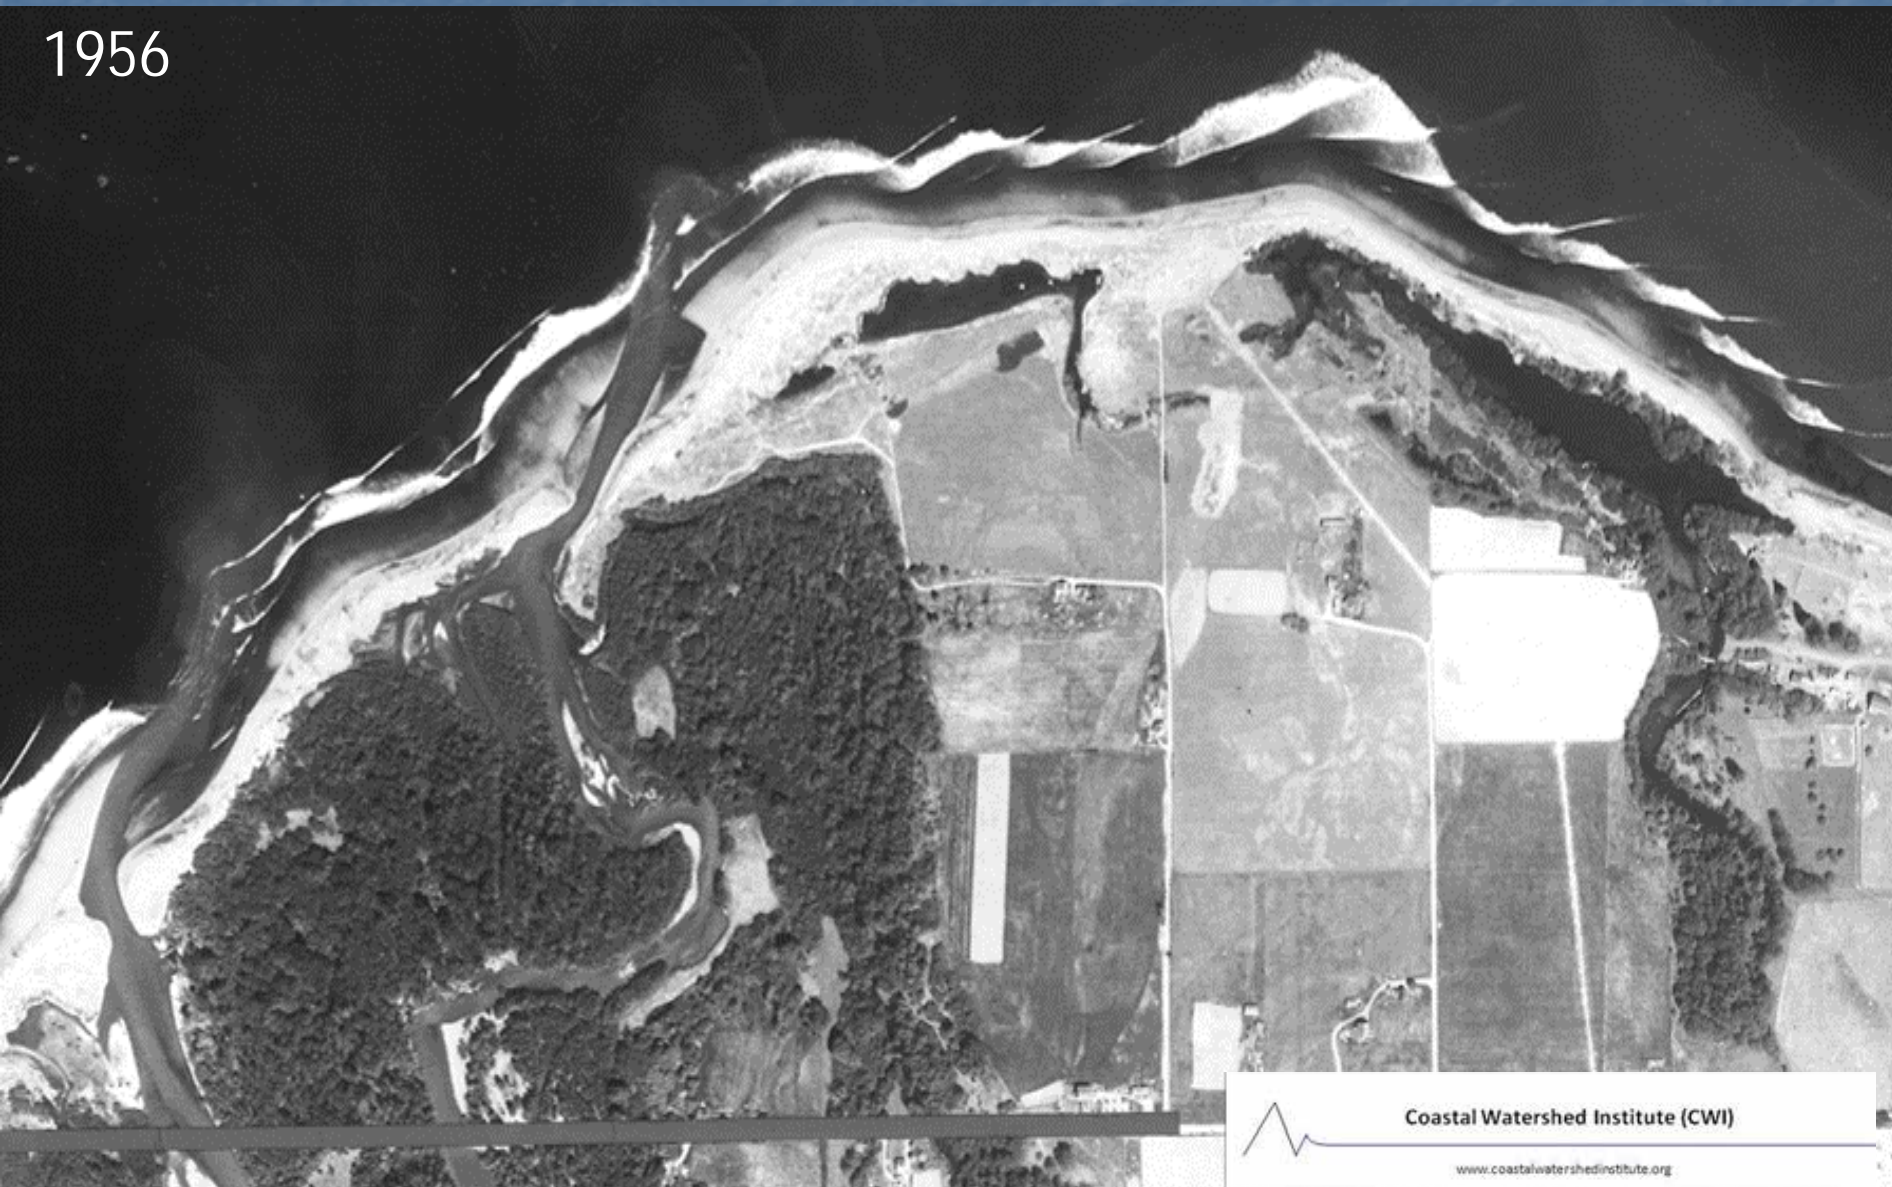
1956

Sediment Starvation Exacerbates Erosion and Results in $\frac{3}{4}$ Mile of Armor

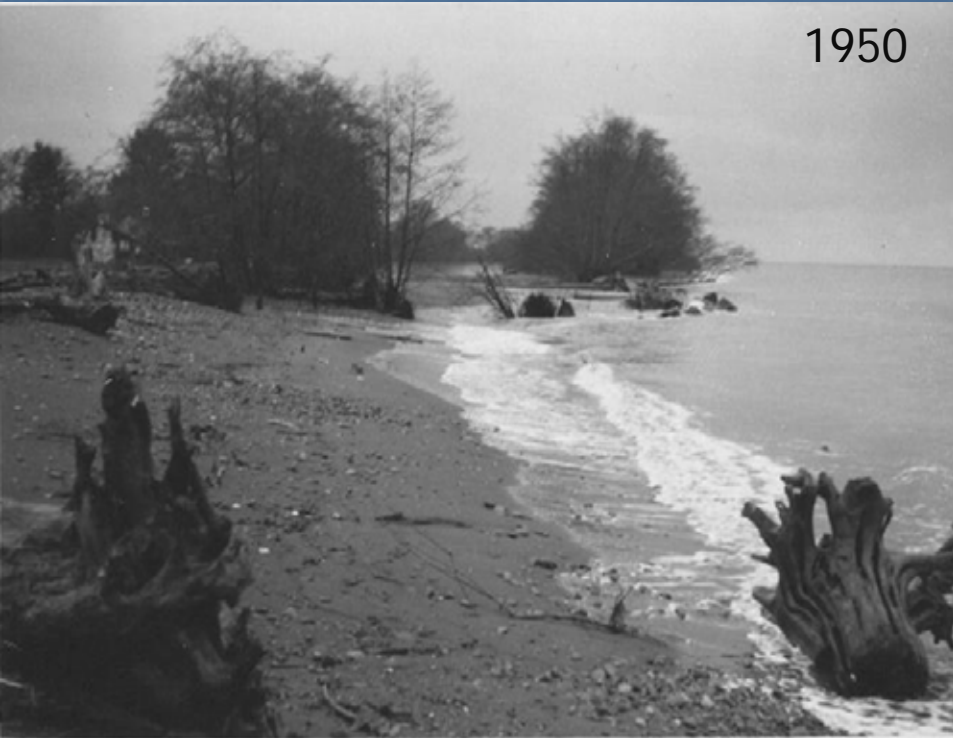
1950

Beach Lake Erosion

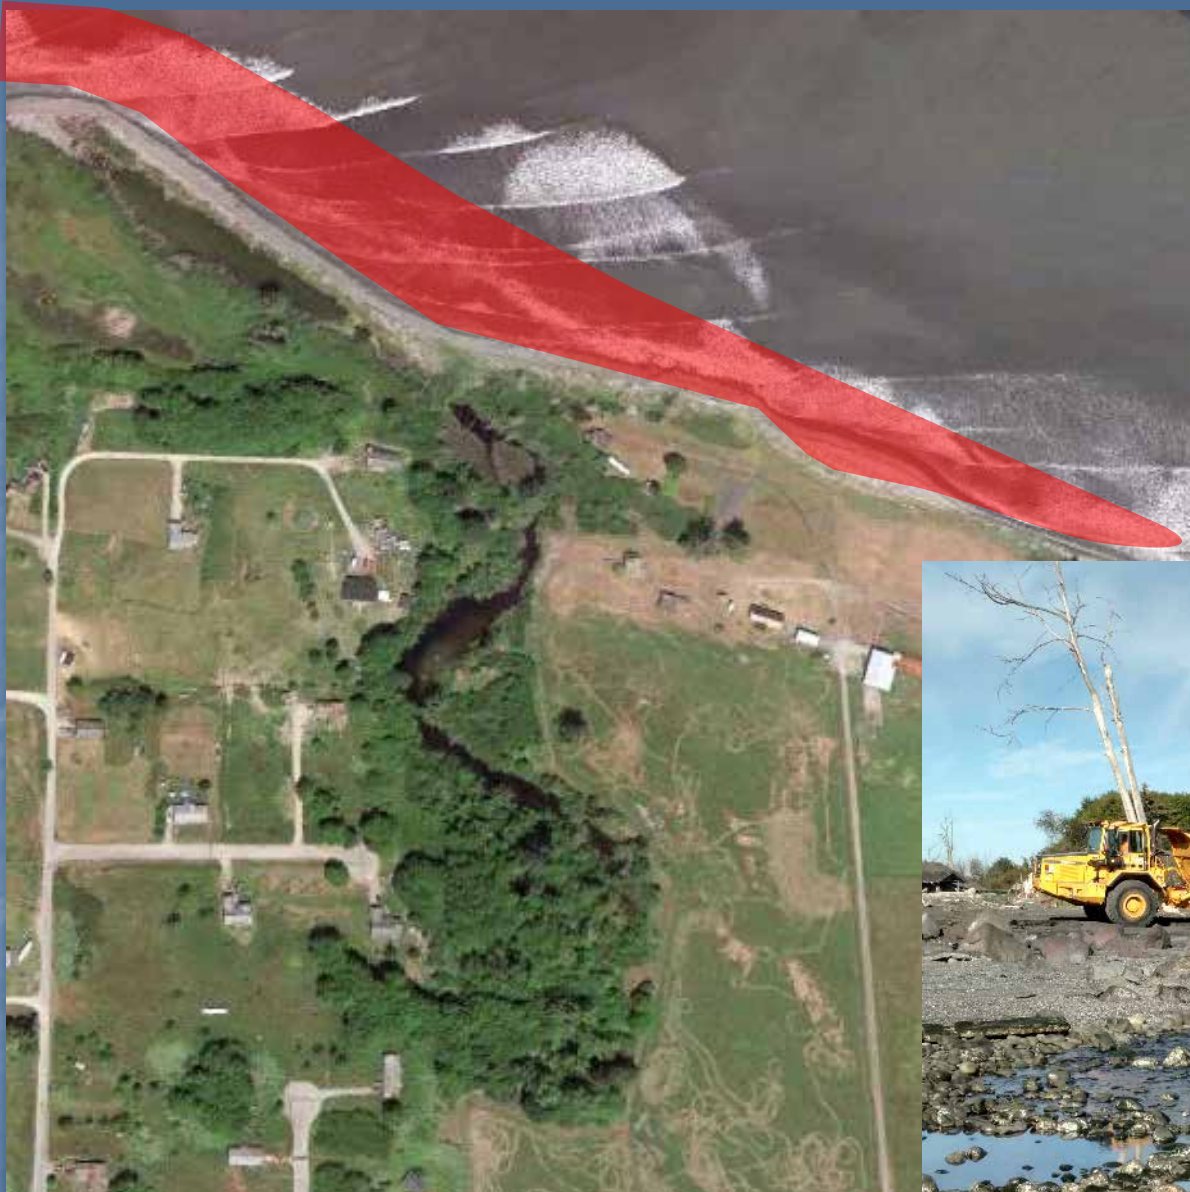
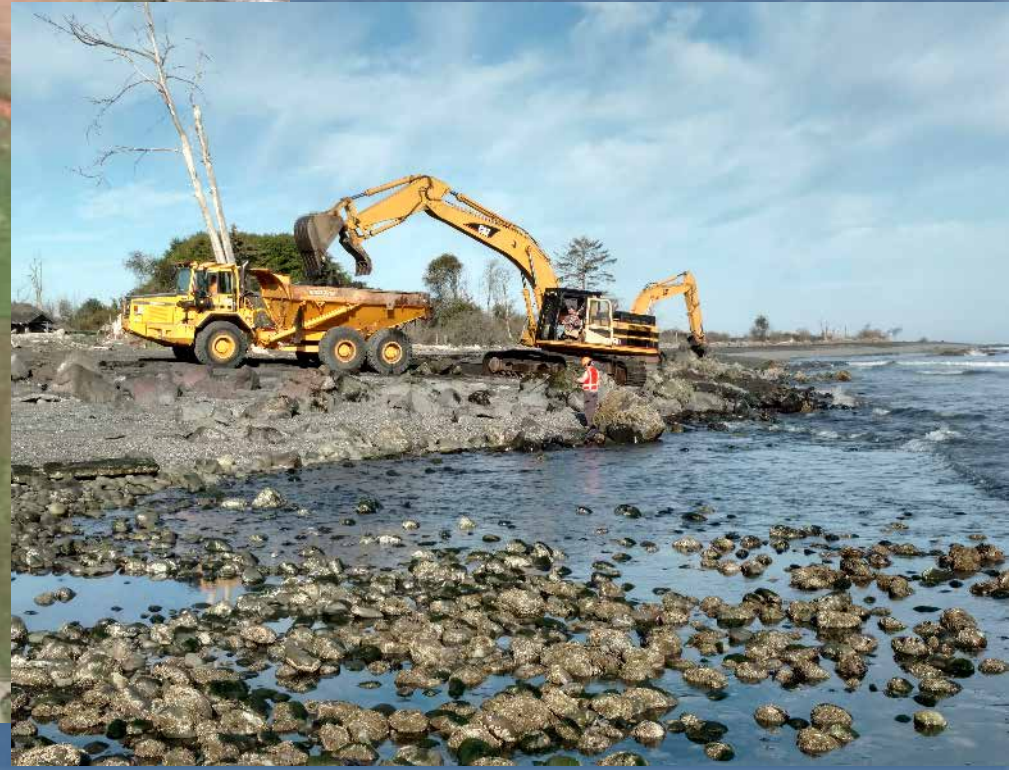
Multiple Mobilizations to remove exposed abandoned shoreline armor from 3 acres of tidelands along ¾ mile of beach in front of Conservation Property, Tribal Reservation and Private Landowner.

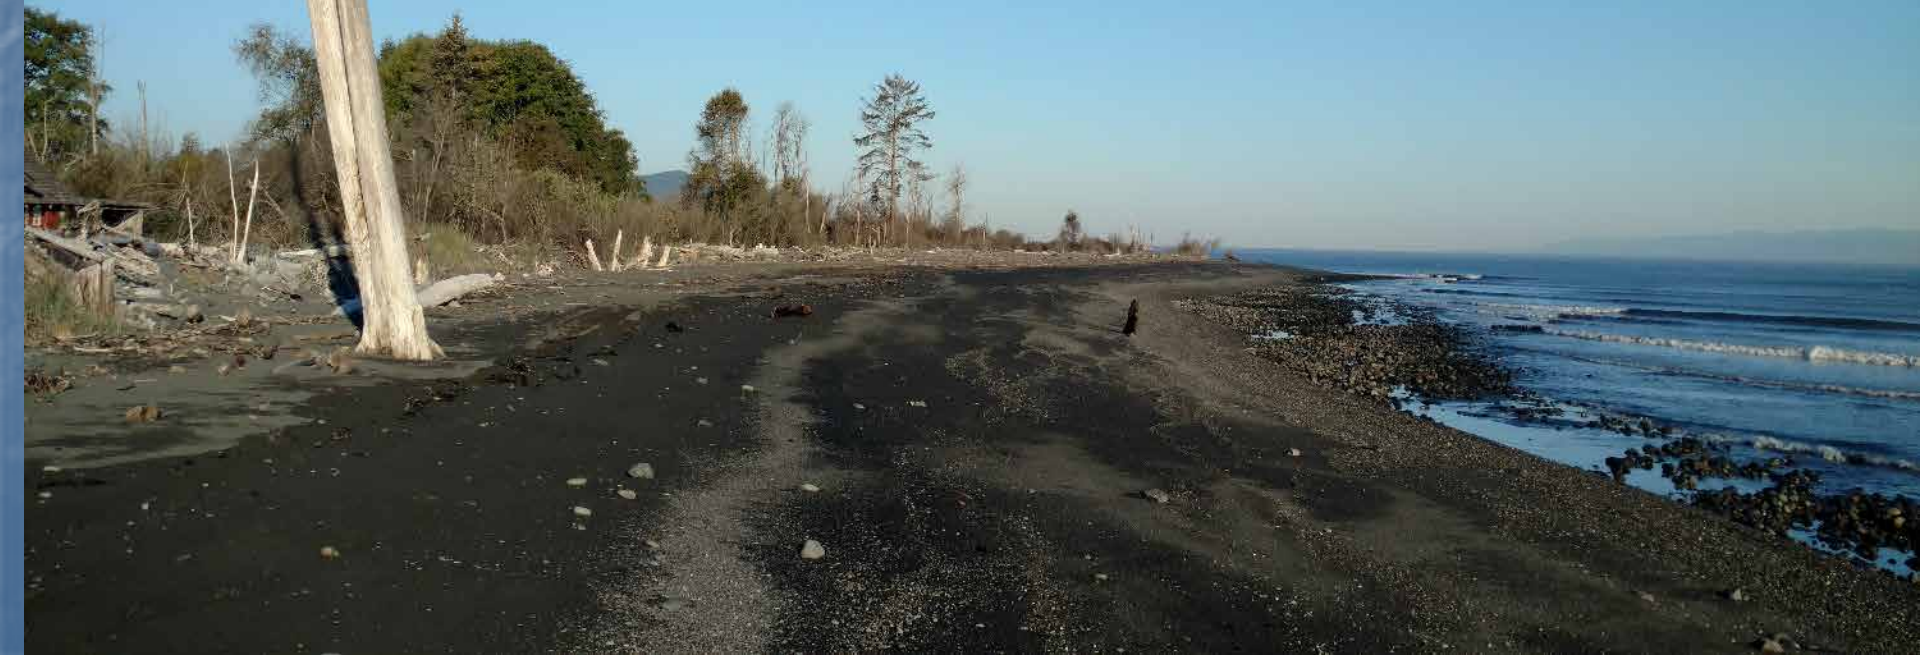
Phase I Armor Removal Demobilization
8/19/2016

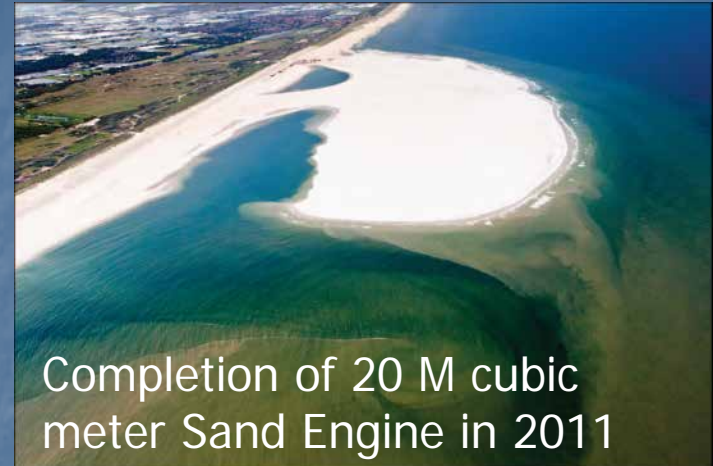
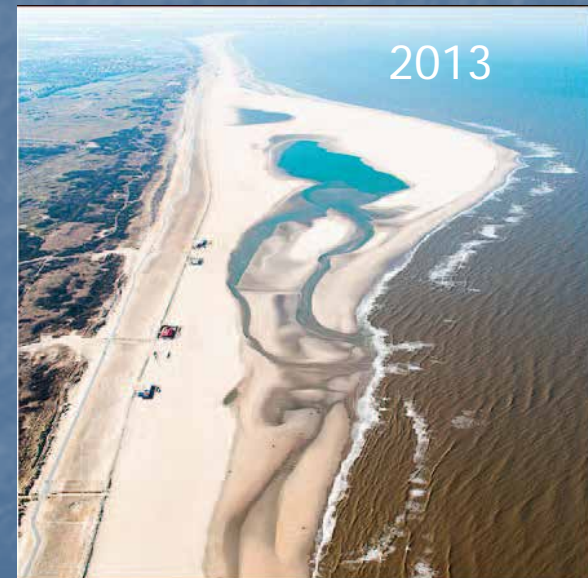
Sand Engine Technique in Holland

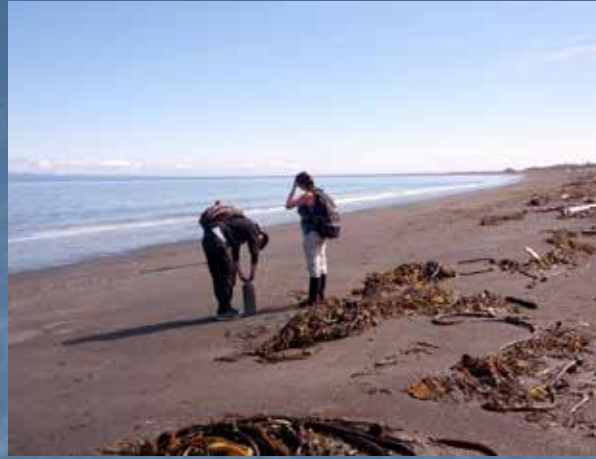
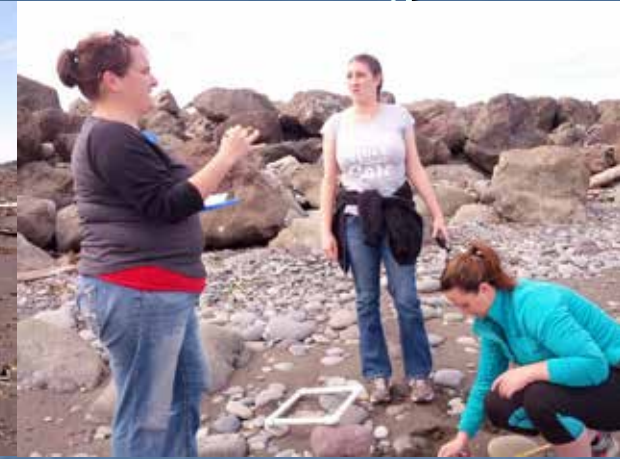
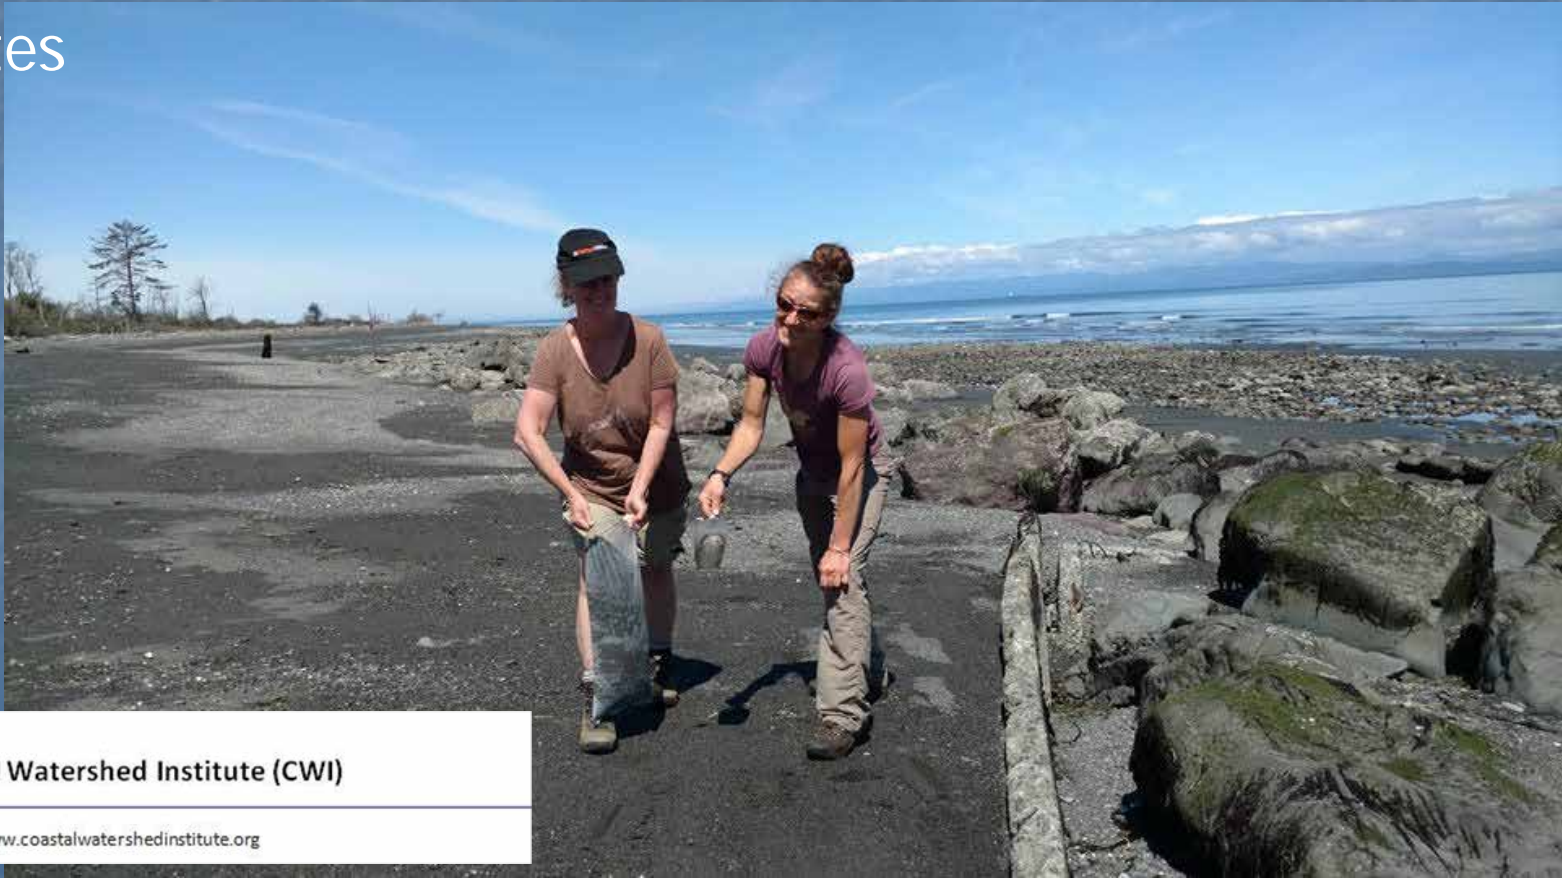
Monitoring Metrics

- Newly Emerged Armor
- Beach Topography
- Beach Sediment Size
- Forage Fish Spawning
- Beach Wrack
- Invertebrates
- Fish Use
- LWD
