# Behavior of FRP-RC Slabs under Multiple Independent Air Blasts

Ganchai Tanapornraweekit, Ph.D.<sup>1</sup>; Nicholas Haritos<sup>2</sup>; and Priyan Mendis<sup>3</sup>

**Abstract:** In some terrorist attacks, it is possible that RC structures might be subjected to more than a single explosion. RC structures designed without the consideration of blast effects tend to lose their capacity after the first explosion. The use of a fiber reinforced polymer (FRP) sheet has been proven to enhance the performance and resistance of an RC member under a single explosion test. However, there appears to have been no experimental programs conducted to assess the performance of FRP-strengthened RC members subjected to multiple explosions reported in the literature. This paper, therefore, presents experimental results for the behavior of RC slabs strengthened by an FRP sheet after undergoing single, double, and triple independent explosion testing. Results from these blast tests indicate that the FRP sandwich RC slab tested was able to sustain the subsequent second explosion of greater impact. A brittle shear failure with FRP debonding was observed following the third explosion on this FRP-stre

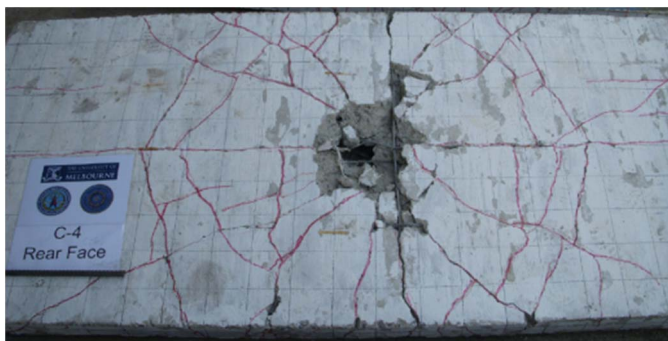
Fig. 6. Crack pattern and concrete spall on rear face of Specimen C4 (Image by G. Tanapornraweekit)

The blast test showed that Specimen C4 failed in a combination of flexure and concrete spalling at the opposite face. Flexural failure was also observed because the slab deflected globally with large flexural cracks and almost collapsed, as shown in Fig. 5. In addition, concrete spall with dimensions of  $200 \times 300 \times 25$  mm was observed at the opposite face of the test slab (see Fig. 6). The residual deflection of the test slab was measured to be 106 mm. The conclusion drawn from the testing of Specimens C3 and C4 was that the response of an identical test member shifts from a ductile to a brittle mode of failure by decreasing the blast scaled distance.

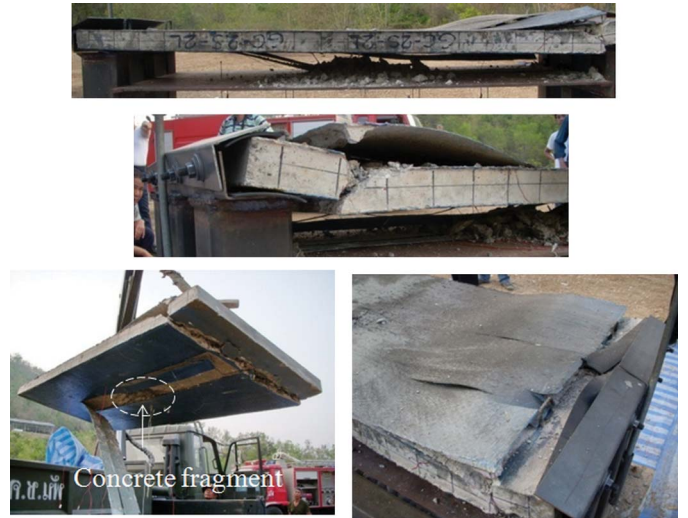
**Fig. 19.** Failure of Specimen GC-2S-2L after third explosion (Images by G. Tanapornraweekit)

After the detonation, the test slab failed from a combination of a large diagonal shear crack and the peeling of the FRP sheets on both the incidence and opposite faces to the blast. In addition, concrete spall was observed on the opposite face of the test slab. The fiber surface was burnt before the third explosion. Fig. 19 shows the failure of this specimen after the third explosion. From the posttest observations, the peeling of the top fiber sheet was deemed attributable to the large relative displacement resulting from the
