A comparative assessment of selected raw water intake systems in Rwanda

I. Nhapi^{a,b}, A. J. Nshimiyimana^a, U. G. Wali^a, F. O. K. Anyemedu^a and J. J. Kashaigili^c

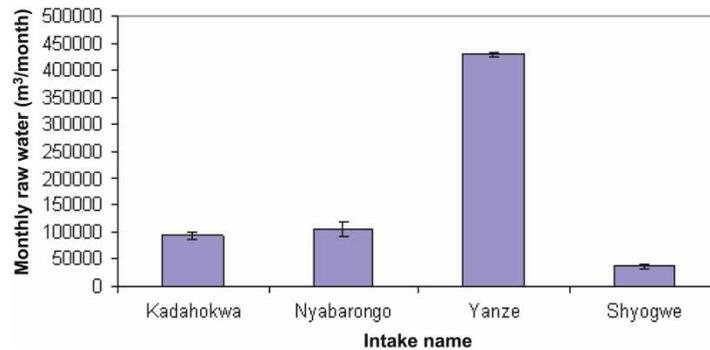
Figure 2 | Average monthly raw water abstractions for the Kadahokwa, Nyabarongo, Yanze and Shyogwe intake systems.

The monthly water production figures for the selected intake systems in this study are given in Figure 2, with Yanze showing to be the largest intake.

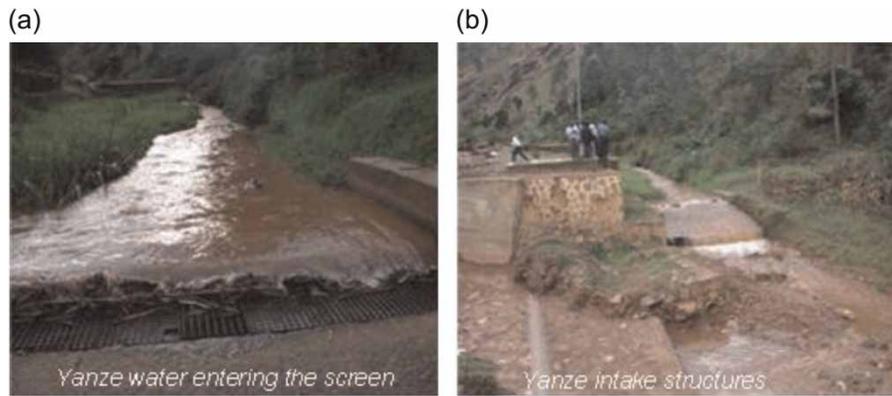
Figure 3 | Yanze water intake up to the treatment plant.

A greater part of water used in Kigali City is abstracted directly from the Yanze River and treated at the Kimisagara Water Treatment Plant. The intake (Figure 3) is located about 5 km from the centre of Kigali. The Yanze River has a discharge of about 2,500 m³/h in the rainy season, and 800 m³/h in the dry season (Electrogaz 2007). There is a 4 m long by 3 m wide and 0.6 m deep screening trough upstream of the intake screen for trapping sand and other floating matter. The flow through this screen is 940 m³/h, whilst its design capacity is 1,000 m³/h. The screen channels the water into a pipe of 700 mm diameter which discharges into two pre-sedimentation tanks. The clarified water is gravitated to the Kimisagara water treatment plant through a pipe of 600 mm diameter up to a point called Bwino, where the pipe is divided into four small pipes of 300 mm diameter. Any excess water at the Yanze intake is diverted back into the river. Figure 3 shows how water is abstracted from the Yanze River.

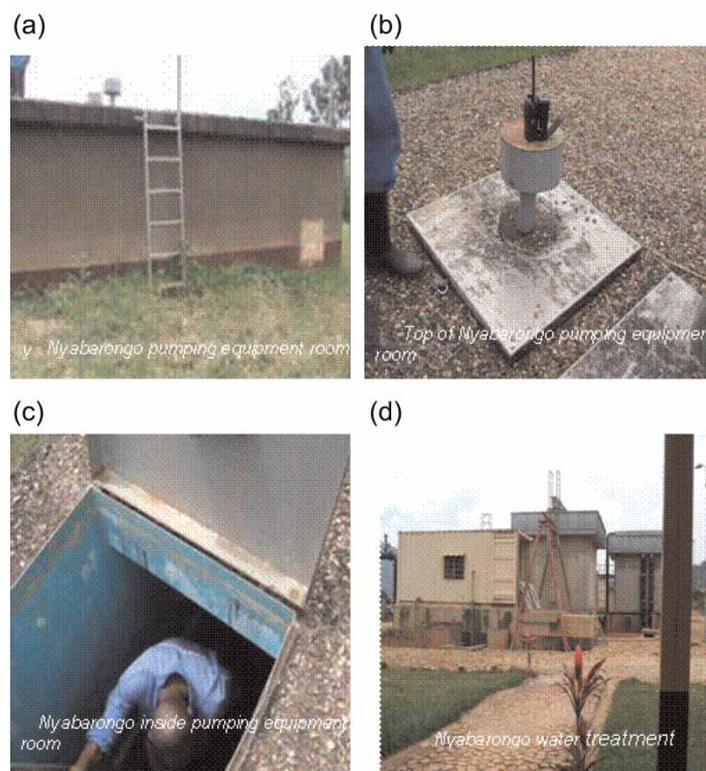
Figure 4 | Nyabarongo water intake up to the treatment plant.

The Nyabarongo intake is underground groundwater abstraction system consisting of four horizontal drains of 3 m length each. These drains collect the water into 14 m deep wells. The outlets of the drains are located at 10 m from the top of the well. The drains consist of perforated pipes laid on two layers of sand at the bottom and activated carbon at the top. These two materials filter the water before it reaches the pipe and a provision is made for closing the drains when necessary. From the well there are automatic pumps which pump the water to the treatment plant. The top of the intake is sealed. The abstraction capacity is 128–130 m³/h for the existing intake. The ultimate aim is to produce 40,000 m³/day upon completion of the new plant and boreholes. The project of installing new boreholes will cover 37 boreholes, nearly 50 m apart, stretching about 1.8 km along the Nyabarongo River. The deepest level is estimated to be 7 m during dry season and to be 3 m during the rainy season. The lowest level is at 1.2 m and it occurs during the rainy season. Figure 6 shows the Nyabarongo intake structures and the treatment plant.

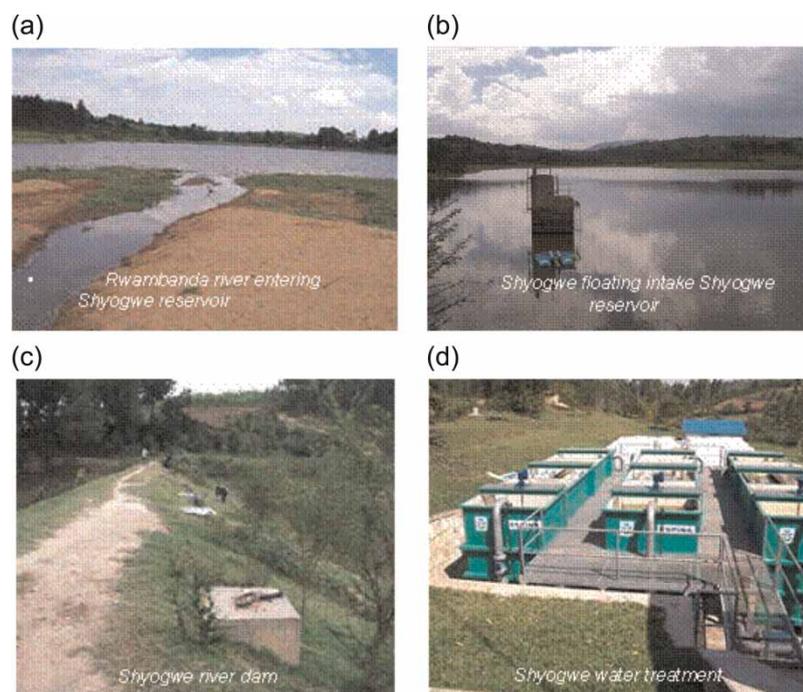
Figure 5 | Photos of key components of the Shyogwe intake system and the treatment plant.

The Shyogwe Dam is supplied by the Rwambanda River. The abstraction is done through a floating intake system. A pipe of 200 mm is used with a system of valves for closing and opening. In addition to the water from the reservoir, other small sources have been used from Karama. Water from this plant is supplied to the Bugesera region. Environmental flows are allowed for downstream ecosystems and the dam is home to a variety of fish and birds. Figure 5 shows some photos of key components of the Shyogwe intake system and the treatment plant. The Shyogwe Dam has a protected foundation, impermeable core and concrete to prevent water from seeping, a sloping embankment of 2 m height, and an overflow channel.

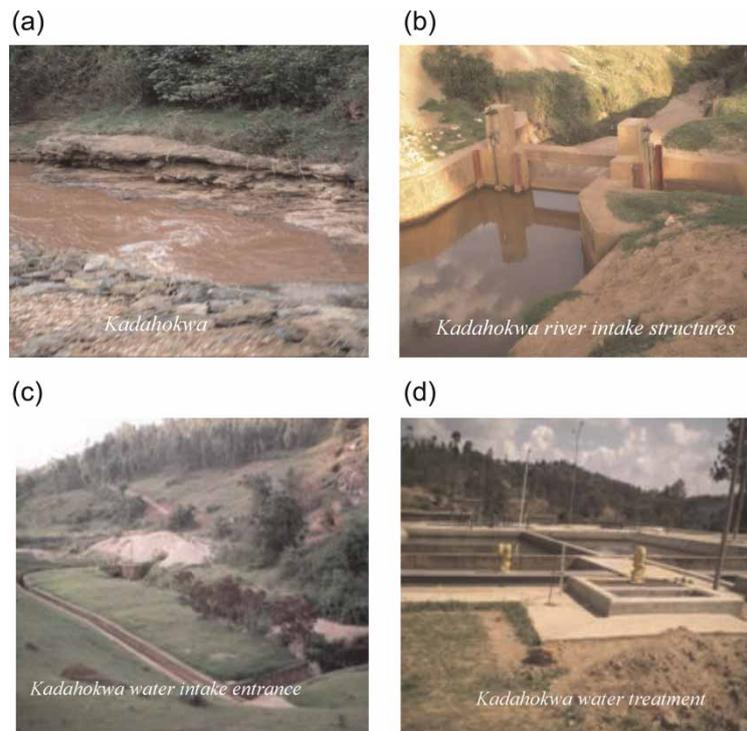
Figure 6 | Kadahokwa intake structures and part of the treatment plant.

Rivers. The discharge was estimated at $65 \text{ m}^3/\text{h}$. In 1997, the second intake feeding the same water treatment plant was commissioned and the discharge increased to $504 \text{ m}^3/\text{h}$. Raw water reaches the plant by gravity flow. Figure 6 shows the Kadahokwa system from the river to the plant. From the Kadahokwa River, water enters intake structures. Along the intake structures there are gates that can be opened to allow the sands and other settled materials to be diverted back to river.

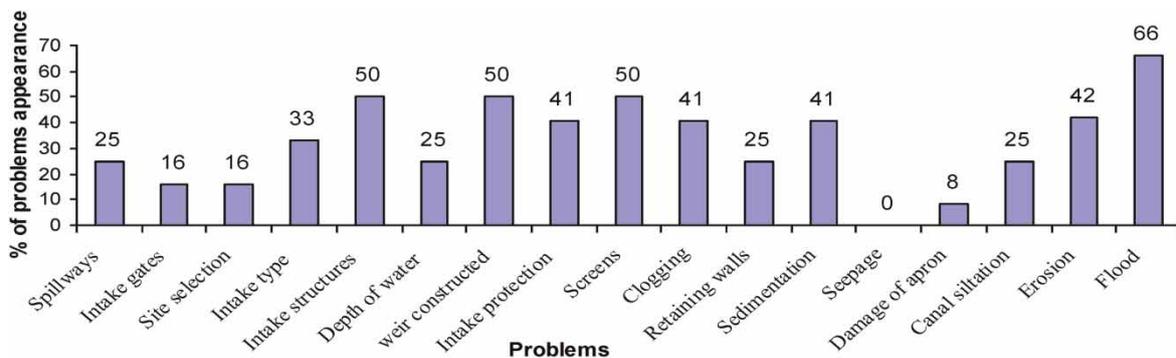
Figure 7 | Design-related problems occurrence.

The occurrence of design-related problems was analysed and the results are shown in Figure 7. A maximum score of 3 was adopted in deriving this graph. The occurrence interval, expressed as a percentage, was found by dividing the sum of scores for each problem by 12 (12 being the number of intake systems studied multiply by 3 (the maximum score)), then multiplying by 100 (to convert it to percentage). Figure 7 shows that the major problems observed are flooding, entrapment of suspended solids on screens, selection of intake structures, weirs, erosion and sedimentation. The level of occurrence in percentages (Figure 8) shows that the intake systems are not well designed because some requirements are not being met in practice. The flood problems accounted for 66% of occurrence especially during rainy season followed by the intake site selection (50%) and screen clogging (50%).

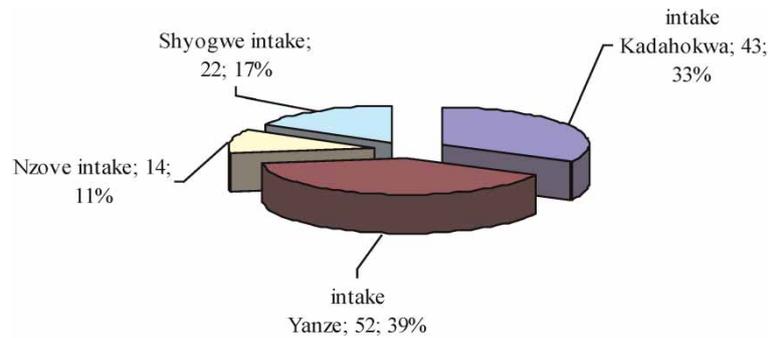
Figure 8 | Percentage of scoring for each intake plant based on design problems.

Figure 8 shows the percentage of scoring for each intake. It shows that the Nyabarongo intake performs well, with the least level of problems at 11%. However, the quantity of water abstracted is not sufficient because there is only a single small well which is not accessible for equipment room control during heavy rains. There were plans to increase the number of wells along the Nyabarongo River in order to increase the quantity of water abstracted. About 90% of water used in Kigali City currently comes from the Kimisagara water treatment plant. The Shyogwe intake system was ranked second with a percentage scoring of 22%. For this plant, the water level in the reservoir has dropped drastically because of reduced inflows from the catchment.

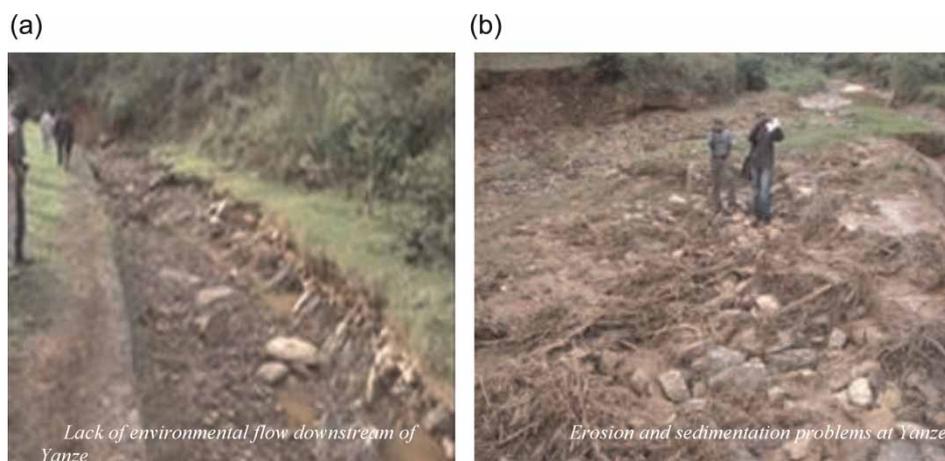
Figure 9 | Typical problems experienced at intake systems: (a) lack of environmental flow at Yanze intake, and (b) erosion and sediment problems at Yanze.

The Yanze intake had the most problems and gets flooded during periods of heavy rains. In many ways the solutions suggested for this intake are similar to those for the Kadahokwa intake. Figure 7 has shown the major problems at the intake works and these are more pronounced at the Yanze intake. Figure 9 shows the sediment deposition and environmental flow problems at the Yanze intake. The sediment deposition problem appears mostly in the rainy season where stones, soils, large pieces of trees and branches, *etc*, come in great amounts and clog the screen and sometimes intake structures are also destroyed. This impacts on the production of treated water as the plant operations are forced to stop until the situation becomes favourable. To solve these problems, there must be an adequate screen to trap all these transported materials and the intake structure design should sufficiently protect against these threats. Besides constructing a dam upstream, catchment protection measures should be adopted to reduce erosion (MINITERE 2007). These measures include terracing, vegetated strips/buffers, cultivation control, zero tillage, *etc*.

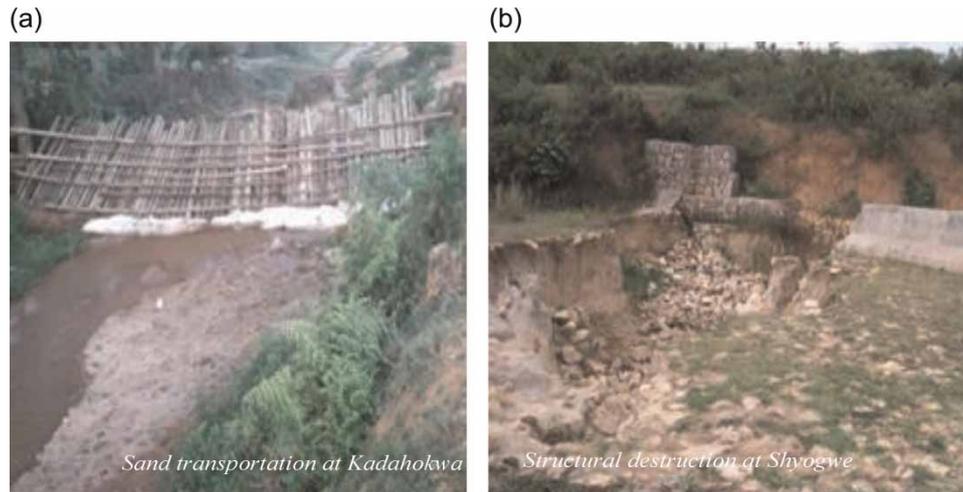
Figure 10 | Typical problems experienced at intake systems: (a) destruction of sand-retaining structure at Kadahokwa and (b) spillway failure at Shyogwe.

Figure 10(a) shows a typical problem caused by excessive sand loads in the Kadahokwa River. The sand-retaining structures are washed away by the sediment-laden floods and this affects the water treatment operations as the intake structure has to be closed in these circumstances. Figure 10(b) shows a destroyed spillway structure at Shyogwe, which reduces the reservoir storage capacity. This normally occurs in the rainy season and could be reduced by preventive maintenance of spillways and embankments during the dry season.

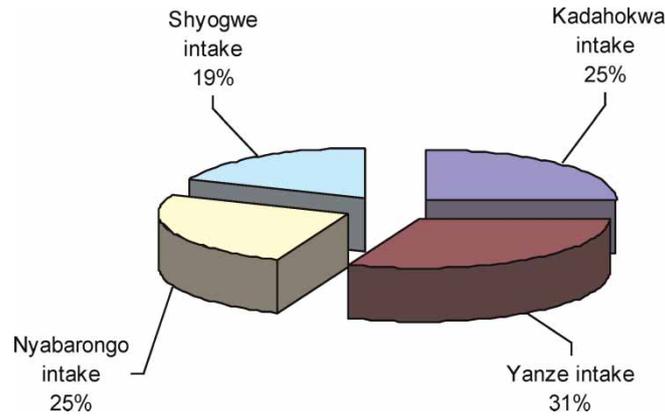
Figure 11 | Assessment results for raw water shortages and raw water turbidity problems for the 4 intake systems studied shown as percentage of occurrence at each plant.

Table 2 shows an assessment of the problems relating to water demand and raw water quality observed in this study. Figure 11 was plotted using the data from the Table 2. It shows the quantitative level of problems. It shows that there are high water shortages and high turbidity problems at Yanze intake and these problems are least at the Nyabarongo intake. Table 2 shows that people complain much about water shortages than about the problems of raw water turbidity.

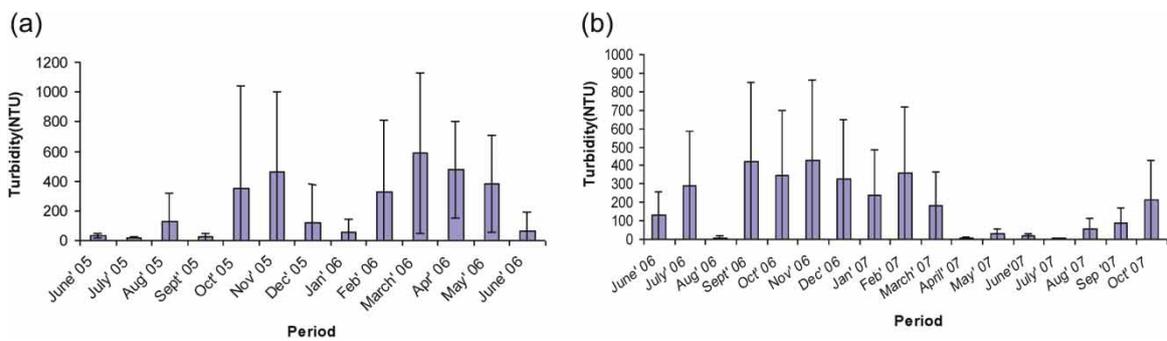
Figure 12 | Average raw water turbidity at Yanze Intake based on data from EWSA (a) period June 2005–June 2006 and (b) period June 2006–October 2007.

In many cases, full data on abstractions were not available from the treatment plants or the EWSA headquarters. Figure 12 was plotted using the turbidity data from EWSA for the period June 2005 to October 2007 and it shows that periods of higher turbidity values correspond with periods of low abstractions.

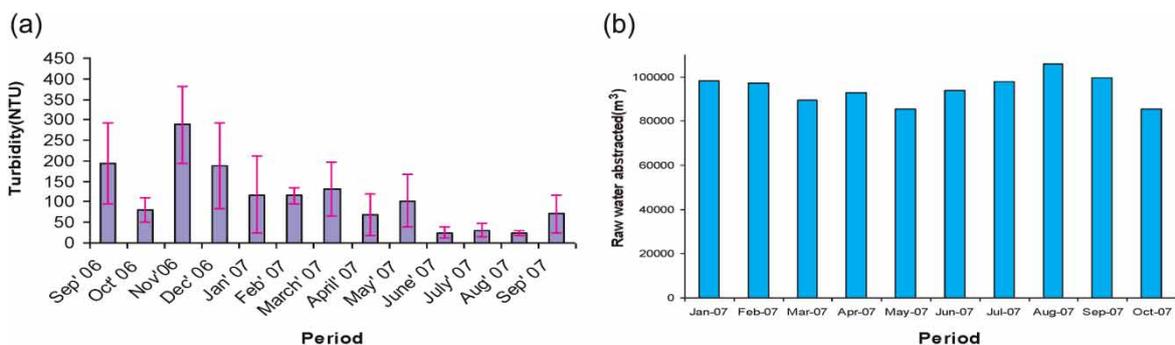
Figure 13 | Monthly variations in (a) raw water turbidity and (b) abstractions from the Kadahokwa Intake for the periods shown.

The monthly average turbidity for the raw water at the Kadahokwa intake for the period January 2006 to September 2007 are shown in Figure 13(a). The results show that the highest turbidity value at Kadahokwa occurred in November. Using the raw water abstraction data obtained from the

Kadahokwa water treatment plant, Figure 13(b) was plotted for the period of January 2007 to October 2007.

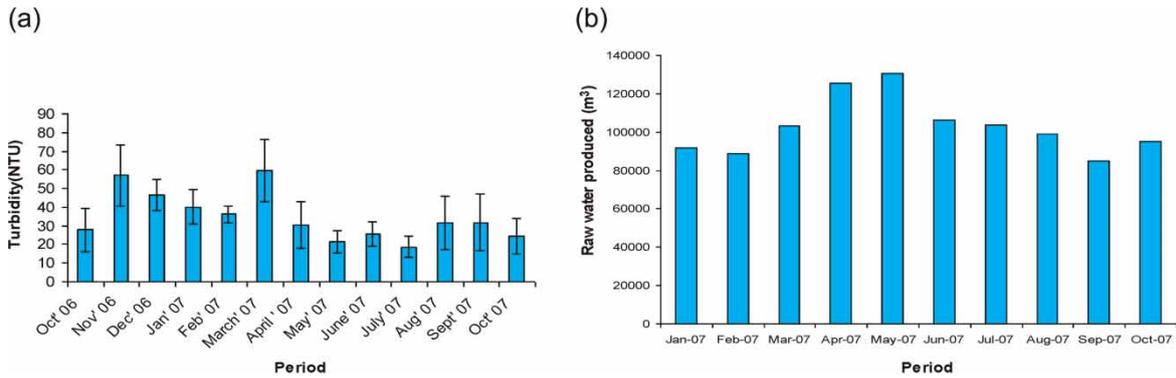
Figure 14 | Monthly variations in (a) raw water turbidity and (b) abstractions from the Nyabarongo Intake for the periods shown.

Figure 14 shows the turbidity and raw water abstraction trends at the Nyabarongo intake for the period October 2006 to October 2007. The graphs show that the high turbidity values occurred in November and March, which are normally high rainfall months in Rwanda. It is also clear from Figure 14(b) that the monthly raw water produced is high in April and May, and the lowest values

are found in February and September. This graph does not have error bars because there were no daily records at the treatment plant. The data used were found in monthly reports sent to the EWSA headquarters.

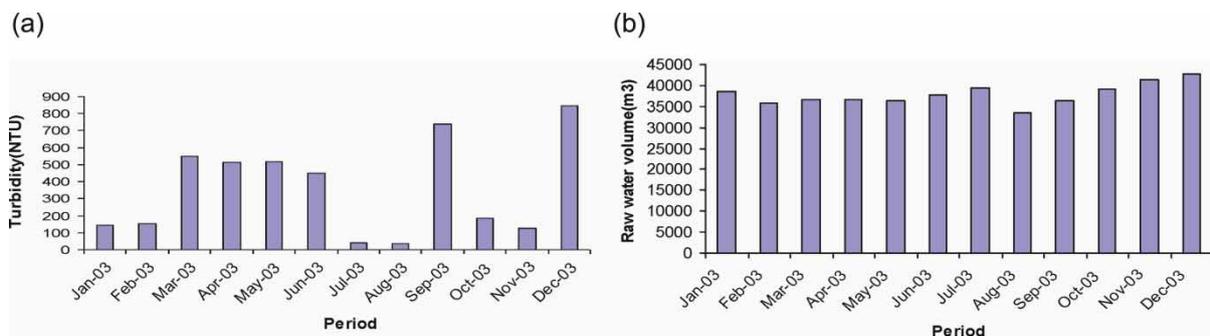
Figure 15 | Monthly variations in (a) raw water turbidity and (b) abstractions from the Shyogwe Intake for the periods shown.

There were very little data for the Shyogwe intake system and the dam had been damaged and not working well by the time this research was completed. The data that were available were for the years before 2003 only. These data were used to produce the graph in Figure 15(a) on the Shyogwe raw water turbidity in 2003 since it is the latest year for which the data were available. Figure 15 (b) shows the amount of water abstracted at Shyogwe in the year 2003. In general, the water produced at this intake was not changing very much.

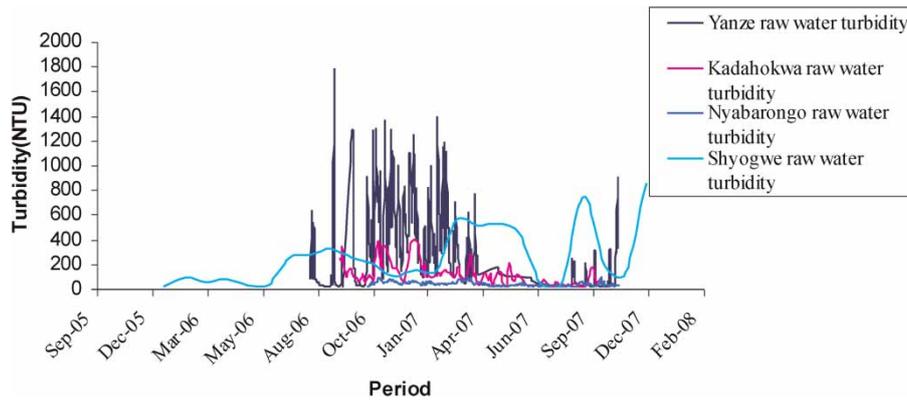
Figure 16 | Raw water turbidity graphs for different intake sites based on data from EWSA.

Figure 16 shows the general view of how turbidity varies for the different sites studied. To have a combined view of how raw water turbidity varies for different intakes, the turbidity values for Shyogwe intake had to be moved from 2003 to the 2005–7 period where data for other plants do exist.

Figure 16 shows that Yanze had highest values and highest variations of turbidity whilst Nyabarongo had the least turbidity and nominal variations. The raw water turbidity in general is high during the rainy season, especially in September, November and March, and is lowest in the drier month of August. Further analysis was conducted to investigate the relationship between raw water turbidity and the quantity of raw water abstracted. Figure 17 shows that at Yanze intake, which supplies Kimisagara water treatment plant, the water abstracted is highest when the turbidity is

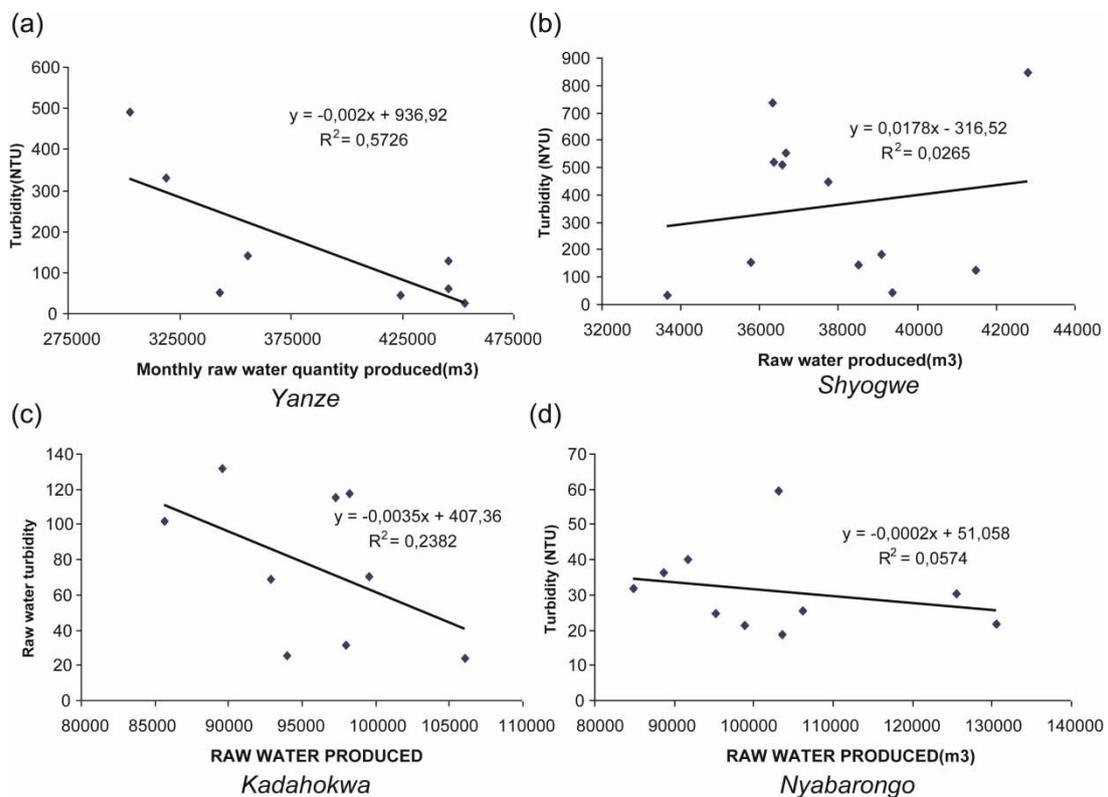
Figure 17 | Comparative assessment of the correlation of turbidity and raw water abstracted for the four studied intake systems.

lowest. The correlation, however, is not very strong. The other river diversion system, Kadahokwa, was next in the extend of correlation ($R^2 = 0.2382$), whilst for Shyogwe and Nyabarongo there was virtually no correlation at all.

From Figure 17 it can be concluded that the raw water turbidity was, to some extent, affecting raw water production at the intakes using river diversion systems (Kadahokwa and Yanze). This was corroborated by personnel on site. The Shyogwe system uses a dam abstraction system and did not show considerable effect. The turbidity problems were lowest at the Nyabarongo intake because the type of intake used (river bank or infiltration intake system) is not much affected by the rainfall since the water is filtered as it passes through the soil.

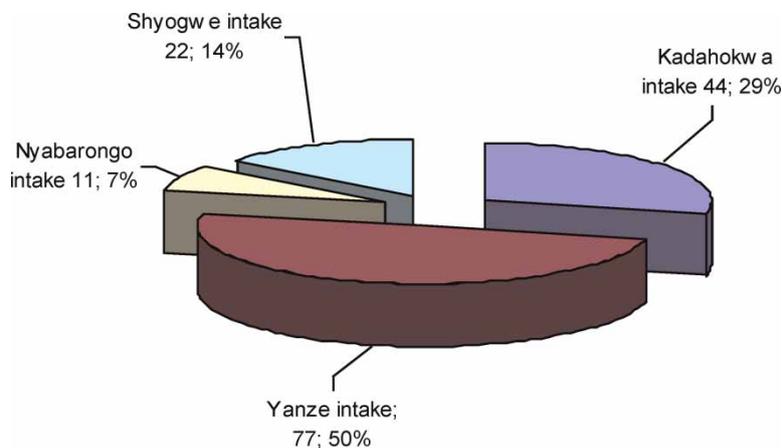
Figure 18 | Percentage of environmental problems for different sites.

Using the data from Table 3, Figure 18 was also plotted, showing the environmental problems occurrence for different sites.
