The Pantheon

Dr. Khaled Mohamed Dewidar *

British University in Egypt

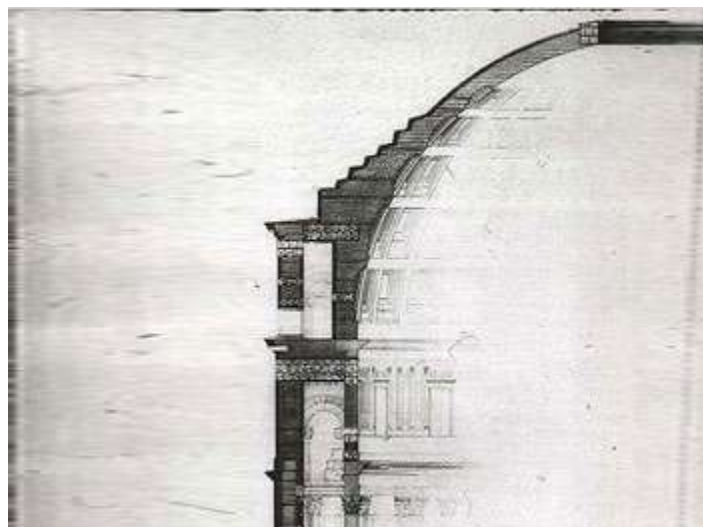
- 5) The oculus, as well as being a beautiful and unique feature to admit light, also reduces the weight of the dome.

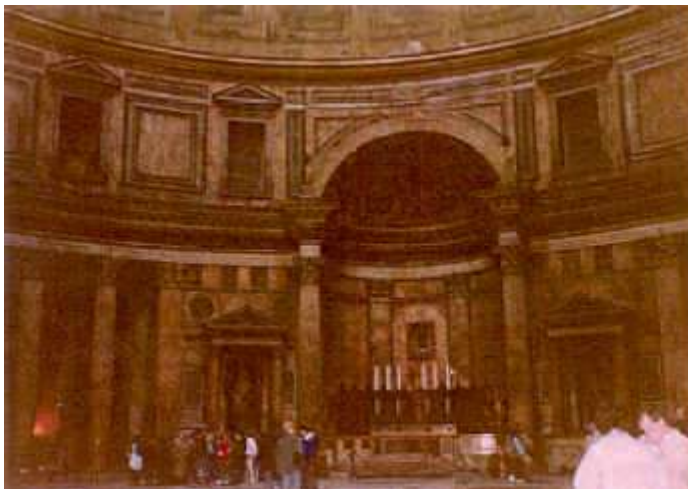
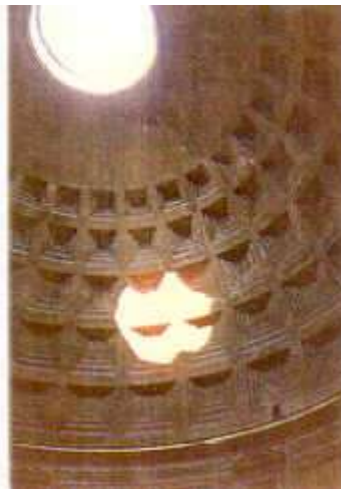
Inside the Pantheon

The building design is one of a large round shape very much like a large barrel with a dome covering the top. There is a light-well in the center of the dome. Layers of beautiful thin brickwork cover the outside, round walls. Small access holes appear occasionally in the wall which were used during construction to frame interior voids. The main entrance is thoroughly impressive: double bronze doors 21 feet high (6.4 meters), a lasting and fitting contribution from their metal smiths. These doors are protected by a high, broad porch, made with 16 well arranged granite columns supporting a gable styled roof. The beams in the roof structure of the porch are wooden. They were substituted for bronze members stripped-out by those in later years needing metal for their canons. Professional Roman surveyors located the inlaid marble floor to conform with a convex contour which drained away the rain from the oculus for these hundreds of years.

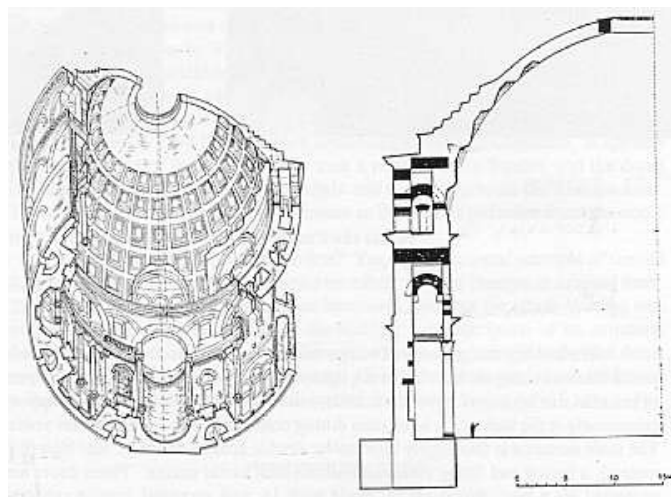
Pantheon Sections (left picture: Ward-Perkins⁶, right picture: MacDonald⁷)

To provide details on this complex configuration, the following figures show the building with its two-ring foundation, voids in the walls, and the step-ring and coffer arrangement in the dome.

Initially, the width of this ring foundation was 23'-7" (7.2 m) wide, only about 3 feet (0.9 m) greater than the walls it supported. The second ring that binds the original together is 10 feet (3.0 m) wide making the total width of the foundation about 34 feet. From the floor level to the bottom of the foundation is 15'-4" (4.7 m).¹⁰

The dome is an interesting and difficult feature to describe because its configuration is so unusual on both sides. The radii of the dome is 71'-2" (21.7 m) which serves as the basis for the original design. However, G. Cozzo (an Italian engineer) cast doubts on this figure and claimed it to be more like 82 feet (25.0 m).¹⁵ This is pointed out to show there are conflicts among the specialists who continue to study the Pantheon. In this case the former figure appears adequate. The relative thickness of the dome is reduced from 19'-8" (5.9 m) at the base to nearly 5 feet (1.5 m) at the top.¹⁶

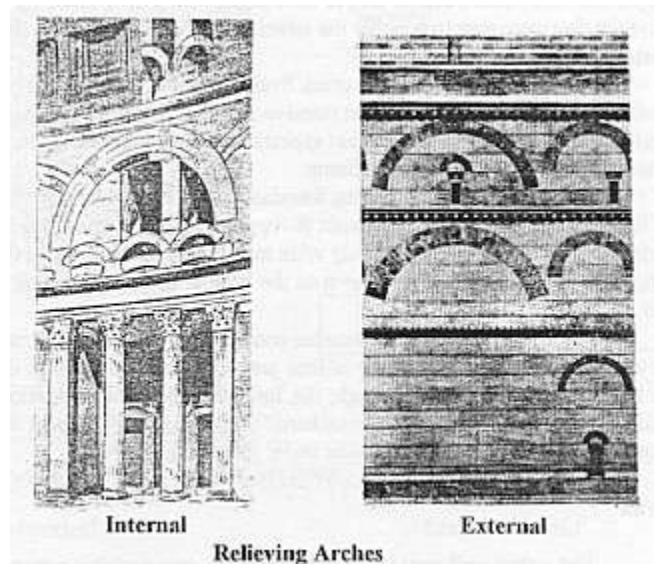
The niches, as well as all other wall openings, have an archway of bricks, known as a relieving arch, to support the upper wall over the openings. The relieving arch is a semicircle of thin bricks standing radially on end extending in the concrete wall. This arch distributes upper loads to the piers during the long time the pozzolan concrete is curing, but after curing, it becomes an integral part of the wall. This archway of bricks was only part of the wall and did not extend into the dome. This type of arch is customary with Roman construction for that period. It is shown together with the niches and their columns in the following figure:

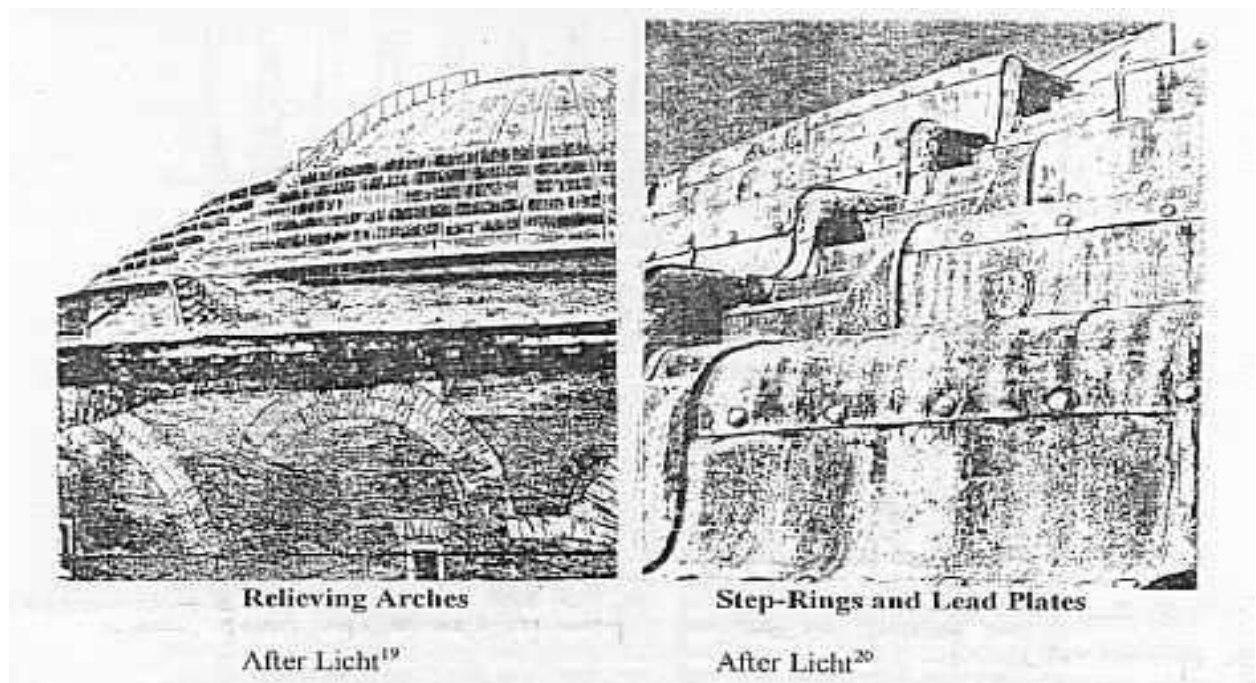
The following figures show the various features such as the step-rings, dome stairway, coffers, lead plates.

On the outside surface, there is a series of seven step- rings half way up the dome, and then the dome line changes into a circular line. On the inside surface the dome contains a series of 5 bands made of waffle-like depressions called coffers. There are 140 coffers which required special forming for the waffle shape. At mid-point the dome contour changes from these coffers to a circular line. In the center of the dome is a large opening, the oculus.

The outside rings are not uniform, there are 7 rings, and the measurements scaled from drawings of the dome are meant to be purely descriptive. The first ring has its outside edge resting on the center of the main wall. It appears to be some 7.5 feet (2.3 m) thick with a horizontal distance to the next ring about this same distance. The remaining 6 step-rings are stepped inward much like placing a series of machine washers, one above the other with their diameters decreasing as they are stacked. The height of these 6 rings vary, and they are estimated to be 2'- 6" (0.8 m) on the average. The horizontal distance to the next of these smaller rings is estimated to be 4 feet (1.2 m). There is an exterior stairway leading through these rings to the oculus.

The compression ring (oculus) at the center of the dome is 19'-3" (5.9 m) in diameter and 4'-7" (1.4 m) thick. The ring is made of 3 horizontal rings of tile, set upright, one above the other; the ring is 2 bricks thick.^{16/17} This ring is effective in properly distributing the compression forces at this point. There is a bronze ring covering the lip dating back to the original construction, but other bronze plates on top of the roof have been removed and later replaced with lead plates.

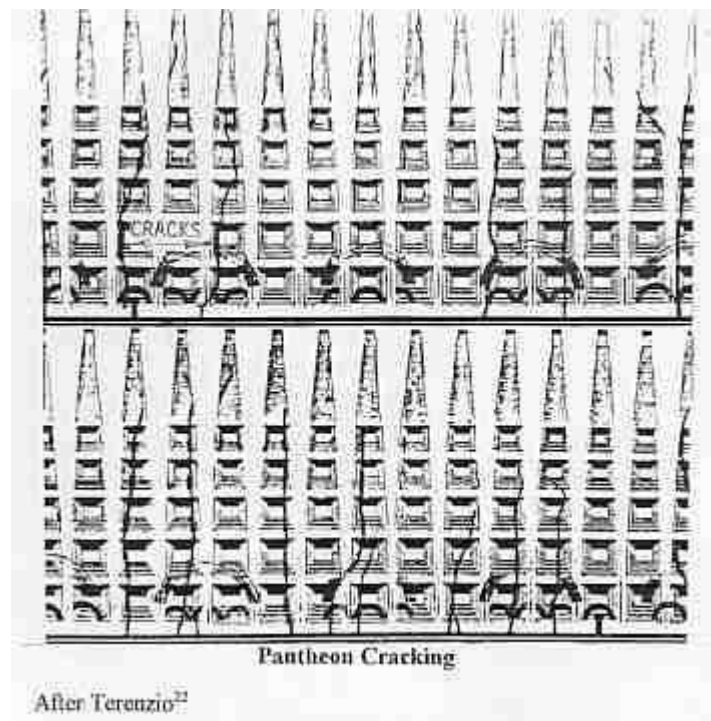
The Pantheon Cracking

Terenzio also identifies fractures 'reaching from the base of the rotunda to the summit of the dome' that he thought were brought about by differential settlement from uneven loading of the wall, particularly near the entrance of the rotunda in the principal niche. Rather than finding vertical differential settlement, we have observed only traces of lateral opening across the cracks-- corresponding to the effect of hoop tension.²¹

Terenzio believed cracking occurred shortly after construction because of dated brick repairs. His sketches of the cracking is shown:

The Mark and Hutchinson study showed that meridional cracking in the dome was in the lower half extending up to about 57 degrees from the horizontal on the spring line.²² An earlier stress analysis of this dome by Cowan theoretically placed this point at 37 degrees 36'.²³

This is the point where hoop stresses in the dome change from tension to compression presenting a point of weakness within the unreinforced concrete dome. This theoretical point is in reasonable agreement with the actual end of meridional cracking. The Mark and Hutchinson study located the cracks as occurring generally at the openings within the upper cylindrical wall which increased local tensile hoop stresses. In addition to the dome, Terenzio mentioned that cracks in the walls extended upward from 24.6 feet (7.5 m) above the floor.
