# **KIEAE Journal**

# A Survey on Improvements of Range Hood in Apartment

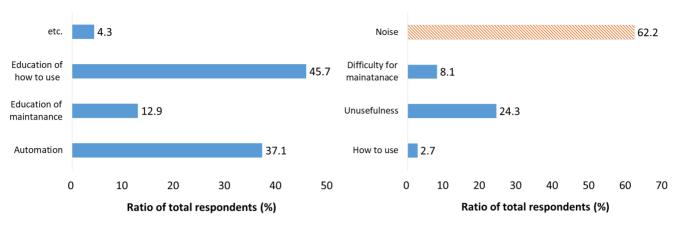
Fig. 4 Survey result of operation, awareness

- (a) Improvement of range hood (N=70, Duplicating answer)
- (b) Reason not to use range hood (N=37, Duplicating answer)

The result of the survey based on this showed that many respondents said the range hood needs improvement (Fig 4(a)). Among them, the use of the range hood (45.7%) was the highest. During the interview process, respondents perceived the use of the range hood as the correct method of use. It would be necessary to provide guidelines for operating the range hood. As an improvement on the range hood, 37.1% answered that if the indoor air quality deteriorates due to cooking, etc., the automation function that the range hood can automatically cope with is required.

As a reason for the reluctance to use the range hood (Fig. 4 (b)), most respondents pointed out the noise problem in the range hood (62.2%). Especially the interview result showed that most respondents do not use the range hood before and after cooking because of noise, and use only intermittently during cooking, showing that they consider the noise problem as an important factor in using the range hood.
