EXPERIMENTAL INVESTIGATION OF MASONRY CALCAREOUS WALLS REPAIRED AND STRENGTHENED BY C-FRP

L. ANANIA^{1*}†, A. BADALA¹, S. COSTA¹, G. D'AGATA¹ and C. GIACQUINTA¹

¹*Dipartimento d'Ingegneria Civile ed Ambientale, University of Catania- Italy*

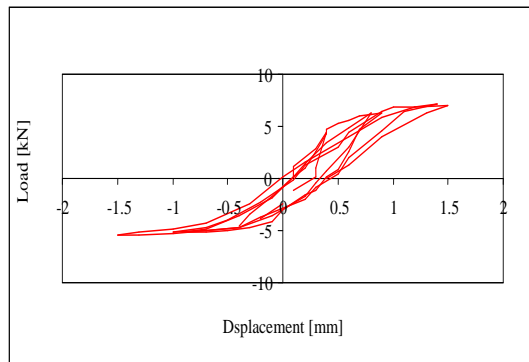
Figure 5. URM :F vs Displacement plot

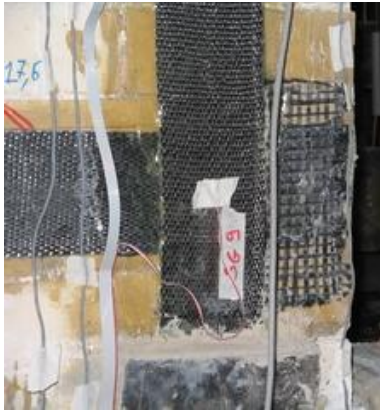
Figure 8. Anchorage at the free extremities

To this aim the cracks were, firstly, repaired either by filling them with high strength epoxy resin or, sometimes, by re-building some highly damaged small masonry portions; then, a grid of single layer uniaxial carbon/epoxy composite laminate 100 mm wide was applied on each side of the wall. The free extremities of the CFRP strips were special anchored transversally by placing a bi-axial CFRP strip at the extremity of the reinforcement (Anania et al. 2007, 2013). The connection between the strip and the basement of the panel was ensured by L steel profiles bolted to the basement (fig.8-9)

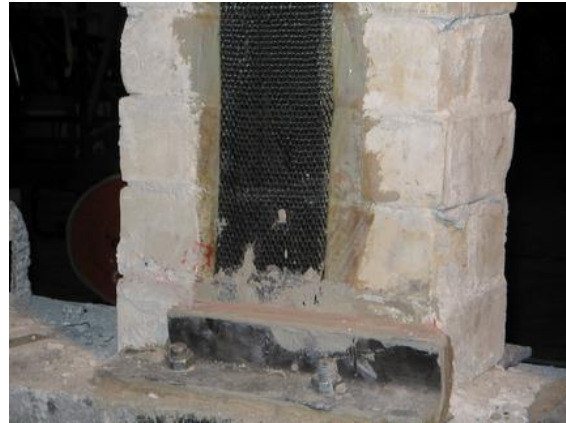
Figure 9. CFRP -basement Connection

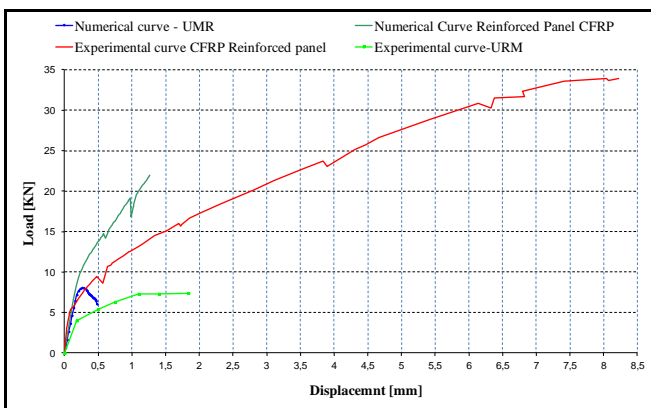
Figure 10. F vs δ curves comparison

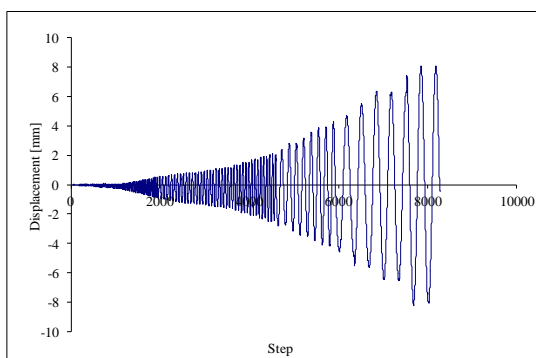
Figure 14. Load history

As in the case of the control specimen, the horizontal shear force was applied in cyclic sinusoidal stages with a frequency equal to 0,01 Hz and measuring the F force until following the load history reported in fig. 14. The panel was instrumented as shown in figure 15. Compared to the as built wall more strain gauges were located along the fiber sheets. Reinforced wall equipped with a CFRP grid, reached failure for an ultimate load of 32,5 kN, with a sufficiently high ductility coefficient value (fig.16) and higher shear resistance if compared to URM panel. Cumulative energy plot (fig. 13) shows that no damage and dissipation occurs during the first 1200 steps (for a displacement of 0,1 mm). After this point the dissipated energy is equal to 2/3 of the inputted one. In this phase the dissipative attitude of the panel varies slightly in all the cycles of equal amplitude even observed the loops recorded on the central bay of wall (fig. 17).

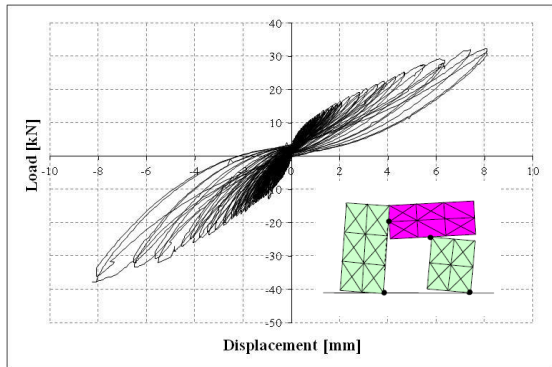
Figure 16. F vs displacement loops at the top

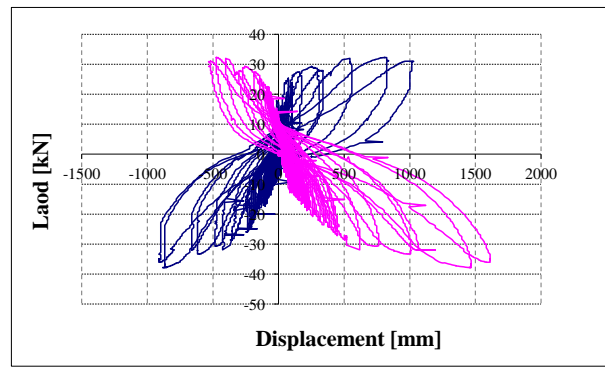
Figure 17. F vs displacement loops on the central bay of wall
