# MANAGING CARPENTER ANT POPULATIONS IN URBAN ENVIRONMENTS

L. D. HANSEN

**Abstract**—Impact of carpenter ant infestations in structures ranges from nuisance pests to seriously damaging pests if structural timbers are attacked. Carpenter ants excavate wood to form galleries for their brood and tunnels for foragers. A mature colony consists of a parent or main colony with the queen, workers, winged reproductives, and young brood plus one or more satellite colonies with workers, winged reproductives, and mature brood.

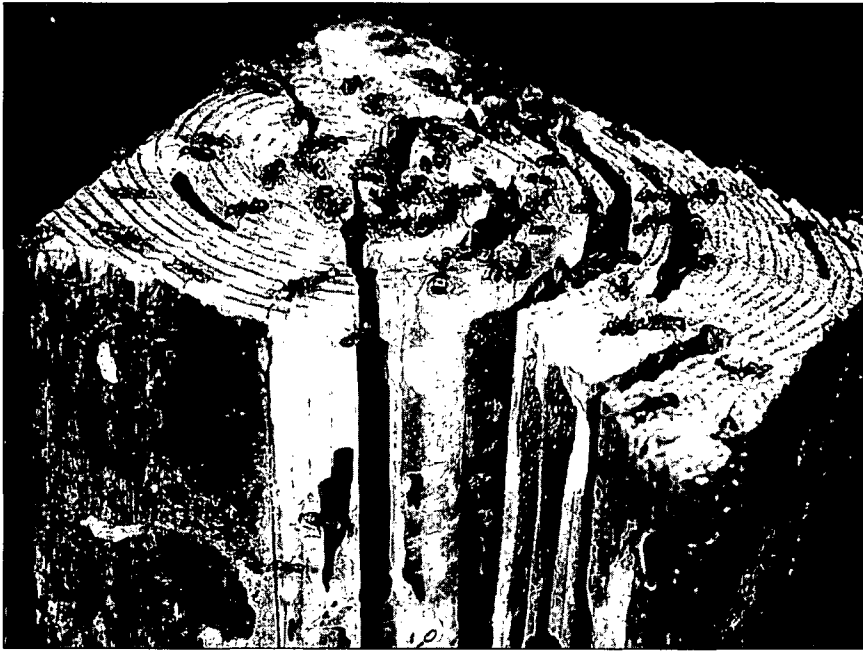
Figure 1. Structural beam infested with *Camponotus modoc*.

Carpenter ants have long been recognized as structurally damaging in the northern United States, Canada, and northern Europe (Hansen and Akre, 1990; Wallin and Schroeder, 1994) (Fig. 1). In many other parts of North America and Europe, carpenter ants are classified as nuisance pests. The categorization of either nuisance or structurally damaging is dependent, in part, upon the species involved (Hansen and Akre, 1994; Hansen, 1995). A total of 23 species of *Camponotus* has been recorded in North America invading structures in one of these categories. Some of these species attack only decayed wood; others will attack sound wood. Nests are made in standing and downed timber, in stumps, and in wood used in structures. Tunneling by carpenter ants was reported in 75% of the ornamental trees in urban environments in the state of New Jersey where the tunneling weakened the trees physically and exposed them to other pests and pathogens (Fowler and Parrish, 1982). Due to these nesting activities, carpenter ants have become a major economic problem in urban environments.

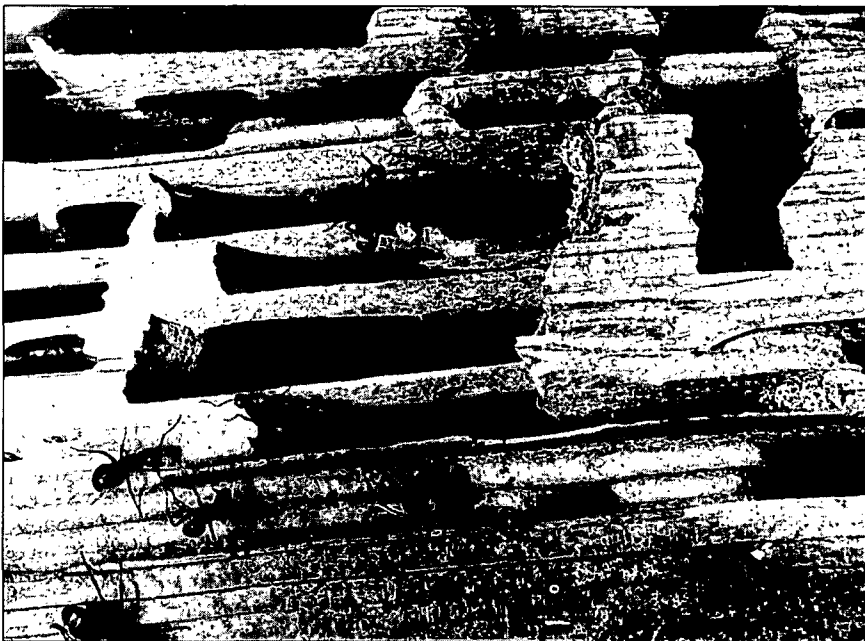
Figure 2. Carpenter ant infestation showing galleries and runways.

Unlike termites, which have symbiotic microorganisms in their midgut to aid them in the digestion of cellulose, carpenter ants do not ingest wood. Instead, they remove wood with their mandibles to excavate brood chambers from the wood matrix and then deposit these wood chips away from their galleries and runways (Fig. 2).
