# SEISMIC VULNERABILITY ANALYSES OF MASONRY AGGREGATE BUILDINGS IN THE HISTORICAL CENTRE OF SULMONA (ITALY)

**KEYWORDS:** masonry structures, seismic vulnerability, vulnerability classes, EMS98 macroseismic scale, limit analysis of macro-elements, Vulnus, aggregate buildings

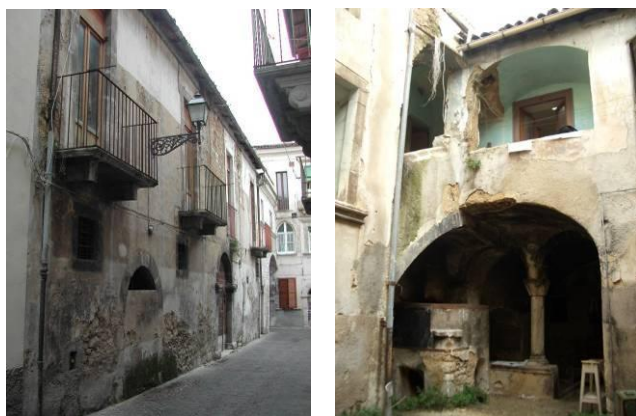
Figure 5: Location and views of the simple block 69 in Acuti street: a) view from outside and b) particular of the internal court.

Aggregates of historical buildings have generally been subjected to the addition of several volumes in different times, and the possible discontinuities between the different volumes could affect the overall seismic behaviour. In Figures 5 and 6 block 69 in Acuti street is shown as an example. Its volume was apparently rather simple when looked from the outside, whereas required to be subdivided into three macro-elements once surveyed in more detail (Figure 7). For a reliable interpretation of the signs of damage, the preliminary in-situ survey, useful to obtain details on the geometry of the structures, identifying irregularities like vertical deviations, rotations, etc. needed complementary indication coming from the investigation of the historical evolution of the structure in its complexity.

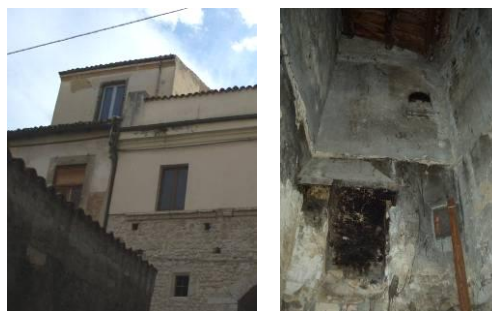
Figure 9: Weaknesses in block 69: standing out body and lack of floor.

After in situ and laboratory characterization and a 3D evaluation of the crack pattern, the main weakness characteristics towards the building seismic response were singled out. In fig. 9 the presence of a standing out body and a room with the lack of the floor are indicated as an example.

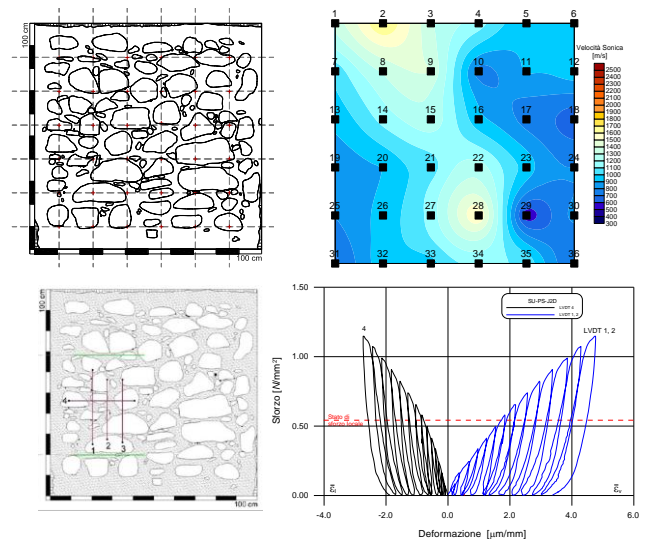
Figure 13: Results of the sonic pulse velocity and flat-jack tests on the extended parts of Sardi Palace.

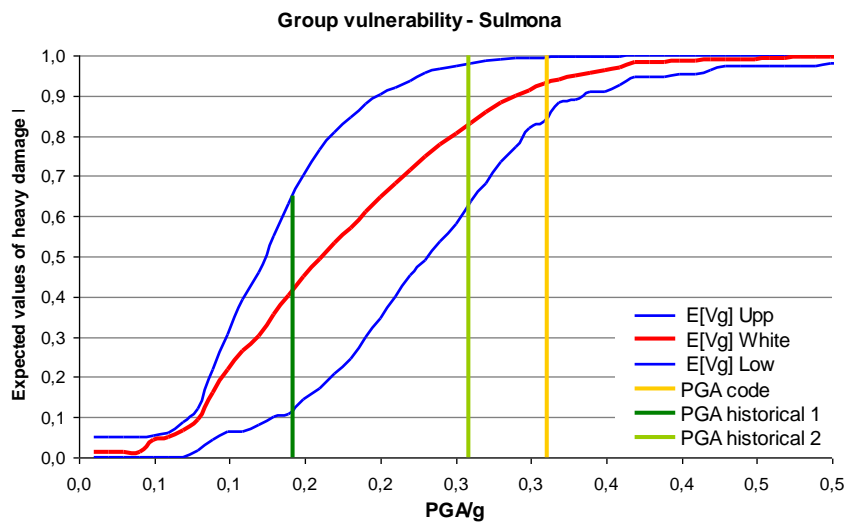
Figure 18: Vulnerability curves obtained with Vulnus for the entire group of aggregates in Sulmona.

Through the Vulnus methodology it is also possible to assess the vulnerability of the groups of buildings through fragility curves (Figure 18), comparing three curves, in order to estimate the expected value of the frequency of Heavy damage  $E[Vg]$  for the different values of  $PGA/g$  (central values) and the uncertainty related to this value (the lower and upper limits). Referring to  $PGA/g = 0.31$ , it is possible to obtain for Sulmona a value of  $E[Vg] > 0.9$ . Considering the historical earthquakes, for  $PGA/g = 0.26$  is  $E[Vg] = 0.8$  and for  $PGA/g = 0.14$  is  $E[Vg] = 0.4$ , with a high uncertainty on these values.
