Corrosion of copper pipes has been associated with waters with high pH and low alkalinity that also contain significant levels of chloride and sulfate. This study systematically evaluated the effect of pH, alkalinity (or dissolved inorganic carbon [DIC]), orthophosphate, and sulfate on the nature of copper corrosion using a pilot-scale experimental pipe loop system. Experiments were conducted in the absence of silica, aluminum, or organic carbon, which previously have been linked to pitting corrosion in drinking water systems, and all test waters contained moderate levels of chloride. The study also investigated the effect of chlorine concentration and form of chlorine on copper-pitting corrosion. Results showed that pitting corrosion of copper pipes was reproduced in the pilot-scale systems after only 91 days of operation. Pitting corrosion occurred in water with low chlorine concentration and DIC and in pH 9 water in the presence of chloride. Pitting was not observed at pH 6.5 and 7 and was evident at pH 8 only when higher chlorine levels were maintained. Sulfate was not necessary to develop pitting corrosion; however, it did affect the composition of the corrosion by-products.

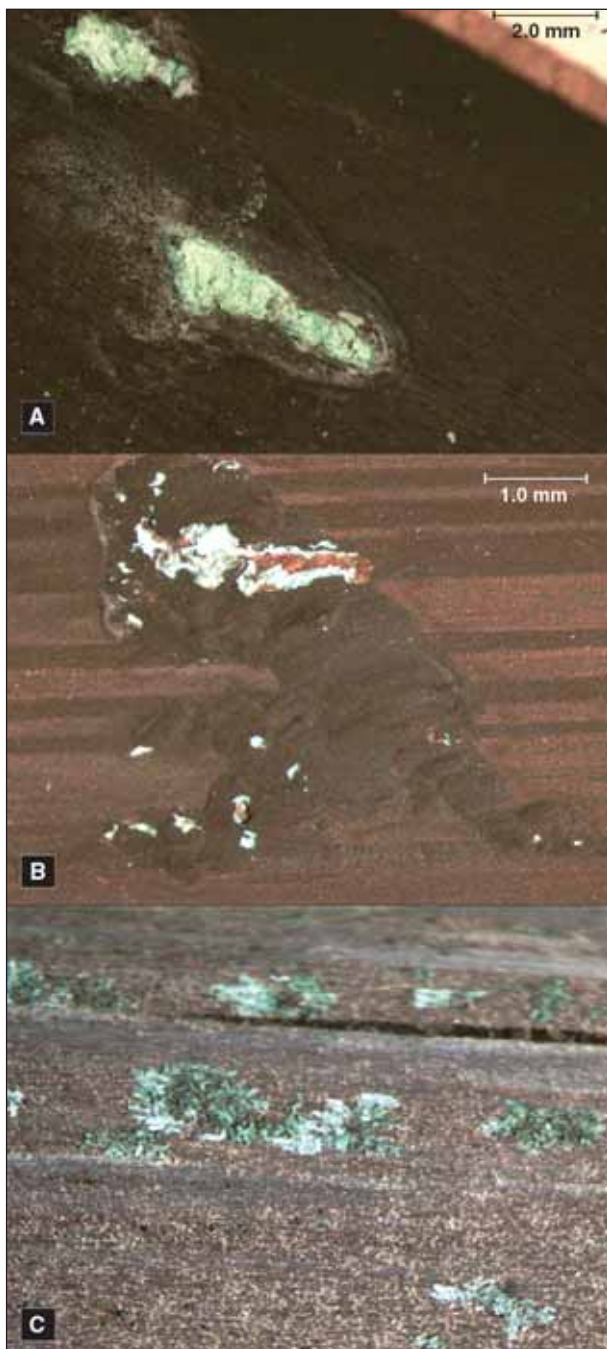
Stereomicroscope images depict the corrosion by-product mounds that formed on the interior surfaces of copper pipes exposed to pH 9 water with 0 mg/L SO_4 in experimental run 9 (A), 5 mg/L SO_4 in run 10 (B), and 150 mg/L SO_4 in run 12 (C).

Runs 9–12 were conducted at pH 9 under conditions of low chlorine, 23–28 mg/L Cl^- , DIC of 10–11 mg/L C, and water temperature of 23°C. Copper pipes from these experiments were predominantly black in appearance. However, as shown in the photographs on page 122, all pipes had mounds of white and green to blue-green corrosion deposits. The mounds were randomly dispersed over the surfaces and present on the pipes under all test conditions. Notably, these corrosion by-product mounds also formed even when sulfate was absent from the water (stereomicroscope image A on page 122). In some cases, particularly with 50 mg/L SO_4 , the mounds appeared to be covered by the black solid, which was later identified as tenorite (image B on page 122). An apparent mix of white and green material was observed, particularly on pipes exposed to lower levels of sulfate, whereas the material appeared blue-green at the higher sulfate conditions. The mounds typically were oblong in shape, with the widest dimension in the direction of water flow. The longest dimension approached 10 mm or more in some cases. The corrosion mounds that formed in the 150-mg/L SO_4 water appeared to be more dispersed and were

not as well structured as under other water quality conditions (image C on page 122). Although the mounds of corrosion deposits observed at pH 9 and 10 mg/L DIC were similar in appearance to pit “caps” associated with localized corrosion, these observations alone were not enough to conclude that pitting corrosion was actively occurring in the pH 9 test waters.

To test the reproducibility of the previous observations, a series of test runs (36–39) was repeated in waters containing a slightly lower DIC (5 mg/L C), low chlorine, chloride only, and pH 6.5, 7, 8, and 9. Pitting corrosion of the copper pipe surfaces (as determined by the presence of corrosion by-product mounds and cross-sectional verification) was observed in water only at pH 9 (no sulfate and 25–37 mg/L Cl^-). The pipe surfaces appeared identical to those exposed to 10-mg/L C DIC water at pH 9 (image A on page 122).

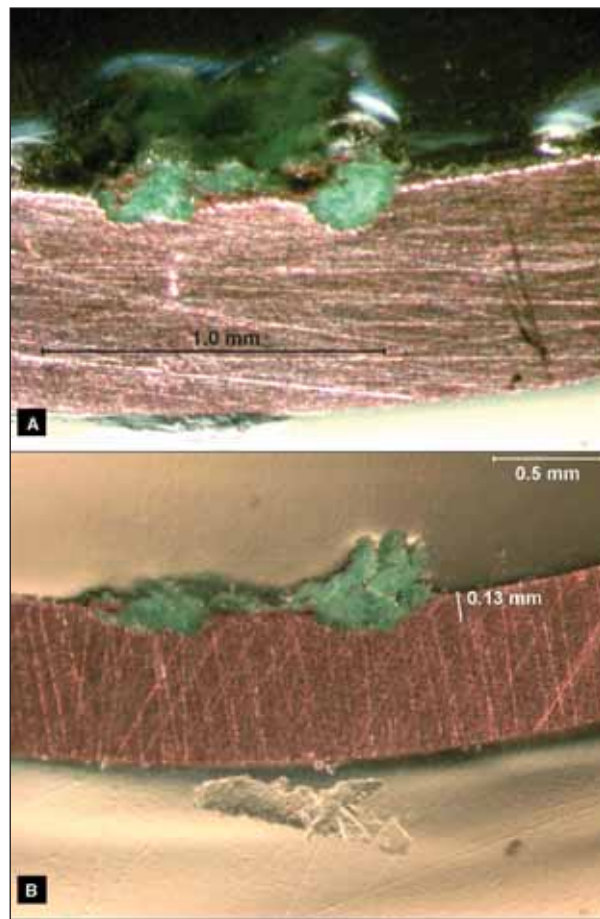
In these stereomicroscope images, cross sections of corrosion by-product mounds show the degree of localized corrosion attack on the interior surfaces of copper pipes exposed to 0 mg/L SO_4 in experimental run 9 (A) and 5 mg/L SO_4 in run 10 (B), both at pH 9.

To provide additional information, pipe sections from pH 9 experiments (test runs 9–12) were cut into smaller segments that were several inches long and solidified in an epoxy resin, as described previously. When hardened, the mounted pipe sections were cut with a diamond saw and polished to expose cross-sectional areas where corrosion by-product mounds were identified. Stereomicroscope images of the polished cross sections clearly showed that localized corrosion and pipe wall degradation was occurring below the corrosion deposit mounds (now appropriately referred to as pit caps). The two cross-sectional stereomicroscope images on page 123 show corroded copper below the pit cap. The thickness of the pit caps varied, with some pit caps as thick as a millimetre. In many cases, the pit cap appeared to extend into the pit itself. Pitting-attack penetration was as deep as 0.2 mm, or approximately 28% of the copper pipe wall. The pits were shaped like a bowl with the widest diameter at the cap–pit interface.

Pitting attack in copper pipes exposed to 0, 5, and 50 mg/L SO_4 appeared very similar in nature, whereas the extent of attack was less in pipes exposed to 150 mg/L SO_4 . Macroscale analysis of pipe cross sections clearly showed that localized attacks that were below the corrosion mounds had taken place after only 99 days. Had the experiments been carried out over a longer time period and had the pitting attack continued at a constant rate, penetration of the pipe wall and leaks would have begun in approximately 500 days.

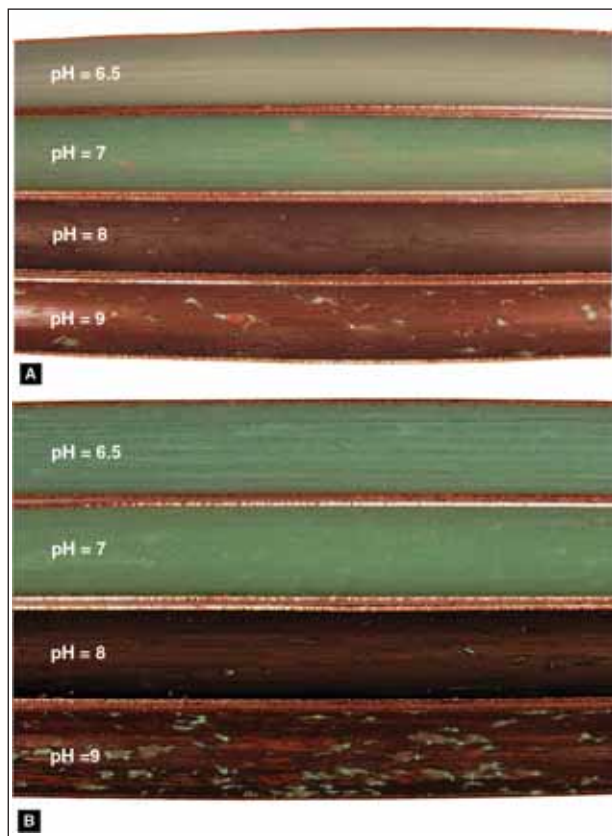
The interior surfaces of pipes show the effects of exposure to waters containing low free chlorine levels in experimental runs 40–43 (A) and high chlorine levels in runs 28–31 (B) as a function of pH dose. Chlorine was added as sodium hypochlorite.

chlorine dose (added as NaClO in water over a pH range of 6.5 to 9 and DIC of 5 to 6 mg/L C) had on the development of localized corrosion. Results for pipes exposed to test waters with low free chlorine (test runs 40–43) agreed with findings of test runs 1, 5, and 9 with respect to the appearance of the surface and signs of localized corrosion (photograph A on page 125). Relatively uniform light-blue–green solids covered the pipe surface at pH 6.5 and 7, and no signs of localized corrosion attack were observed. Localized attack was apparent at pH 9 as shown by the presence of blue–green mounds of corrosion deposits and cross-sectional analysis of the pipe and mounds. A uniform light-black solid covered the pipe surface and local mounds in many cases. A uniform light-black solid covered the pipe surface exposed to pH 8 water as well, and close examination found a few, less-obvious local mounds. Cross-sectional analysis was not performed to verify whether pitting attack was in fact occurring in those areas. Pipe surface observations in the test waters with high chlorine concentrations (photograph B on page 125) were nearly identical to the low chlorine conditions, with the exception that there tended to be more uniformly deposited solids present and the presence of more corrosion deposits mounds at pH 9 and 8. Elevated chlorine doses appeared to enhance the rate of localized corrosion and expanded the range of pH values susceptible to pitting attack.

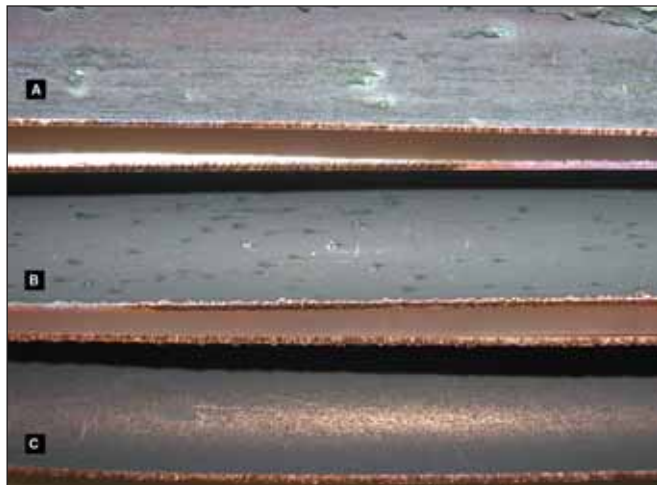
Localized corrosion is evident on the interior surfaces of copper pipes exposed to pH 9 waters with dissolved inorganic carbon of 5 mg/L C (A), 25 mg/L C in run 35 (B), and 50 mg/L C in run 20 (C).

Effect of DIC. Recirculation experiments were conducted at pH 9 in water containing DIC of 28 mg/L C (run 35) and DIC of 50 mg/L C (run 20) to investigate the effect of DIC on localized corrosion (Table 2). As shown in photograph B on page 128, signs of localized corrosion were evident on pipes exposed to 25 mg/L C water,

although the blue–green mounds of corrosion products were small in size relative to those observed in water with DIC of 5 mg/L C at pH 9 (photograph A, page 128). A spotty layer of tenorite was observed, and cuprite was identified on the surface of the pipes exposed to water with a DIC of 50 mg/L C (photograph C, page 128). No signs of pitting corrosion were observed. Increasing DIC increases the alkalinity and buffer capacity of the water and thus could play a role in preventing pitting corrosion.

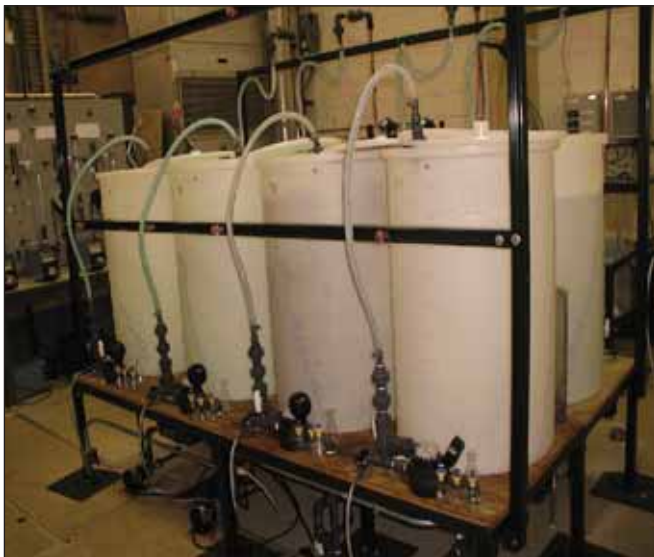
The pilot-scale copper recirculation system used in these experiments included 200-L (53-gal) heavy-duty polyethylene tanks.

The most significant modification to the original system design was the replacement of the stainless-steel tanks with 200-L (53-gal) heavy-duty polyethylene tanks. All parts of the recirculation system connection plumbing were made of polyvinyl chloride plastic or transparent vinyl plastic. A magnetic-drive centrifugal pump continually circulated water through the 1.2-m (4-ft) length of 1.27-cm (0.5-in) inner diameter type M hard-drawn copper piping (0.71-mm wall thickness) at a rate of approximately 3,785 L/day (1,000 gpd). The pipe sections mounted in the recirculation systems were chemically cleaned before the start of the experimental runs by the same procedure described elsewhere for the coupons and pipes used in the single-pass pipe loop systems (Schock et al, 1995).

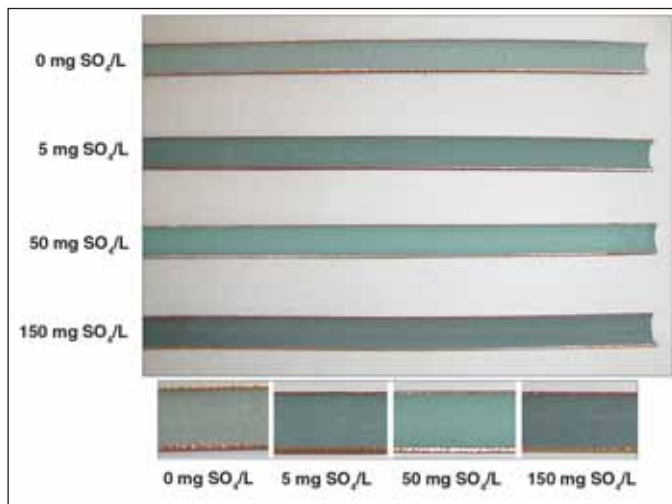
Photographs from runs 1–4 offer a side-by-side comparison (top) and close-up views (bottom) of the interior surfaces of copper pipes exposed to 0, 5, 50, and 150 mg/L SO_4 at pH 7. Uniform deposits of light-green-colored solids are evident across the surfaces of all pipes.

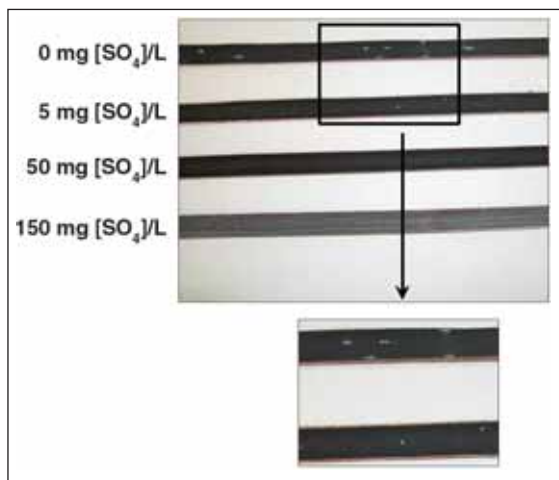
The interior surfaces of copper pipes exposed to 0, 5, 50, and 150 mg/L SO_4 at pH 9 (experimental runs 9–12) show pipe surface scales. A close-up image highlights the randomly dispersed blue-green corrosion by-product.

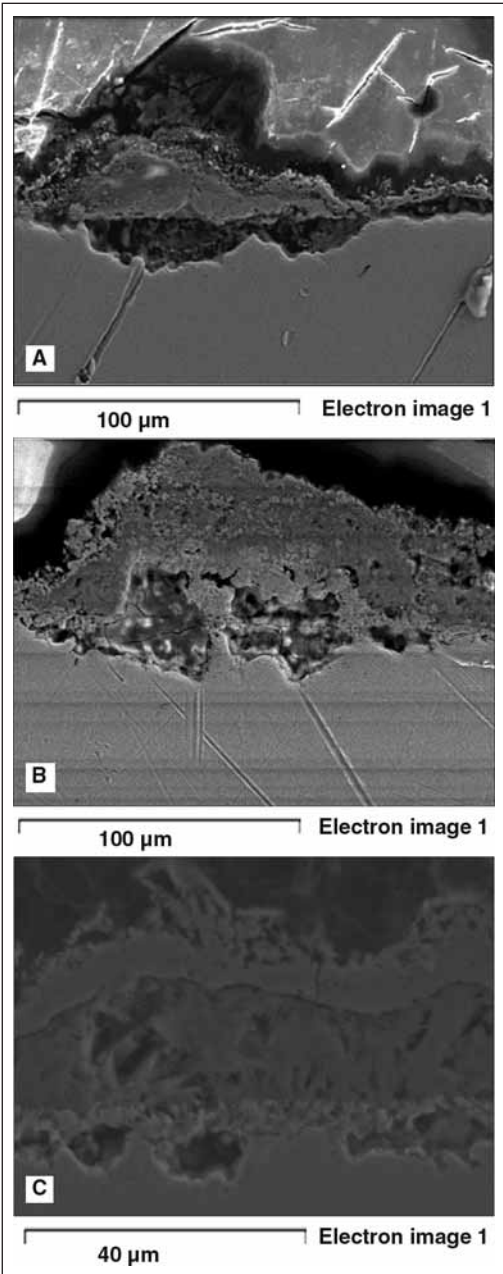
Scanning electron micrograph and energy dispersive spectroscopy elemental scans show the cross section of a corrosion by-product mound formed in the absence of sulfate on the interior surfaces of copper pipes (exposed to 0 mg/L SO_4 at pH 9 during experimental run 9).

EDS elemental maps of pit cross sections showed that the composition of the corrosion by-products associated with localized corrosion changed with water chemistry. SEM and EDS scans showed the cross sections of pits formed in the absence of sulfate solids during experimental run 9. EDS analyses indicated that the cap material and solids within the pit contained copper, chloride, and oxygen. Pits on pipes exposed to 5 mg/L SO_4 contained predominantly copper, chloride, and oxygen, although small amounts of sulfur were noted at some locations (not shown). SEM and EDS scans also showed the cross section of a corrosion by-product mound from run 11. The pit caps associated with pits formed in water containing 50 mg/L SO_4 were predominantly composed of copper, sulfur, and oxygen. The material within the pit, however, was primarily composed of copper, chloride, and oxygen. There was visually less material in the pit relative to the pit cap, and many of the pits were void of material. These observations showed that as the sulfate concentration increased

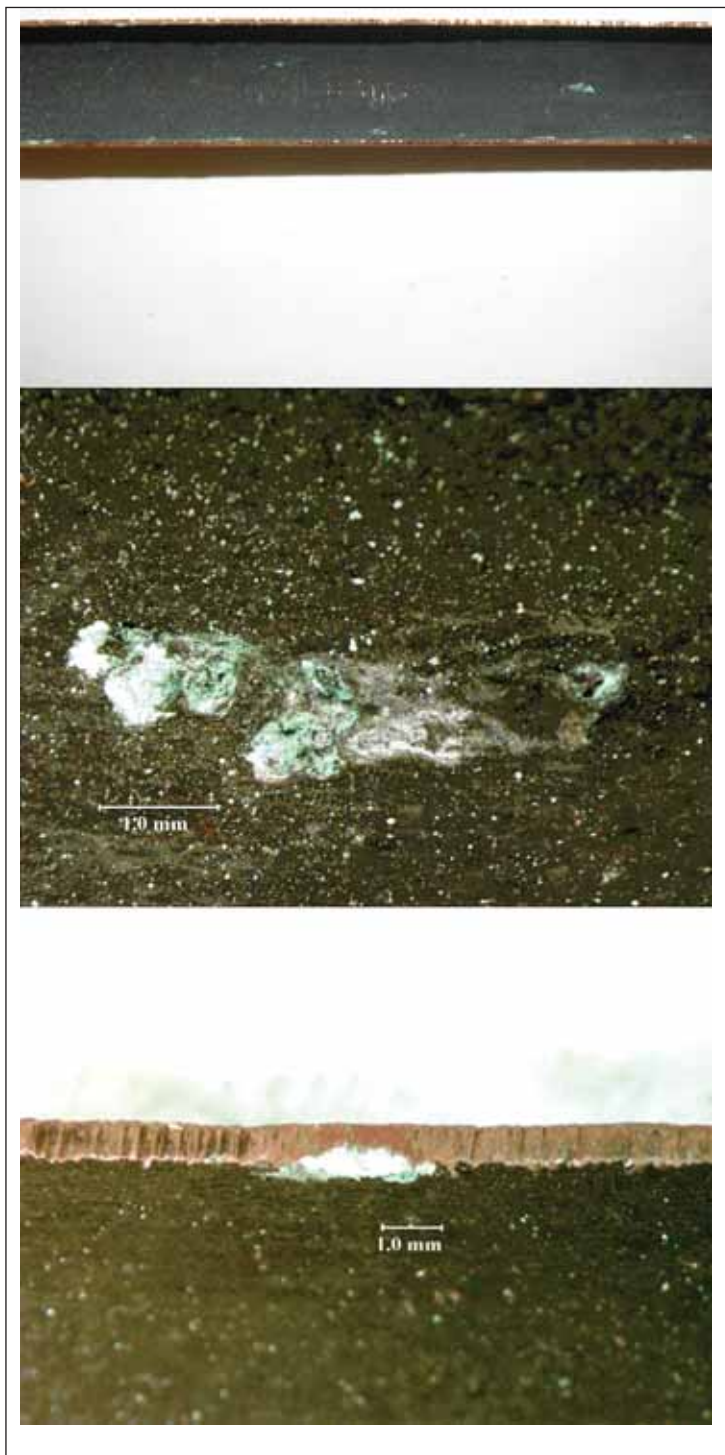
Photographs and stereomicrographs show the interior of copper pipes exposed to pH 9 water (run 39) with the free chlorine residual adjusted with chlorine gas.

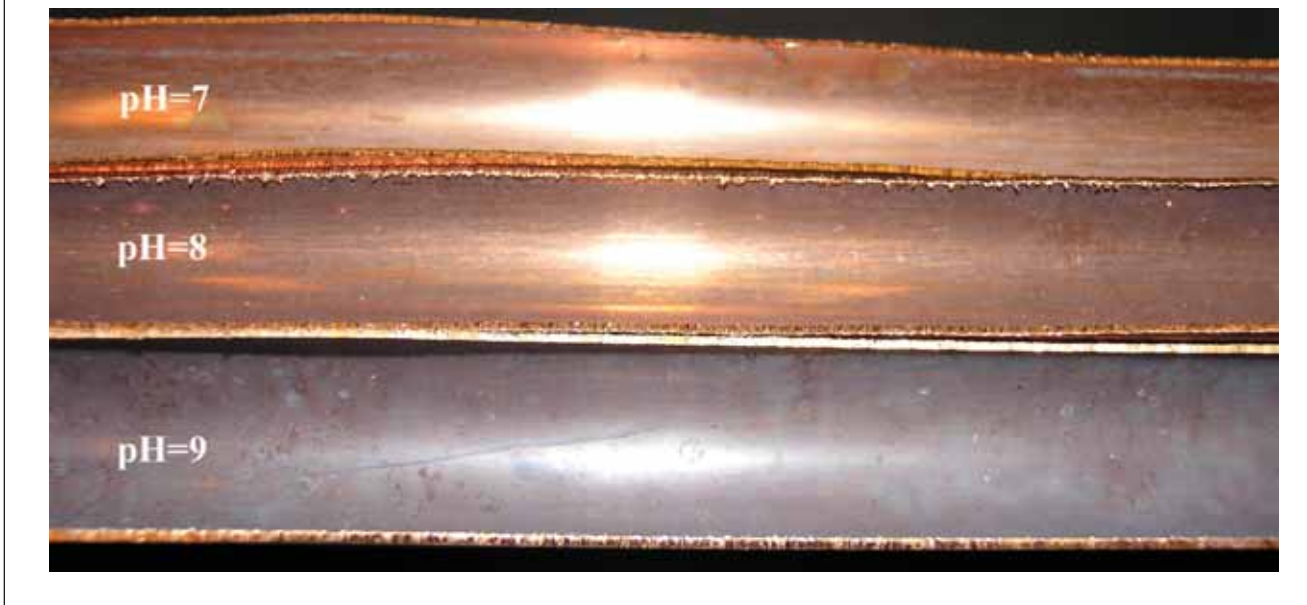
During experimental runs 14-16, the interior surfaces of copper pipes were exposed to 2.9 to 3 mg/L orthophosphate at different pH values and dissolved inorganic carbon of 10 mg/L. A thin, barely visible uniform layer of corrosion deposits was seen on pipes exposed to orthophosphates in any conditions.

matically different from the cases in which orthophosphate was not present. There was a very thin, barely visible uniform layer of corrosion deposits on the pipes exposed to orthophosphates in any conditions. The pipes appeared new in that they were relatively shiny. There was no evidence of localized pitting corrosion attack (e.g., mounds of by-products, irregular surface formations) at any condition including pH 9 where pitting corrosion was clearly identified when phosphate was not present. XRD analysis identified only cuprite on the surfaces. It was also observed that orthophosphate at the dosed level (3 mg/L PO₄) greatly reduced chlorine demand, based on the frequency and amount needed to maintain the desired free chlorine residual. Orthophosphate appeared to significantly reduce the oxidation rate of Cu(I) to Cu(II), possibly by the formation of a thin amorphous cupric orthophosphate film. The exact nature or mechanism of the inhibition requires further study.
