**ESTIMATING VOLUME, NUTRIENT CONTENT, AND  
RATES OF STREAM BANK EROSION OF LEGACY SEDIMENT IN THE  
PIEDMONT AND VALLEY AND RIDGE PHYSIOGRAPHIC PROVINCES,  
SOUTHEASTERN AND CENTRAL PA**

**A Report to the Pennsylvania Department of Environmental Protection**

**Submitted January, 2007, and Revised February, 2007, by**

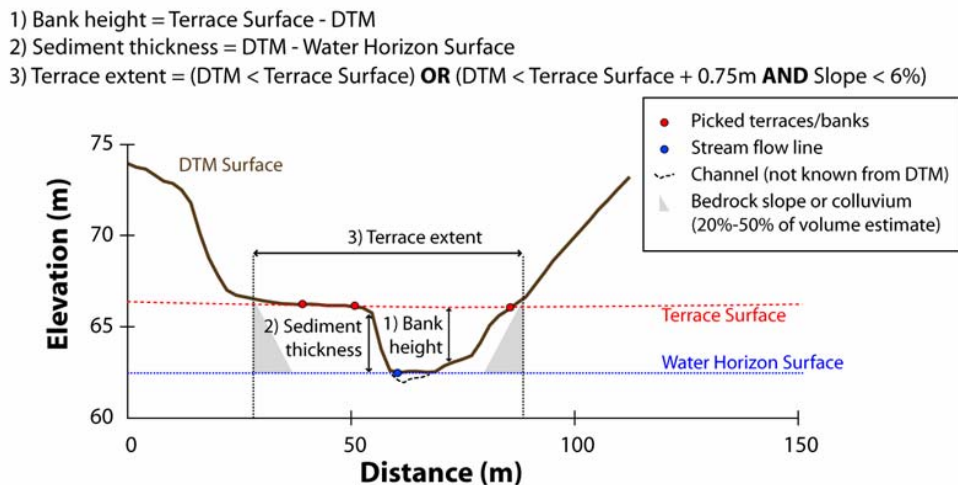
*Two-dimensional representation of method of assessing volume of legacy sediment in storage (remaining) and removed by channel erosion, using a digital terrain model (DTM).*

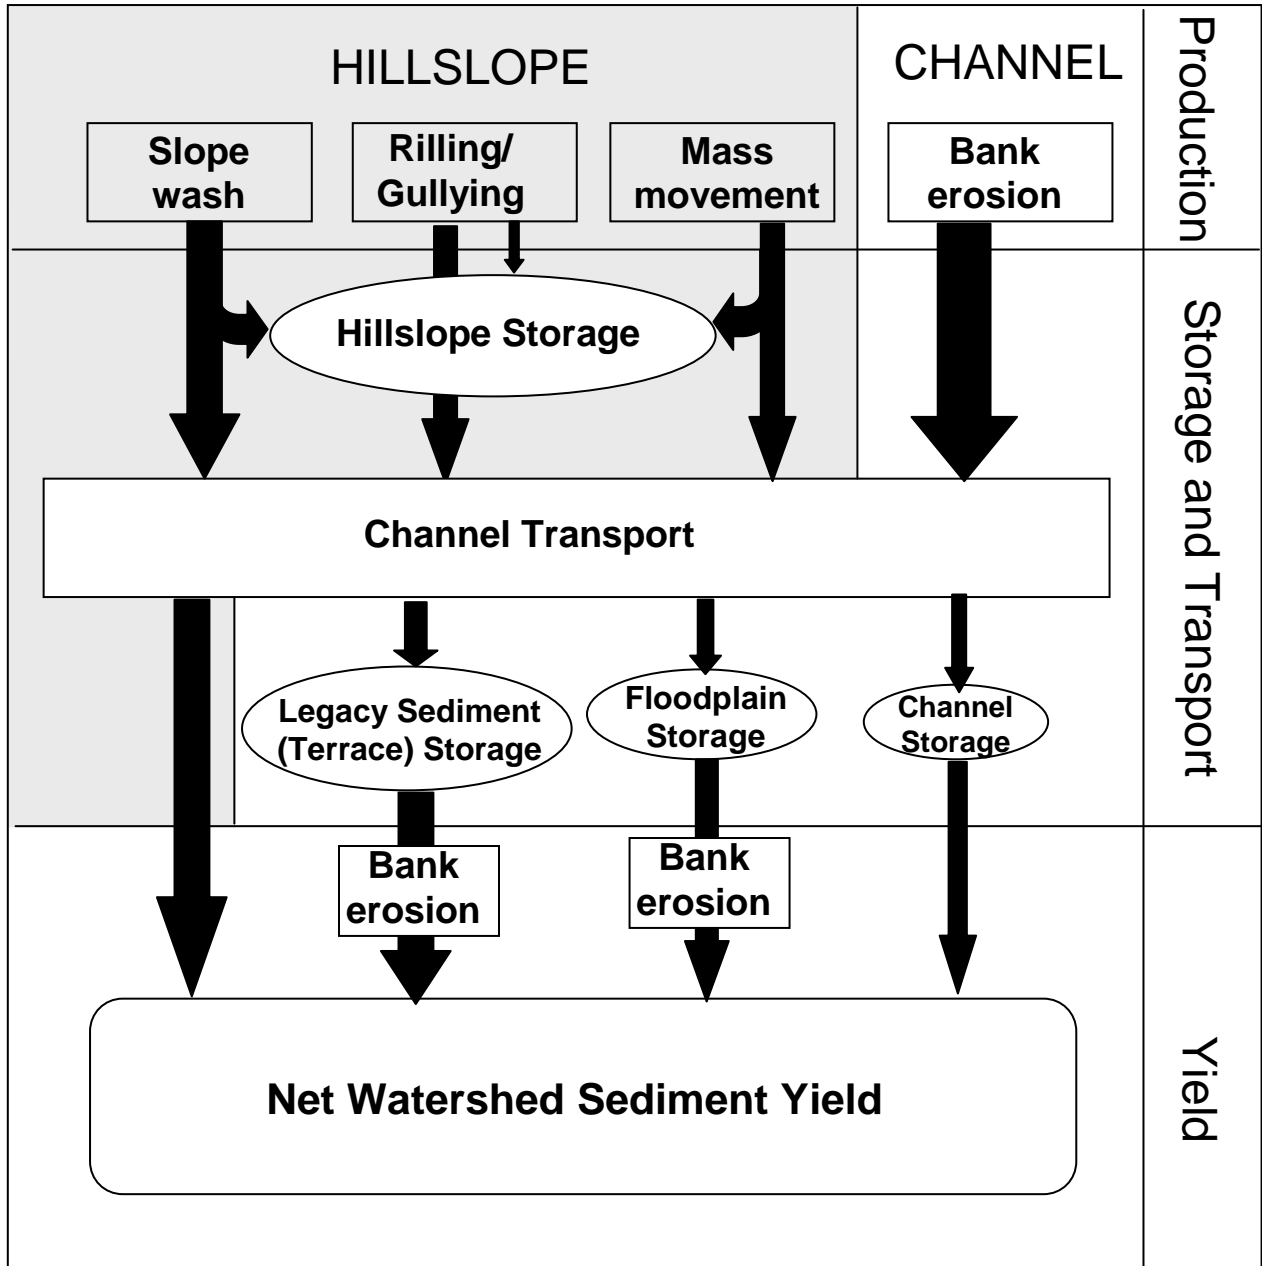
Figure 2. a) Flow diagram illustrating production of sediment from hillslopes and channels (the stream corridor); storage of sediment on hillslopes; transport of sediment in the stream channel; storage of sediment in the stream corridor in terraces, floodplains, or the active channel; and net yield of sediment from a watershed. Ultimately, sediment comes from the hillslopes and stream corridor. Not shown is the role of alluvial fans, which can be substantial in some areas. Arrows show fluxes of sediment from one place to another, as from the hillslopes via slope wash to the channel, then into storage as legacy sediment; and finally out of the watershed by bank erosion. Fluxes vary with time and space, as do amounts of sediment in storage and transport. Figure is modified from Smith et al (2003), with a storage area added for legacy sediment.

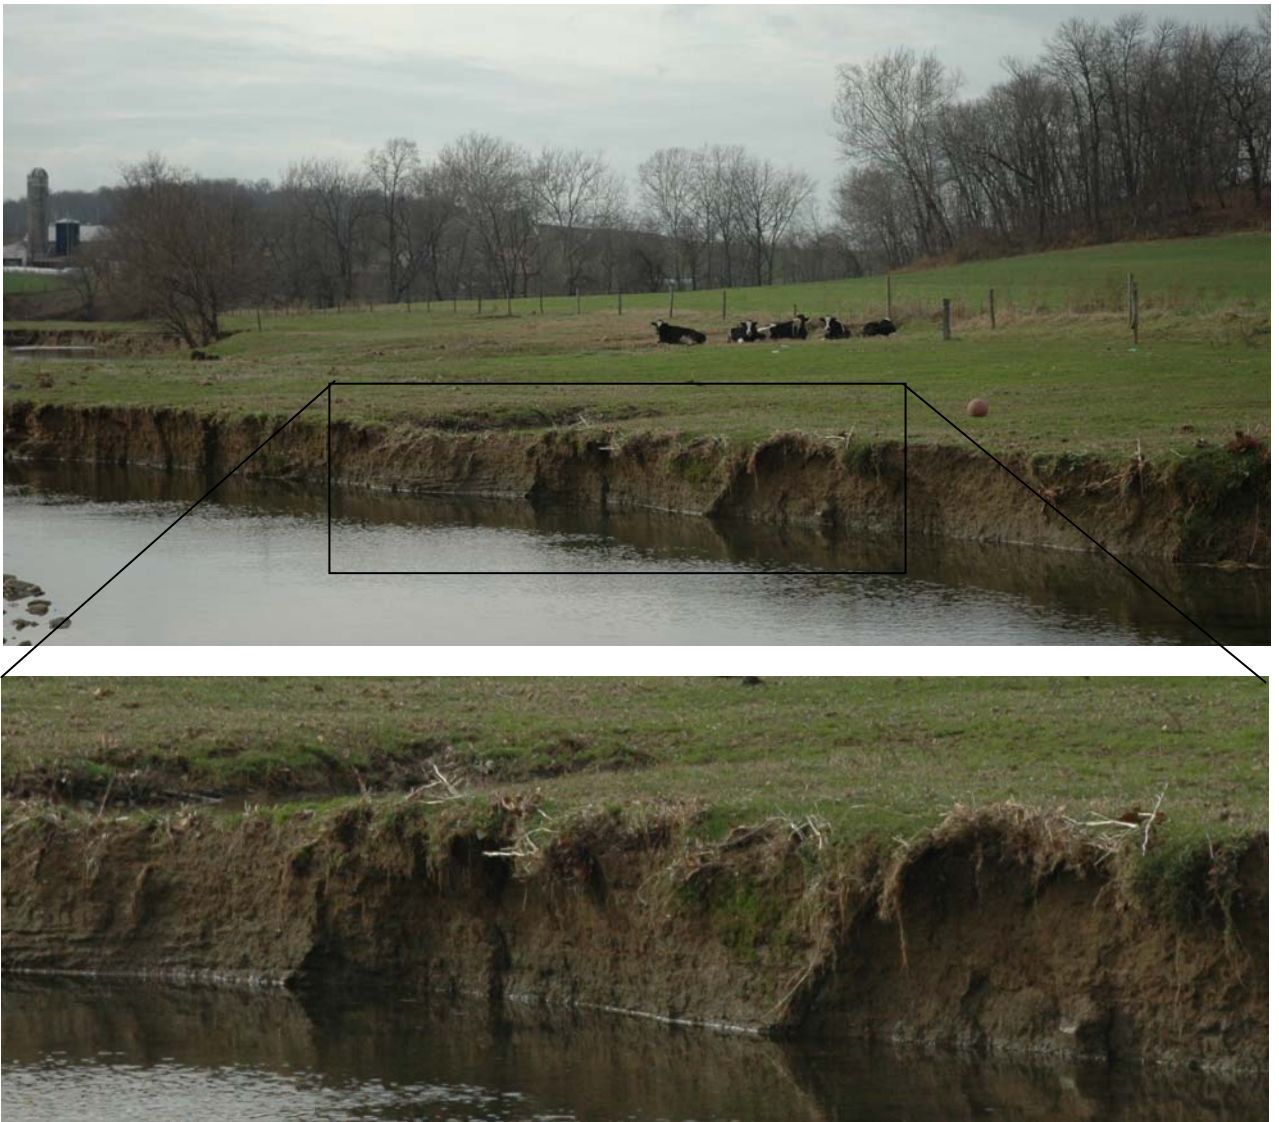
Figure 2. b) Eroding right bank along Big Beaver Run, Pequea Creek watershed, southern Lancaster County, ~100 ft upstream of a breached mill dam. Downstream flow is from right to left. All but several of the types of sediment production, storage, and transport can be seen at this location. Sediment might be moving down the hillslope during storms as slope wash, and the small channel on right bank (top left in bottom enlargement) could be considered as a rill. Bank erosion is extensive, and is associated with vertical fractures along which slabs of cohesive, fine-grained mill pond sediment collapse. At least three fractures are shown here in the laminated and cross-bedded sediment. Uppermost part of bank might have some hillslope sediment derived from upslope. Undercutting is occurring at the base of the bank, below the water, where a gravel layer lies upon bedrock. Little to no storage occurs in the channel, as it is bedrock. Just downstream, however, a large gravel bar exists. We note that most channel storage along this part of Big Beaver Run is coarse gravel, whereas most legacy sediment storage is sand, silt, and clay. No active floodplain exists, as the channel is incised and flow rarely tops the high banks.

Bank erosion of floodplains, alluvial fans, and terraces is typically the primary process to mobilize sediment from the stream corridor, making the landforms a source rather than a sink. Bank erosion proceeds laterally and usually occurs through multiple processes (Ritter et al, 2004; Thorne, 1982). The three major processes are weakening of the bank material, mass wasting of the weakened material, and fluvial entrainment of the loosened sediment. Feedbacks occur among these processes. For example, fluvial entrainment of the least resistant (most non-cohesive) bank material occurs during higher velocity flows, leading to undercutting and formation of overhanging ledges in the more cohesive

material (Figure 2b). These ledges are more prone to collapse (mass wasting). Large slabs of cohesive sediment can fall into streams after storms that cause widespread undercutting. Banks become weakened when saturated, a condition that occurs frequently after rain storms in high, steep banks consisting of fine-grained material (e.g., silt and clay) with poor drainage.

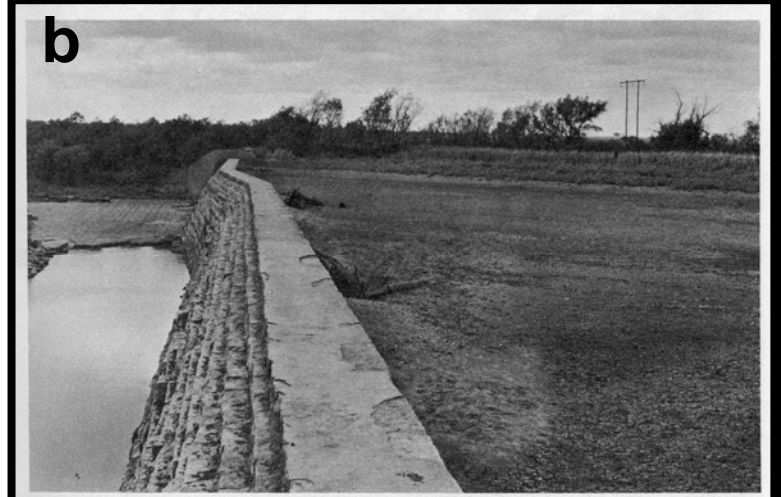
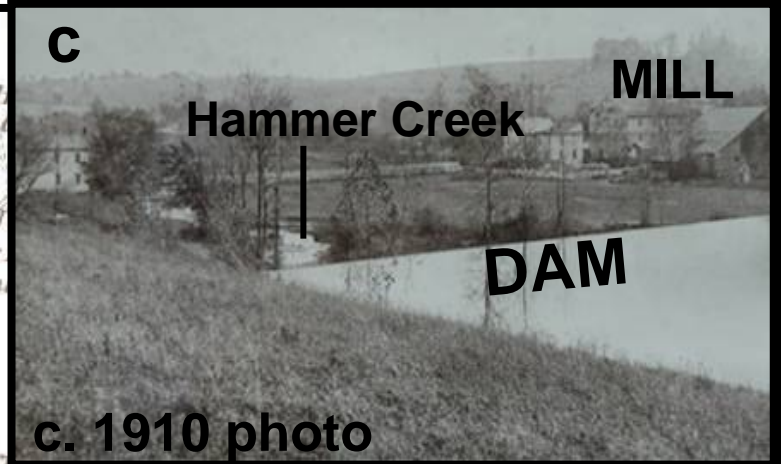
Figure 5. (a) View downstream of a USDA reservoir built in the 1920s (from Basile, 1971). (b) Same reservoir as in (a), after the reservoir filled with sediment in 1952 and was drained (from Basile, 1971). (c) An early 20th c. photo of Hammer Creek (see box of area in Figure 5d) shows a 10-ft mill dam and pond just upstream of an old mill building. The race is out of view, to the right. View is downstream, to the south. Today, the dam is breached and Hammer Creek has incised to the depth of the original valley floor. Remnants of the dam still remain. Hammer Creek was named for the continuous, round-the-clock pounding and hammering at the numerous forges and foundries along its length. (d) Historic (1864) map of part of Elizabeth township illustrates multiple dams and races along Hammer Creek. Photo in (c) was taken by Merritts of an original photo on the wall of the miller's house shown in the photo. Images in (a) and (b) are from Basile, 1971, and were flipped on the horizontal axis for comparison with (c). The map in (d) is from Bridgen's 1864 Atlas of Lancaster County, Elizabeth township.

A typical example of the impact of milling on streams is given by Hammer Creek in northern Lancaster County (Figure 5). The 1864 map of Elizabeth township shows multiple mill dams and races along Hammer Creek (Figure 5d). One of these dams, shown in ~1910 in Figure 5c, is breached today, and the stream channel is deeply incised into the reservoir sediment. At the remnants of the dam, the stream flows along the base of the wall of the dam on its upstream side, then crosses over rubble from the dam base near right bank. A 25-ft dam was built at Speedwell Forge just upstream in the 1960s, submerging the dams and ponds of the two upstream mill sites shown in the 1865 map. Further upstream, at the Pump Station site just north of Rte 322, a dam was rebuilt at least once within an older stack of legacy sediment, and the reservoir for this newer dam submerged an older dam and small sediment-filled reservoir on a minor tributary (Walnut

Removal of the dam produces an instantaneous drop in base level, providing an increase in potential energy equivalent to the height of dam removed. For example, consider the sediment-filled reservoir shown in Figure 5b. Dam breaching at that site led to a channel incised into the fill (on right bank below power line on photo). The difference between the historic mill dam reservoirs in the mid-Atlantic region and the reservoir shown in Figure 5b is that the mill dam reservoirs filled long ago, and their wide, stable surfaces adjacent to the modern stream channel became vegetated. In Pennsylvania and Maryland, many of these fill surfaces became pastures. It is probable that many farmers, acting over several generations, aided in the process of conversion of filled mill ponds to pasture land, referred to by farmers as “bottom land”.

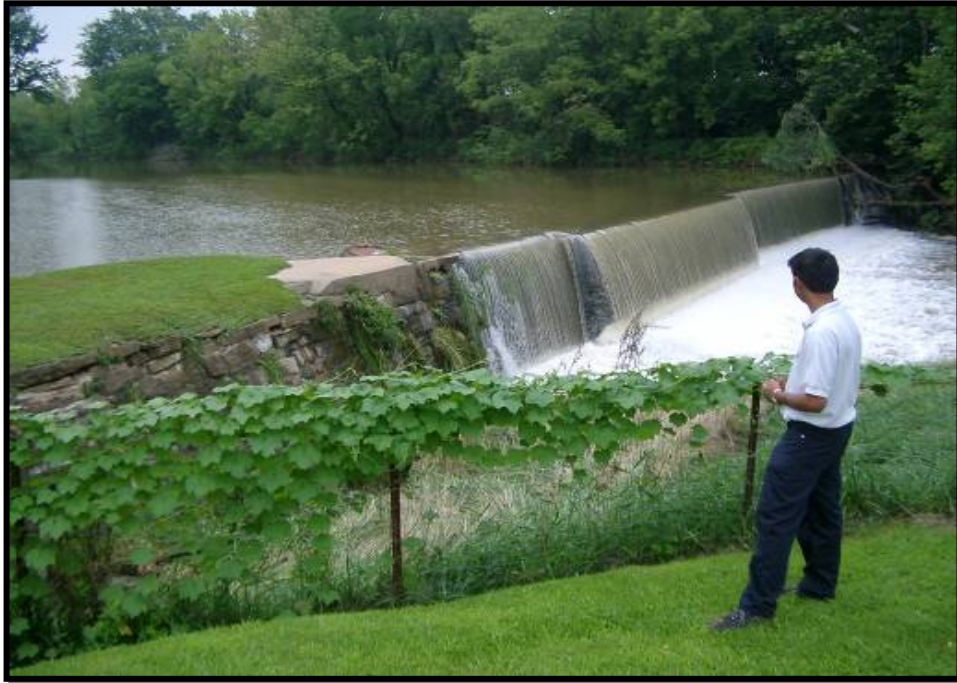
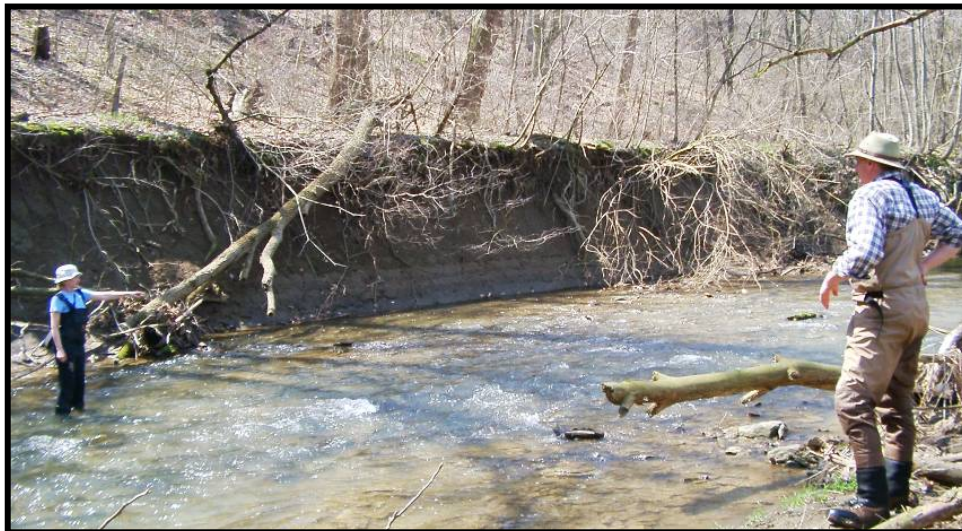
Figure 7. a) Shallow stream flowing across sediment-filled reservoir behind 18<sup>th</sup>-century dam at Mascot Mill on Mill Creek, Lancaster County. Owners dredge the pond about every 2 to 5 years to maintain capacity to run the mill. Both the dam and sediment fill surface extend from valley wall to valley wall, ~200 ft in width. b) Incised channel of the W. Branch, Little Conestoga Creek, upstream of Denlingers Mill (see mile mark 7.6 on Figure 23). Note that mature trees are unable to protect the banks from erosion because the banks are ~20 ft high in the photo and 20 ft high at the dam breach immediately downstream. Gray sediment in lower 5 ft of bank is older reservoir sediment from a lower dam that preceded the 20 ft dam that produced the uppermost 17 ft of fill. Channel bed is bedrock (Wissahickon Schist).

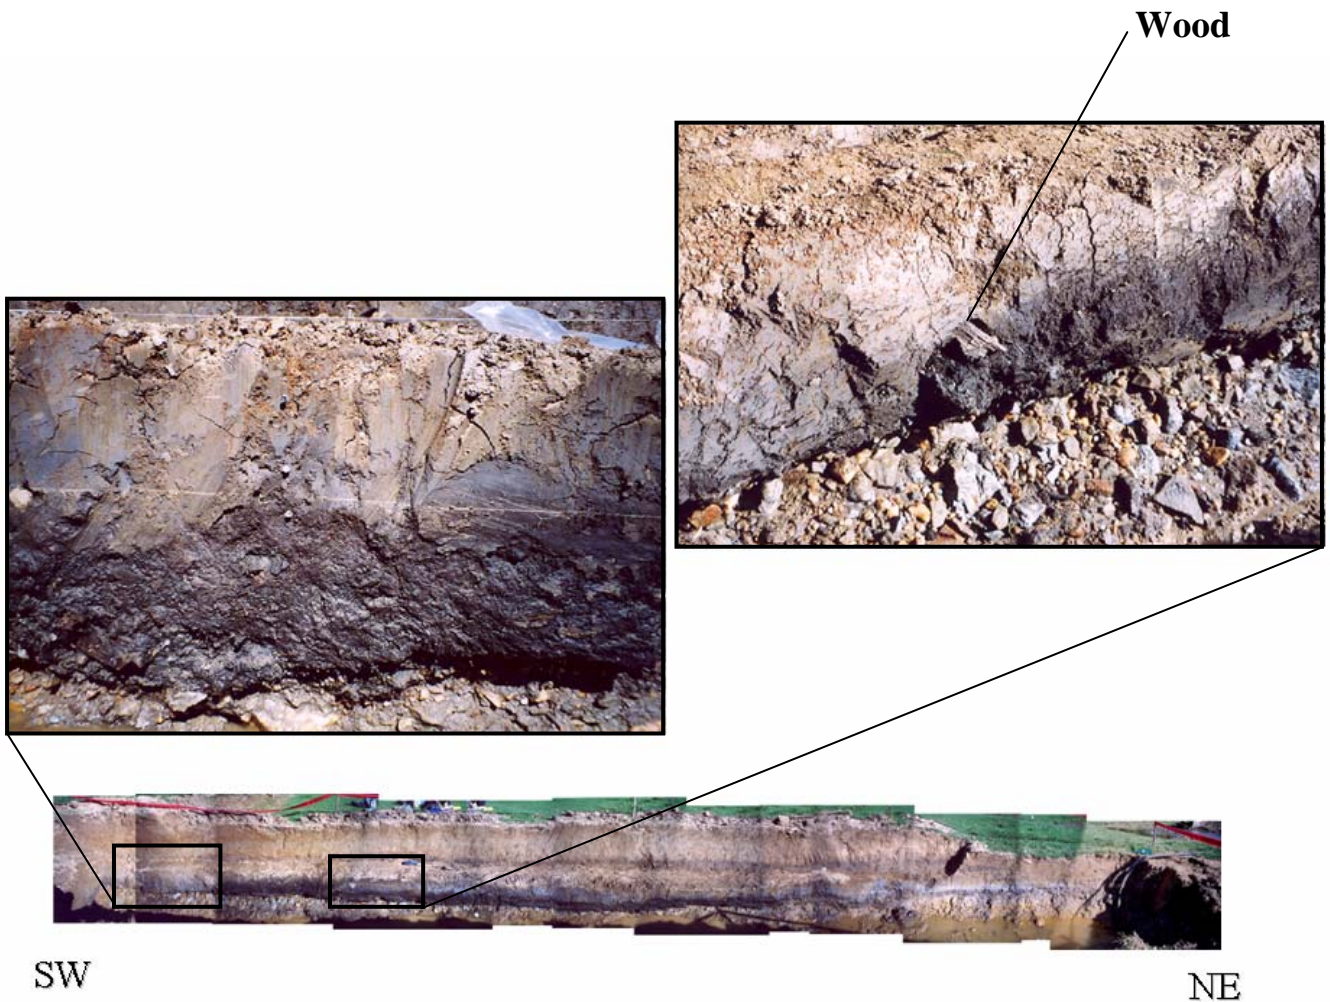
Figure 8. Pre-settlement layer (black) exposed in 85 ft wide, 10 ft deep trench (bottom panel) perpendicular to stream flow, along right bank, Swarr Run, a tributary to Little Conestoga Creek in Lancaster County. View in bottom panel is toward the upstream direction. Swarr Run is to the right, just out of view. Trenching was done during stream restoration work in 2002. Close-up views of the pre-settlement layer (upper left and right) show abundant woody debris, charcoal flakes, and organic-rich silty clay. Note that the underlying material is angular to sub-angular gravel, which coarsens and thickens toward the valley margin on the left (SW). This gravel, which we interpret as periglacial in origin, overlies bedrock. We interpret the fine-grained blue to white clay overlying the pre-settlement layer as sediment that was ponded behind a mill dam located just downstream. Photos are from A. DeWet, professor at Franklin and Marshall College.

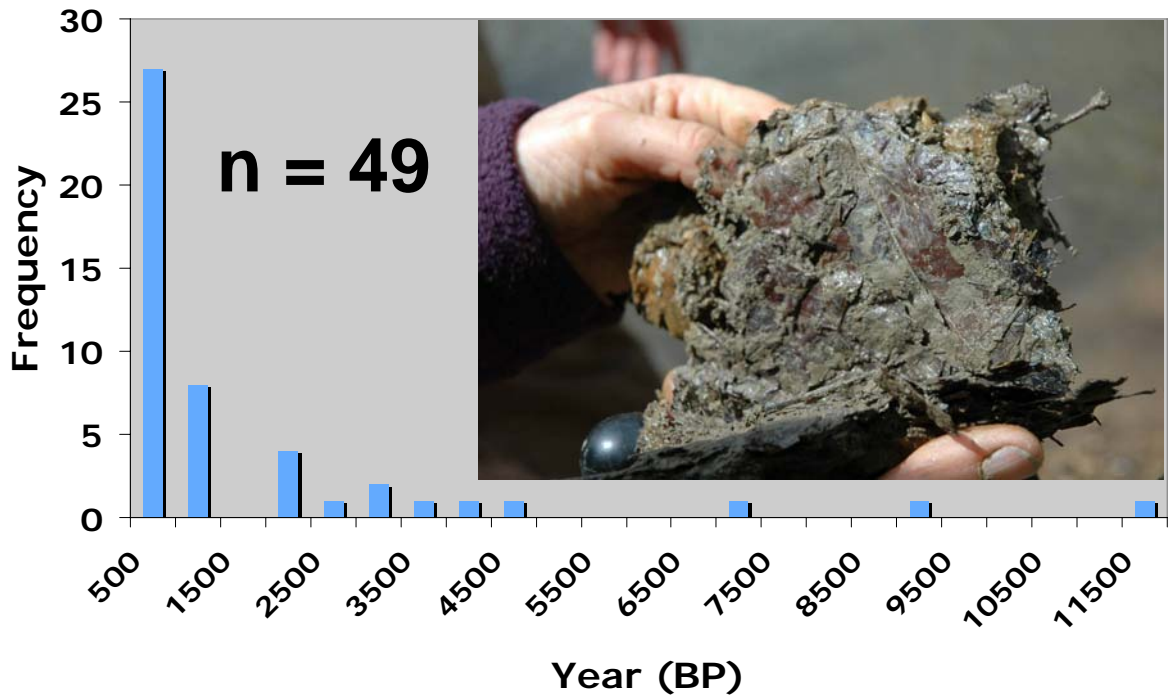
Figure 9. Age-frequency diagram for eleven accelerator-mass spectrometry (~40-60 yr uncertainty) and 38 conventional radiocarbon ages (~60-90 yr uncertainty) from pre-settlement layer at ~30 sites in Pennsylvania and Maryland. Inset photo illustrates leaves and twigs from the pre-settlement layer. Ages range from 11,500 to 300 yr BP, with most less than 1500 yr BP (~500 AD). Twenty nine of these ages were provided from archaeological investigations by Dr. Fred Kinsey, retired director of the North Museum.

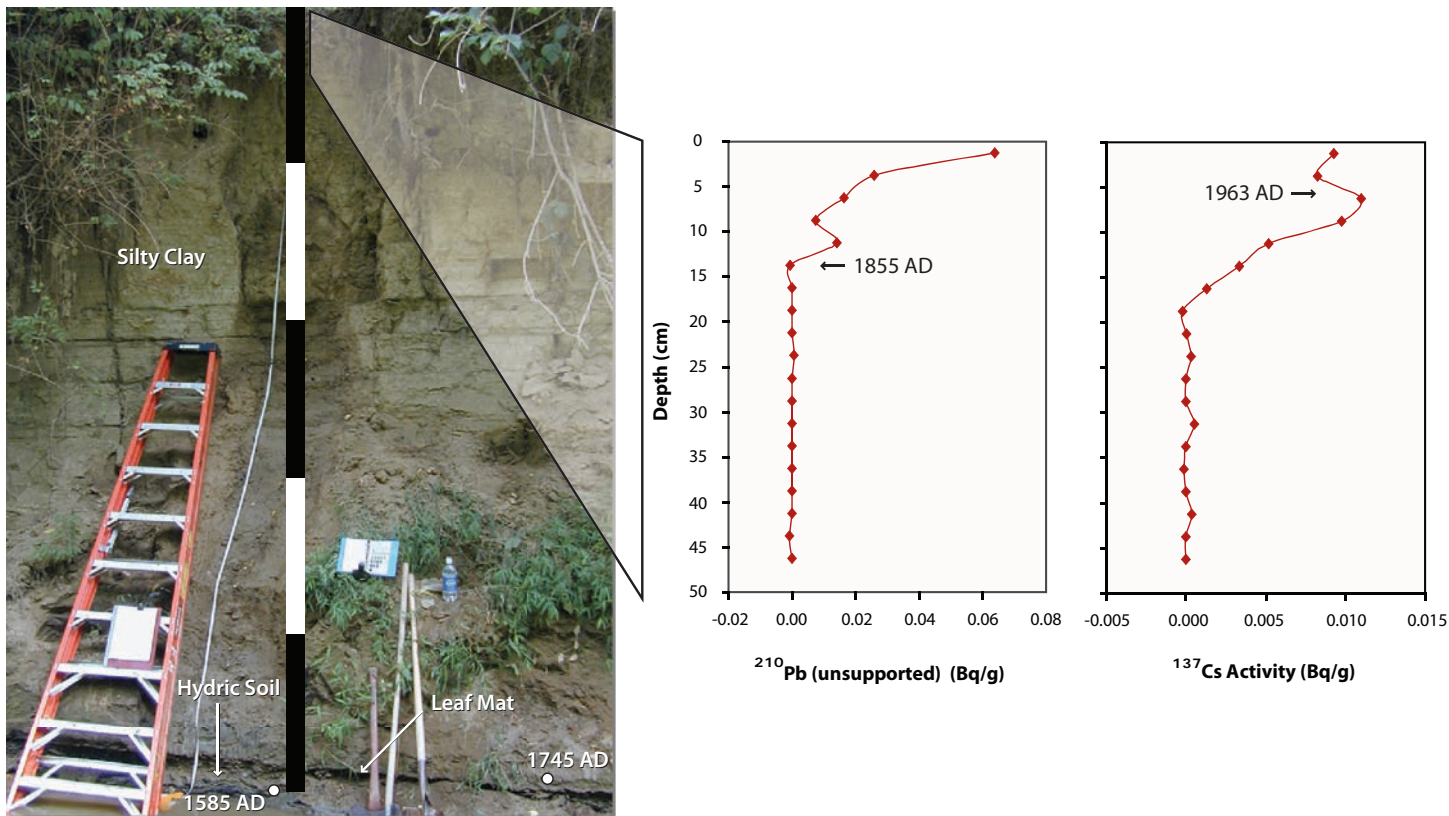
Figure 10 - Stratigraphic section at Denlinger's Mill on Little Conestoga Creek, West Branch. Age control for the sedimentary sequence exposed at the mouth of the W. Branch of Little Conestoga Creek, just upstream of a 20 ft high mill dam. Stadia rod has one meter markings. Whereas radiocarbon ages are used to date the base of the section,  $^{210}\text{Pb}$  is used to estimate the time of most recent deposition at the surface (upper right diagram). The rapid decrease of  $^{210}\text{Pb}$  to a near-constant, background value at a depth of ~6 inches indicates that no deposition occurred above 6 inches since ~1855 AD (Civil-War era). The depth curve of  $^{137}\text{Cs}$ , an isotope associated with atmospheric fallout from above-ground nuclear weapons testing, indicates that the uppermost part of the sedimentary sequence ponded behind the mill dams at the mouth of the W. Br. Little Conestoga Creek has been stable since the 1960s. Some infiltration of  $^{137}\text{Cs}$  has occurred.

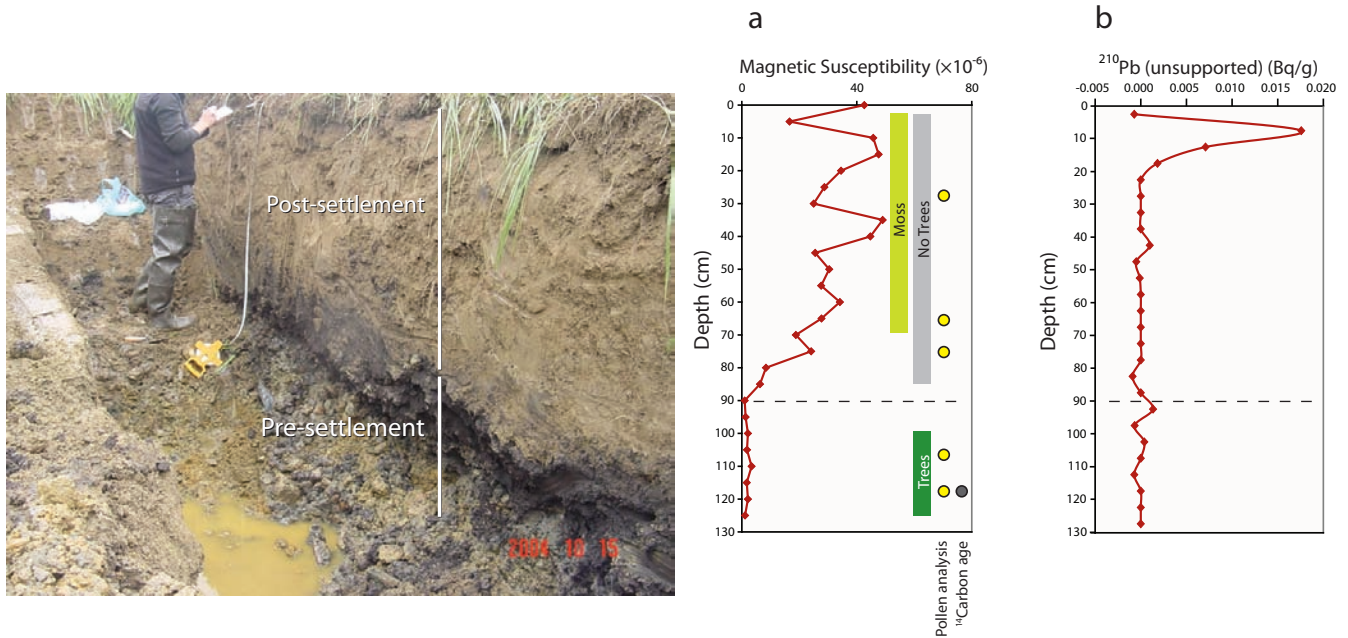
Figure 11

b. Graph of  $^{210}\text{Pb}$ .  $^{210}\text{Pb}$ , with a half-life of 22.3 years, reaches secular equilibrium in  $\sim 150$  years from its time of formation and its atmospheric deposition on the landscape. This diagram shows that the activity of  $^{210}\text{Pb}$  is high, as expected, in the uppermost part of the sediment profile and diminishes exponentially to zero (secular equilibrium) at a depth of ca. 20 cm below the surface. This indicates that  $\sim 80\%$  of the legacy sediment was deposited by before 1855, which agrees with historical accounts that many mill dam reservoirs were filled with sediment by the Civil War.

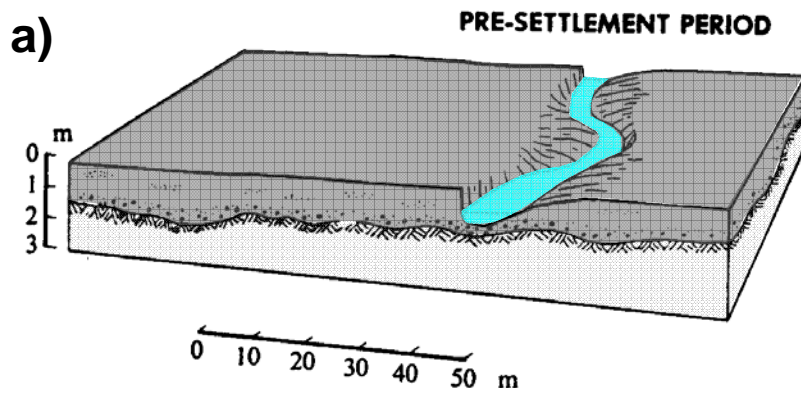
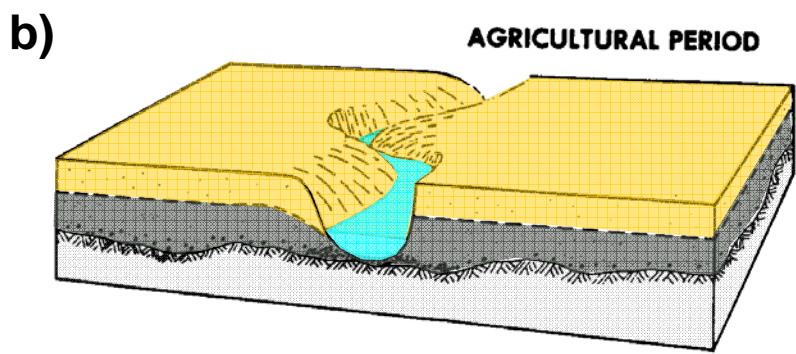
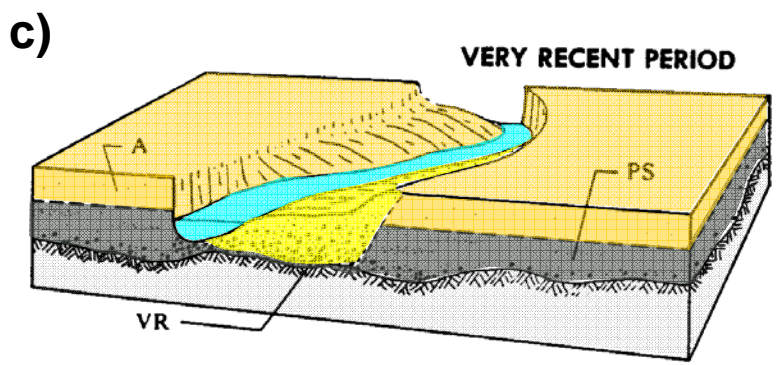
Figure 12. Three stages of development (a-c) of alluvial flood plains based on interpretations of stratigraphic exposures along streams in the Maryland Piedmont (modified from Jacobson and Coleman, 1986). (a) Pre-European settlement meandering streams in their undisturbed state were interpreted to have gravel beds and fine-grained alluvial banks. (b) Excessive upland erosion and floodplain sedimentation during the post-settlement agricultural period buried original waterways and valley bottoms during a period of rapid aggradation. (c) With reduced sediment loading as agricultural practices improved and more land became urbanized, post-settlement deposits (labeled A) are reworked by incising streams that deposit coarsest sediment (labeled VR for very recent) along inset, lower floodplains. Streams readjust to the depth of the original pre-settlement gravel bed (dark gray with circles to indicate sparse gravel). (d) In this work, we present evidence that tens of thousands of 18th-19th c. low-head mill dams throughout Maryland and Pennsylvania account for the widespread aggradation of fine-grained alluvium (PSA for post-settlement alluvium) to levels graded to the crests of dams (Walter et al, 2004; Merritts et al, 2006a and 2006b). Our direct-step backwater calculations indicate that 1-3 m-high dams on low-gradient Piedmont streams would have produced low-velocity backwater effects at least 2-3 km upstream. As a result, we modify the earlier conceptual models of Jacobson and Coleman, revising Figure 12c as shown here, with a dam to indicate that impoundment was critical to sediment trapping in along many thousands of km of stream reaches in the PA and MD Piedmont region. Note that legacy sediment is graded to downstream dam crests. Fill surfaces along stream corridors are actually alluvial terraces, not modern floodplains. Dam breaching leads to incision and bank erosion, and coarser sediment (where available) is deposited along inset, lower floodplains associated with new bankfull discharge levels. A photo of a stream bank along Big Spring Run, near Willow Valley (tributary to Mill Creek, Conestoga watershed, Lancaster County, PA), illustrates the typical stratigraphic section seen in this region: a pre-settlement, nutrient-rich stratum (dark bottom layer) overlying a thin layer of quartz gravel (sub-rounded to sub-angular weathering and colluvial lag), which in turn overlies Paleozoic limestone bedrock (with quartz veins). Scale bar in meters. Note blocks of grassy bank which have fallen (slumped) into the stream channel, tree saplings planted for a riparian buffer, and low relief to drainage divide in background. Our radiocarbon dates from the dark, organic-rich horizon at this site range from ~600 to 1400 AD. This pre-European settlement horizon contains stumps of trees (growth position) and vertical root casts from sedges, and is interpreted as a hydric soil associated with a wetland environment with frequent overbank flow. Fine-grained silts and clays above the pre-settlement surface formed in the backwater environment from a mill dam ~1.7 km downstream.

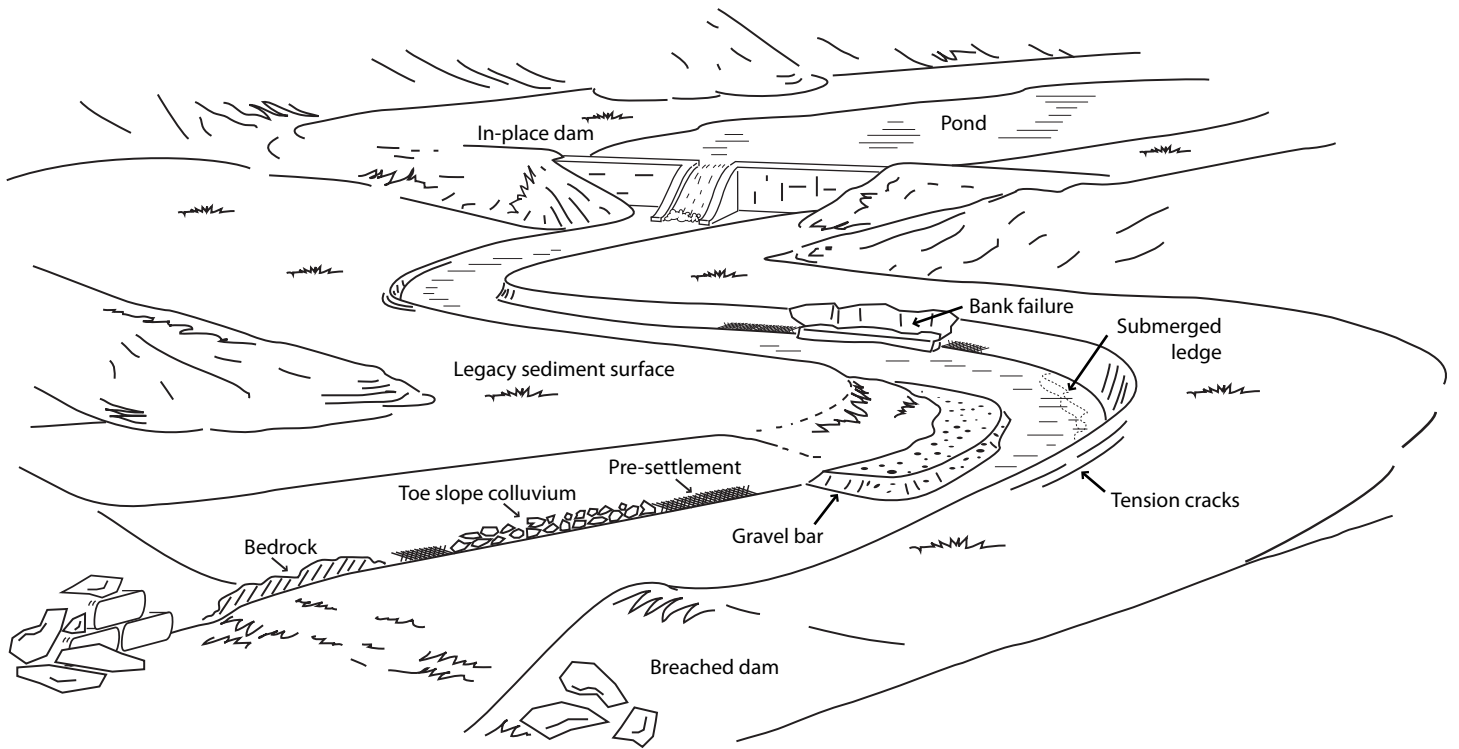
Figure 13 - Conceptual model of a legacy sediment-impacted stream showing many features, including those formed in response to dam breaching, as well as those features that were buried beneath pond-filling sediment and then exhumed.

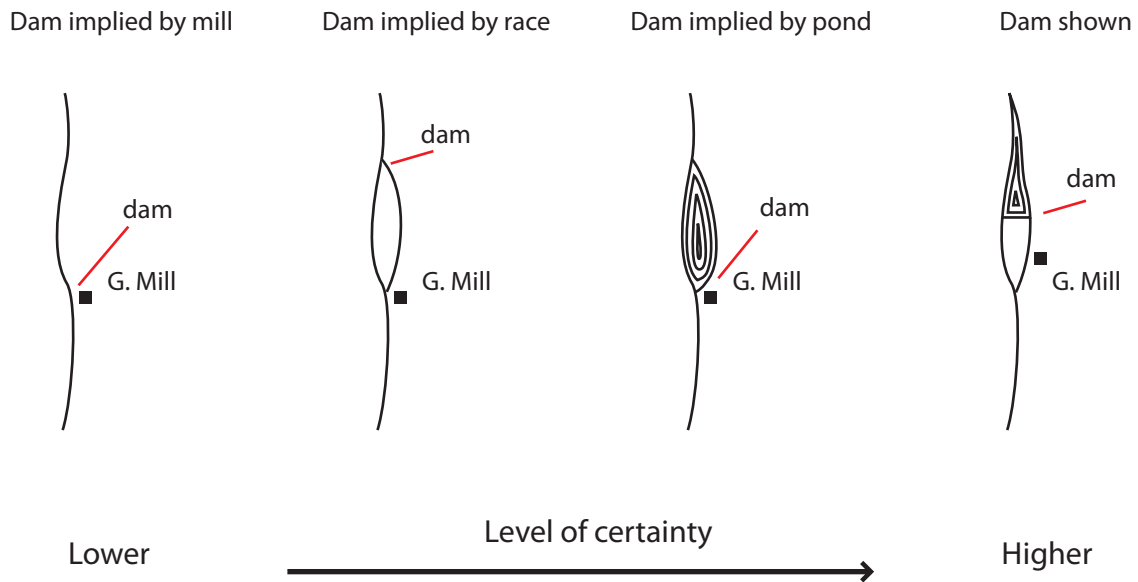
Figure 16 - Cartographic representation of dams and the mills served. The cartographers who created historic maps made decisions about the best or most feasible map representation of mills, streams and textural information. The cartographic representation of these features leads to varying degree of certainty with respect to dam location. It is possible for mills to have very short head races and tail races and historical records available in Lancaster County verify that almost every mill had a dam regardless of its cartographic representation in historic atlases.

We use historic 19<sup>th</sup> c. maps and documents to locate dams and, in some cases, to infer dam locations from races and mills (Figure 16). Although some older maps have been valuable to find dams at specific locations, only 19<sup>th</sup> c. township maps have provided enough aerial coverage to enable us to locate dams across entire counties. We have found historic low-head dams in the field that are not on any maps that we have examined; these might have been built much earlier than the maps we use and perhaps the associated mill was gone, so the structure was not included during 19<sup>th</sup> century map-making. Another possibility is that the dam was built after the maps that we use, although we have examined maps in series to account for this possibility. Finally, it is possible that some small dams simply were not included in 19<sup>th</sup> c. maps.

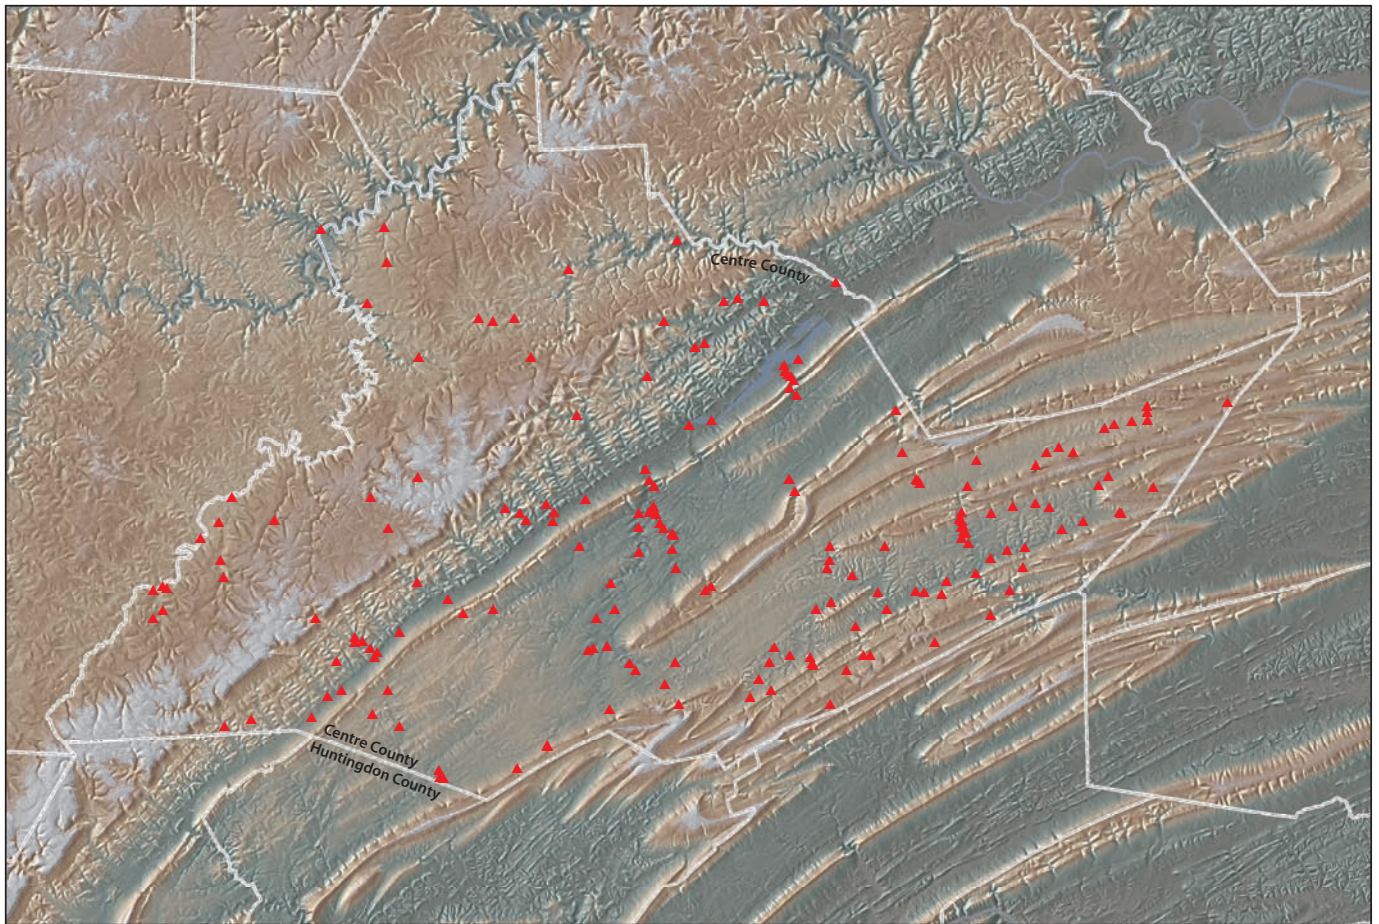
Figure 18 - Historic mill dam locations in Centre County. Dam locations are based on Beach Nichols, 1874, “Atlas of Centre County, Pennsylvania”. The basemap hillshaded topography is generated from 1/3 arc-second USGS National Elevation Data. The historic atlas indicates that there were 186 dams in Centre County and the majority of these are in the Valley and Ridge and at the eastern edge of the Appalachian Plateau.

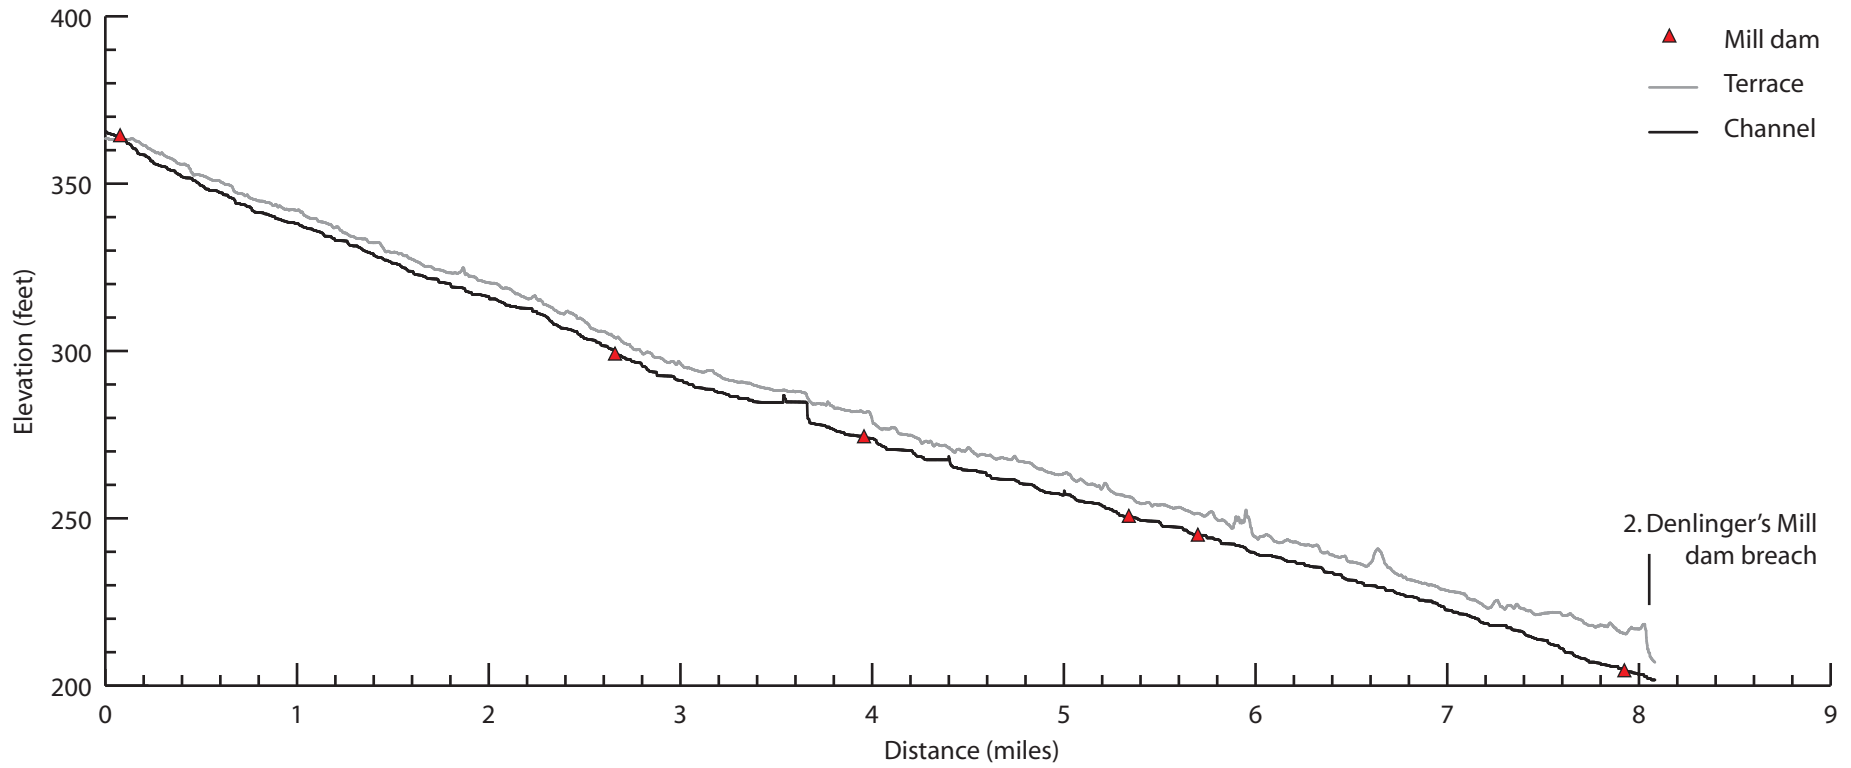
Figure 23 - Little Conestoga Creek, West Branch stream long-profile. This stream profile is extracted from a LiDAR-derived DTM and depicts the location of historic mill dams. The black line approximates the water surface profile, and the gray line represents the profile of the stream bank terrace horizon. A clear divergence between the water surface elevation and stream bank elevation is apparent above the Denlinger's Mill dam breach.

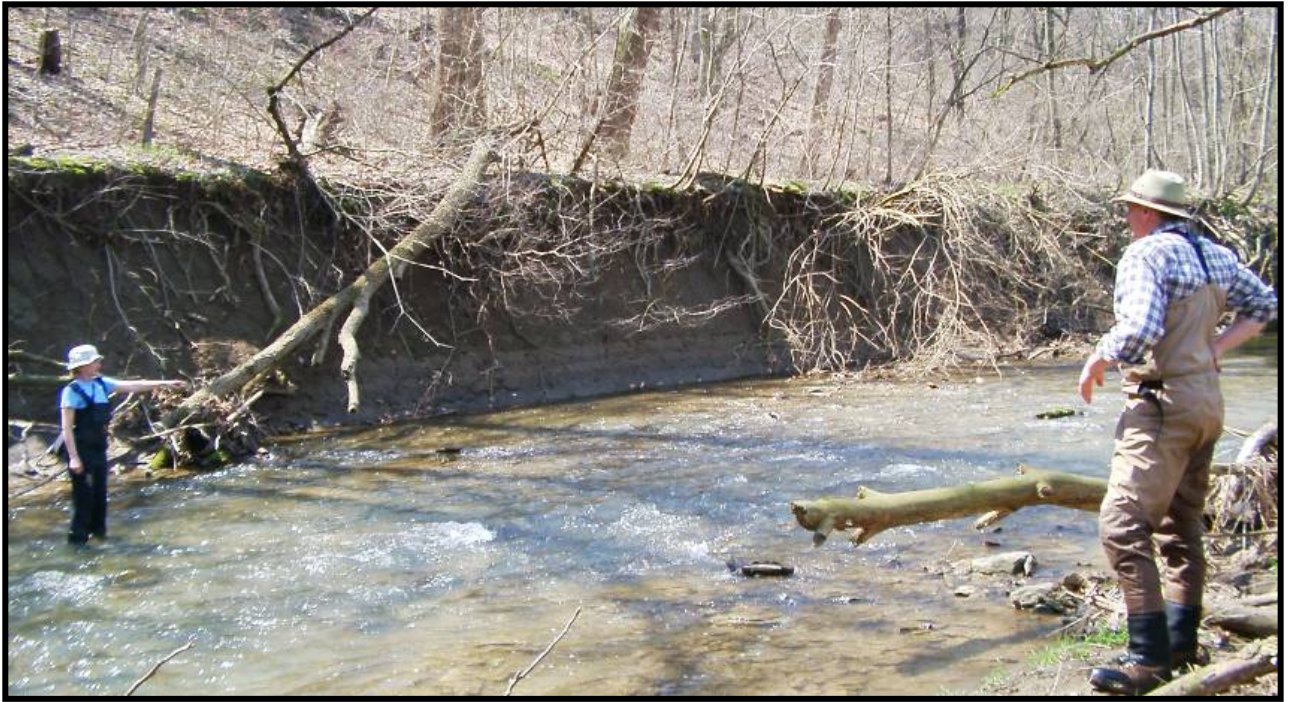
Figure 24. Extensive bank erosion along the right bank of the W. Br. Little Conestoga, just upstream of Denlingers Mill. Bank is ~20 ft high, and is graded to the 20-ft high dam just downstream, behind photographer. Note that mature trees are unable to protect the bank from erosion because of undercutting along a basal gravel layer (~10 in thick) and bank collapse of fine-grained cohesive sediment. Darker layers at base (~5 ft thick) are the sediment fill in an older reservoir with a lower dam that was buried by the subsequent higher dam's reservoir. Floor of channel is bedrock. Erosion rate at this location is ~0.7-1.1 ft/yr. Sediment production rate from bank erosion is ~0.17 tons/ft/yr.

reservoir has been eroded since 1901. Using the measured bank heights along this reach of the W. Br. Little Conestoga, we calculate that the average rate of sediment produced by bank erosion since 1901 (~105 years) was 0.17 tons/ft/yr (tons per linear foot of stream length per year). This corresponds to an average bank erosion rate of 1.1 ft/yr, using an average bank height of 8 ft. This number is very similar to that we have calculated by repeat measurements of the distance between the bank edge and a line of fence posts along a corral on left bank ~100 ft to 300 ft upstream of the breached dam.

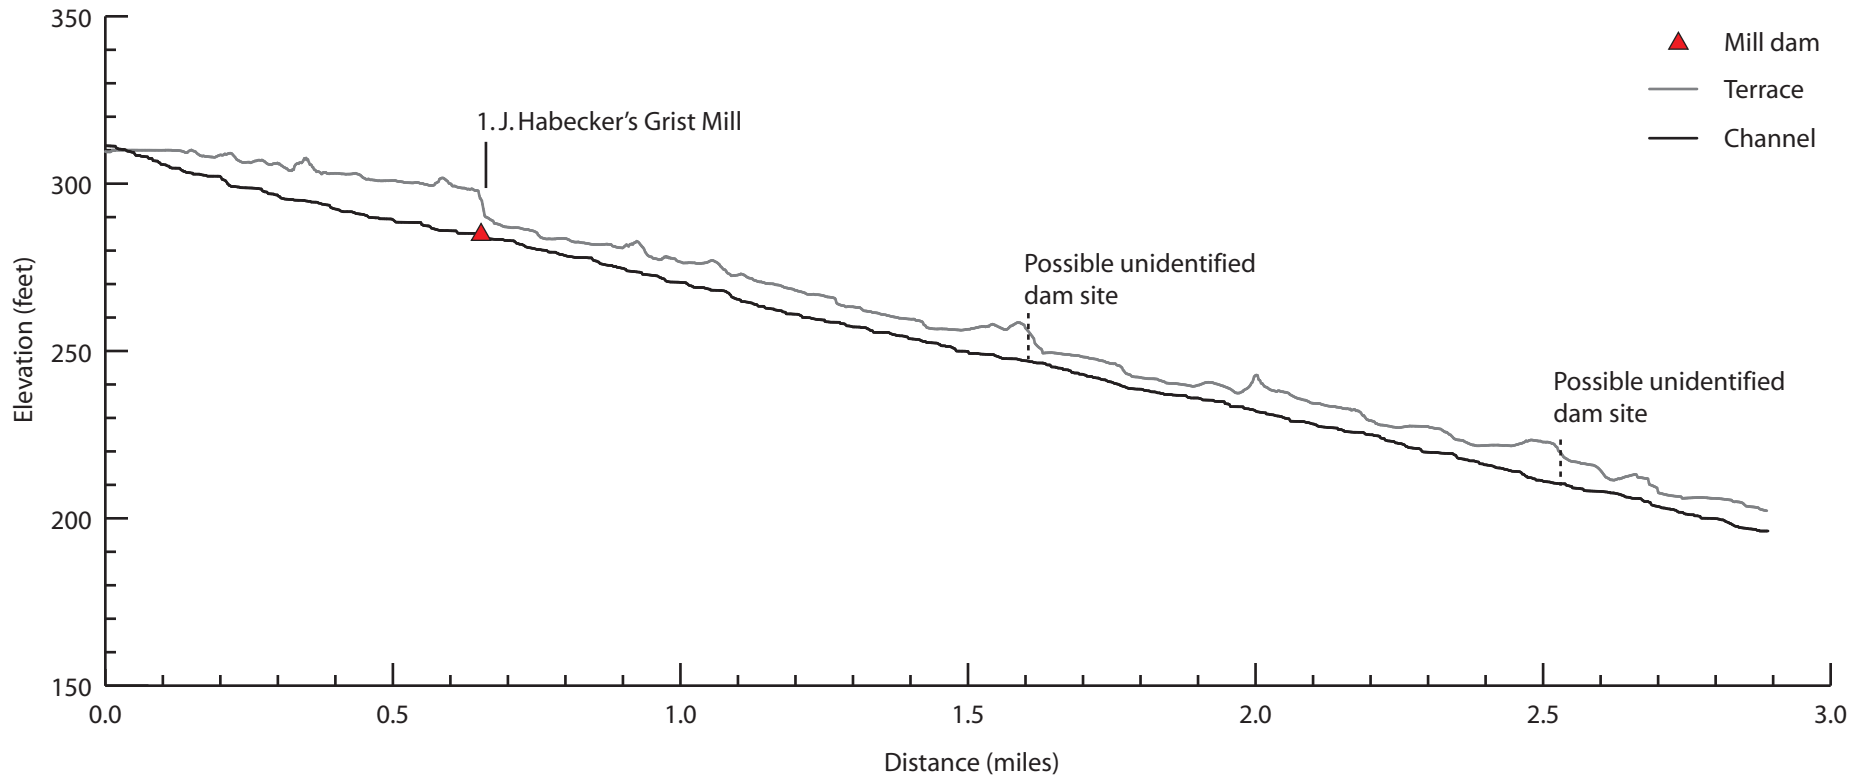
Figure 27 - Indian Run stream long-profile. These profiles were extracted from a LiDAR-derived DTM. The black line approximates a profile of water surface elevation and the gray line is a profile of the stream bank or terrace elevation. The dam breach at the former J. Habecker Grist Mill is clearly apparent, as are at least two other potential dam breaches that are not associated with any mill or dam shown on the 1875 Lancaster County atlas.
