**ESTIMATING VOLUME, NUTRIENT CONTENT, AND  
RATES OF STREAM BANK EROSION OF LEGACY SEDIMENT IN THE  
PIEDMONT AND VALLEY AND RIDGE PHYSIOGRAPHIC PROVINCES,  
SOUTHEASTERN AND CENTRAL PA**

**A Report to the Pennsylvania Department of Environmental Protection**

**Submitted January, 2007, and Revised February, 2007, by**

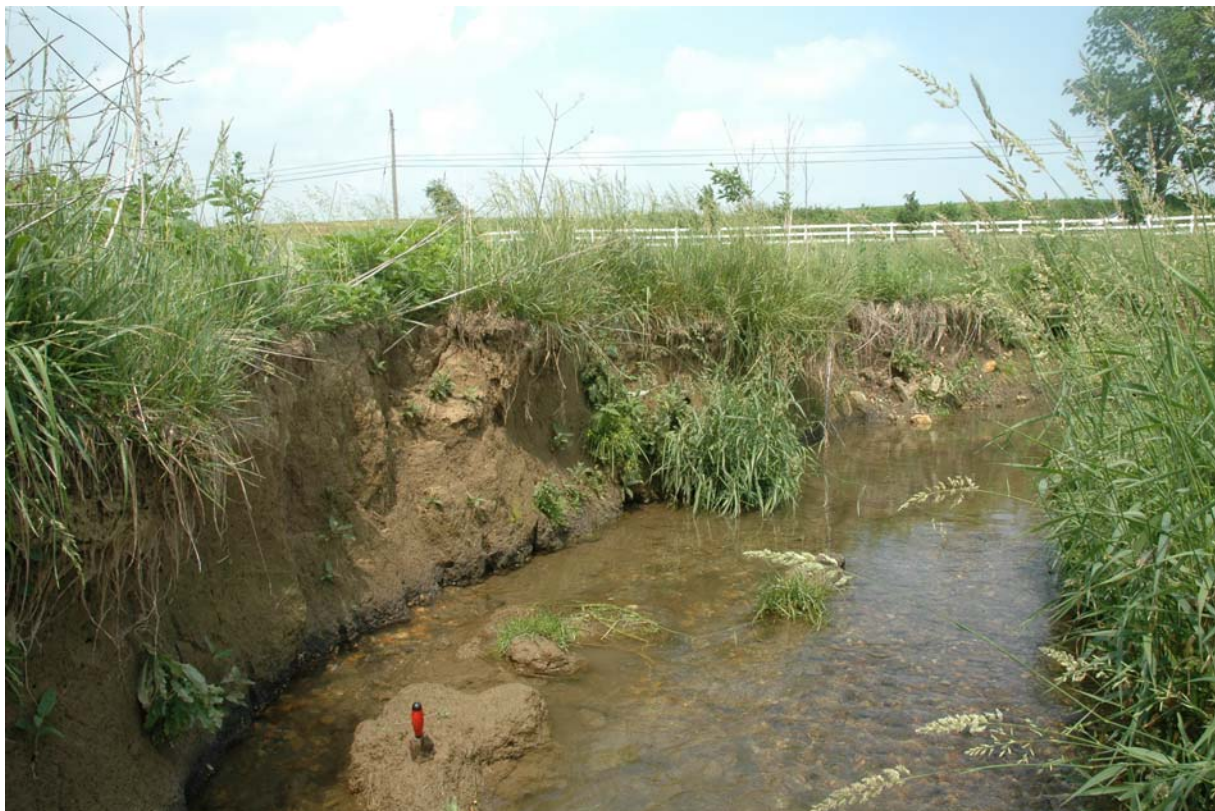
Figure 28. Bank erosion along Big Spring Run (tributary to Mill Creek in the Conestoga watershed, Lancaster County, near Willow Valley) illustrates typical erosion processes of undercutting along basal gravel and collapse of overlying fine-grained, more cohesive silty clay. Average bank erosion rates at this site are  $\sim 1.1$  ft/yr, and sediment production rates are  $\sim 0.2$  tons/ft/yr (units are tons of sediment eroded per linear foot of stream channel length per year).

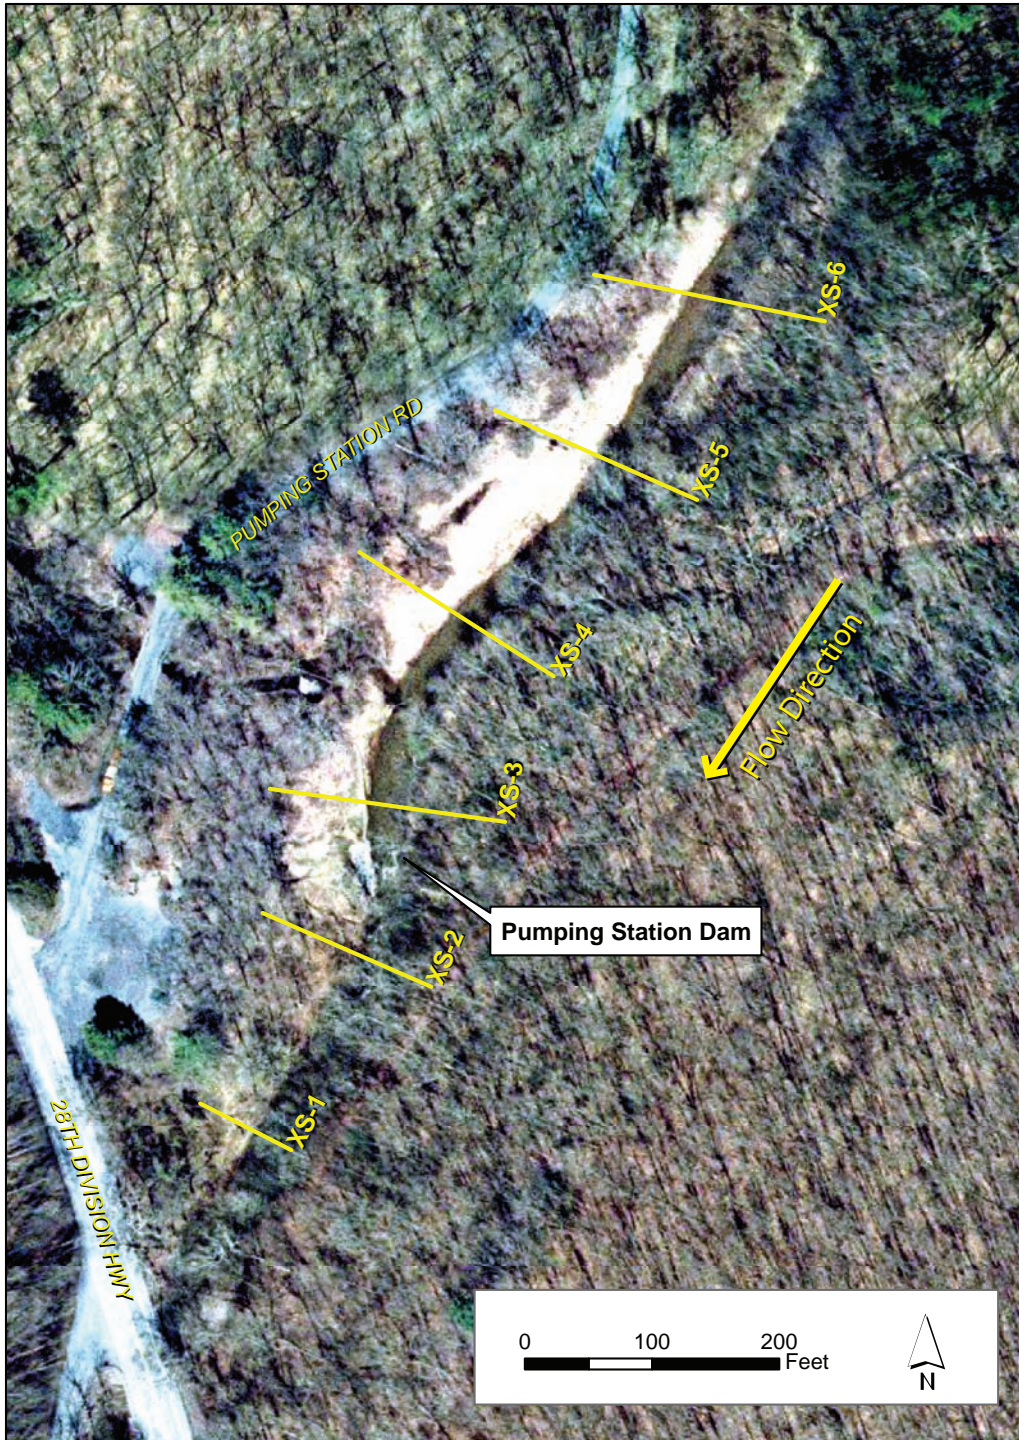
Figure 30 - Hammer Creek Pump Station dam breach. Orthophoto map on the left shows surveyed cross-section locations in relation to the dam breach. Flow is from the top of the image toward the bottom. In 2001 PA DEP surveyed these cross-sections prior to dam breaching, which was planned as part of a fisheries improvement project (cross-section shown in blue). DEP monitoring of the reach has been ongoing and in 2006 DEP aided F&M in reproducing the cross-section survey. The channel cross-sections show a significant amount of change from 2001 to 2006. Channel cross-sectional area increased by 107 ft<sup>2</sup> at XS-5, 104 ft<sup>2</sup> at XS-4 and 118 ft<sup>2</sup> at XS-3. The cross-sections show from 2 ft of channel incision at XS-5 to 4 ft of incision just above the dam. The dam was not completely removed and its remnants control grade at this time so that further incision cannot occur. Today, however channel widening due to bank collapse is the dominant process and occurs sporadically along the length of the study area above the dam breach.

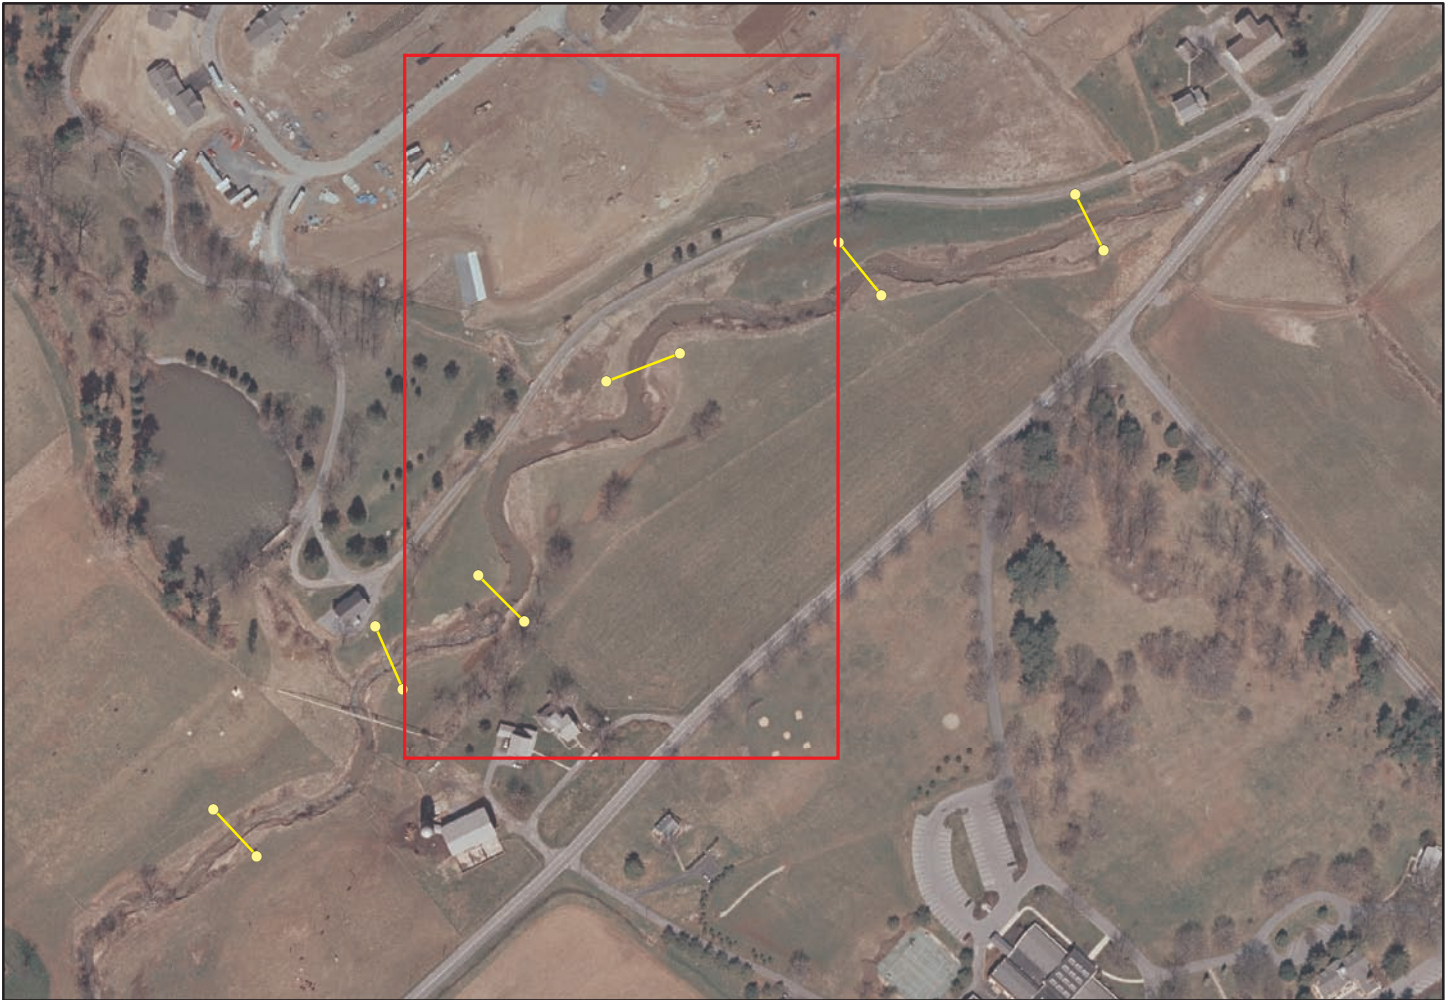
Figure 31a - Conoy Creek overview map showing cross-section locations. The PAMAP orthophotography (1 ft resolution, 5 ft horizontal accuracy) clearly resolves stream bank edge features. The construction of cottages for the Masonic Home at the top of the view. Conoy Creek flows from upper right to lower left in this view. The red rectangle indicates the view extent of the orthophoto map in Figure 32a.

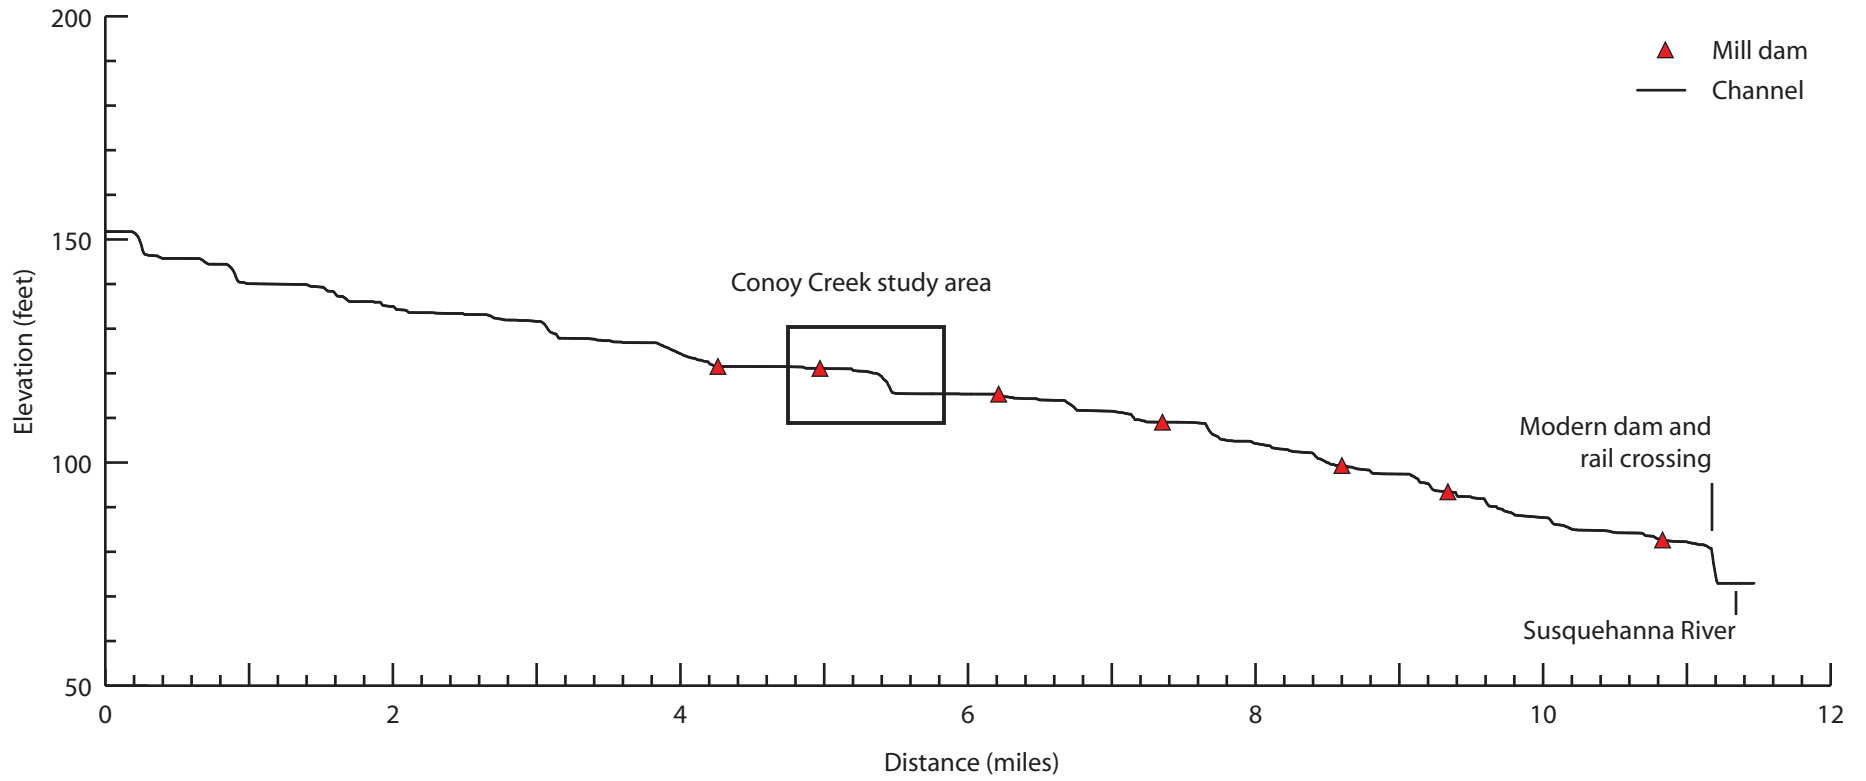
Figure 31b - Conoy Creek stream long-profile with historical mill dam locations (red triangles). This profile was extracted from 1/3 arc-second USGS National Elevation Data.

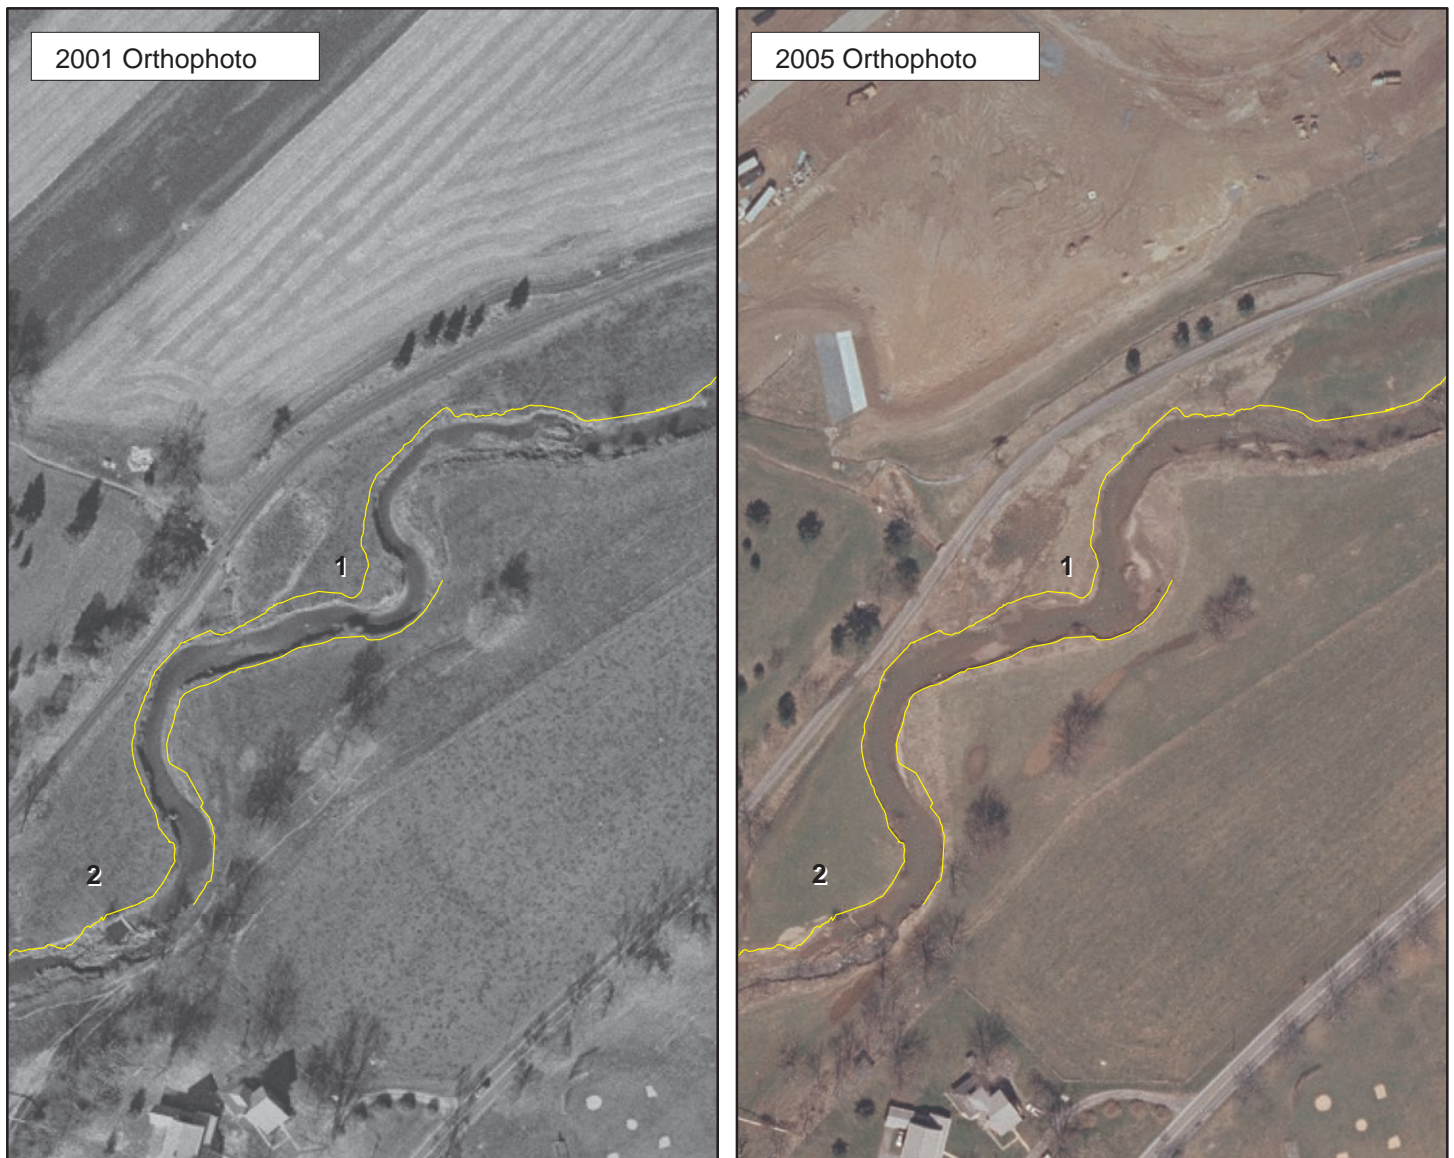
Figure 32a - Conoy Creek upstream at the Masonic Home, comparison of orthophoto maps from 2001 and 2005. The yellow line represents a GPS bank-edge survey. At the location marked “1” a terrace on the inside of the bend has been removed between 2001 and present; as much as forty feet (40’) of lateral erosion occurred. The location marked “2” is the site of a breached low-head dam. The orthophoto map comparison shows a general channel widening.

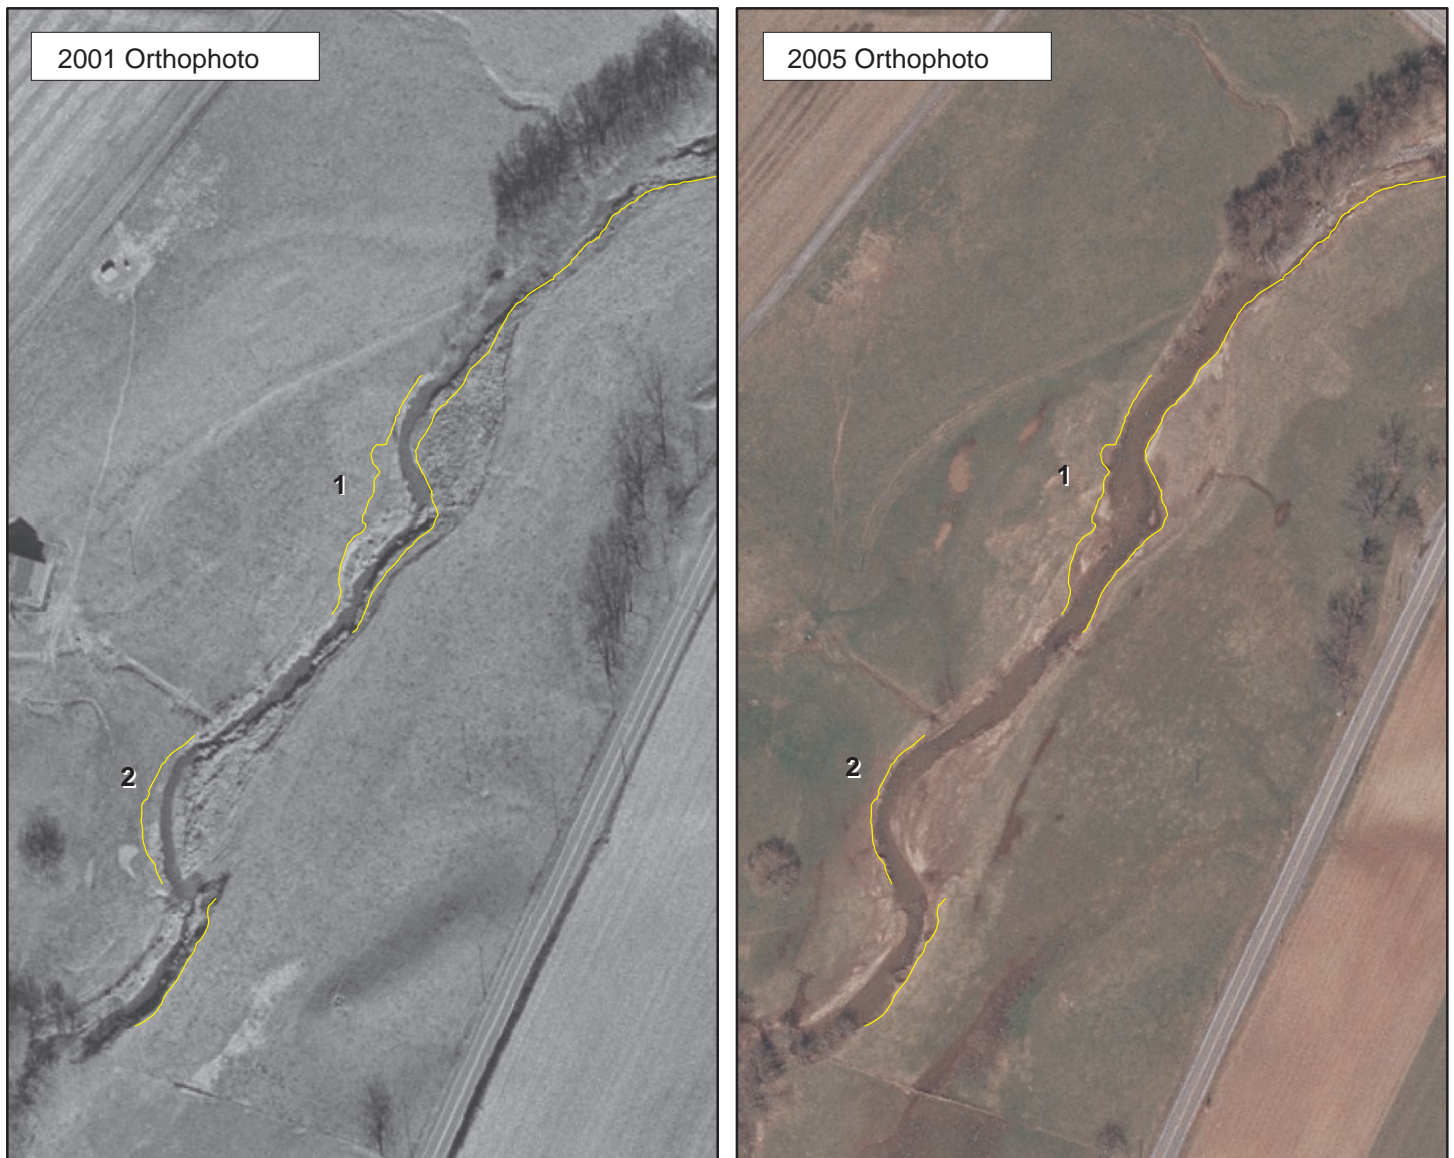
Figure 32b - Conoy Creek downstream at the Masonic Home, comparison of orthophoto maps from 2001 and 2005. The yellow line represents a GPS bank-edge survey. At the location marked "1" a bar or terrace has been removed resulting in as much as forty-five feet (45') of lateral erosion. At the location marked "2" lateral erosion has occurred on an outer bank of a bend resulting in as much as twenty feet (20') of erosion. Comparison of the orthophotos shows a general channel widening between 2001 and 2005.

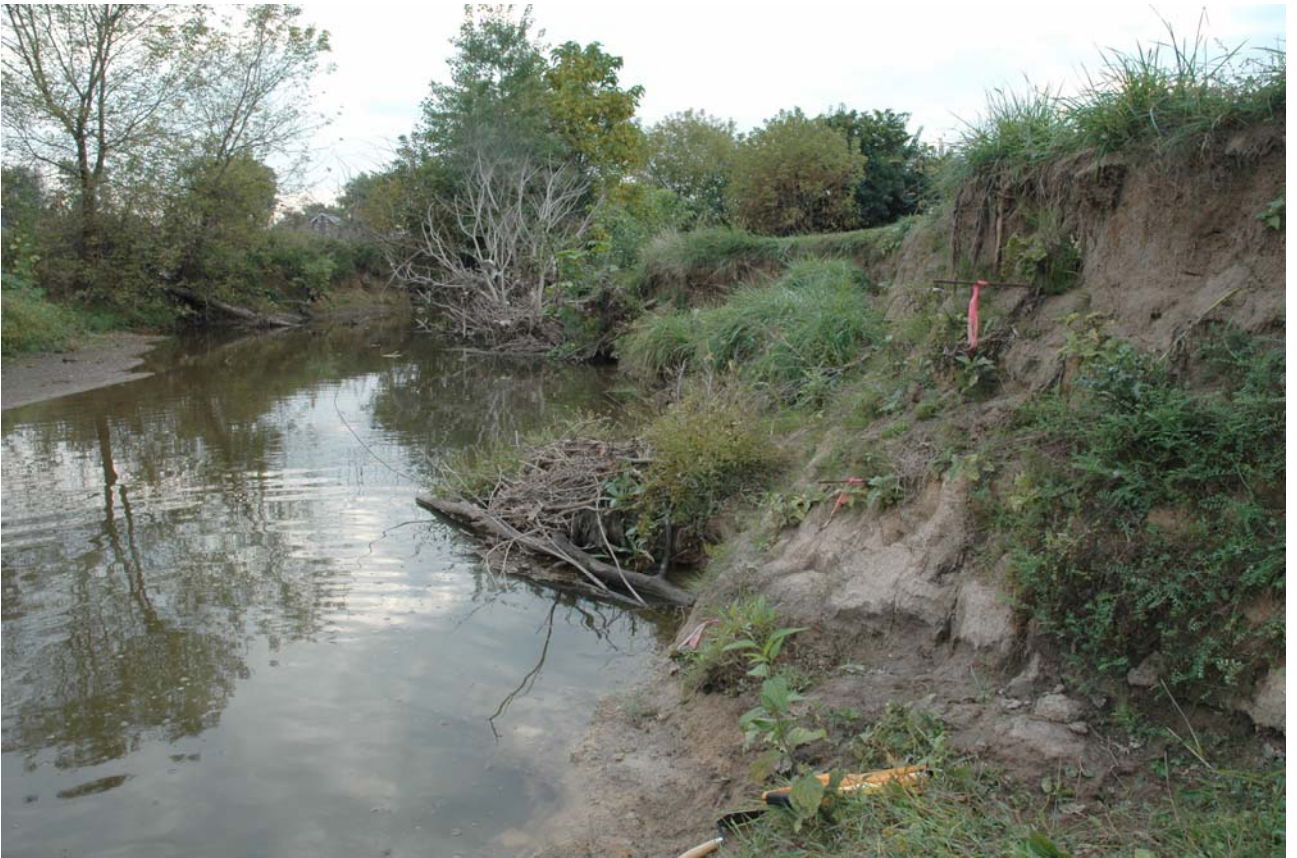
Figure 33. Right bank, Conoy Creek, showing three bank pins installed by LandStudies, Inc., just south of Elizabethtown, in February, 2006. A breached dam is located downstream ~600 ft upstream of a breached mill dam. Note bank pins (rebar) near top, middle, and bottom of bank, indicated by orange flagging tape. All pins were flush with the bank edge when installed, and by the time of this photo (Oct 10, 2006), the pins were exposed up to 2 ft. This is also the site of cross section 2 (shown as the second section line from the right on Figure 31a, at ~mile mark 5 on Figure 31b). Our GPS surveying of the bank edge in the vicinity in December 2006 indicates up to 40 ft of lateral erosion between 2001 and 2006. Our analysis indicates channel widening along this reach of Conoy Creek. This section of Conoy Creek is funded for stream restoration in 2007-2008 by LandStudies, Inc.

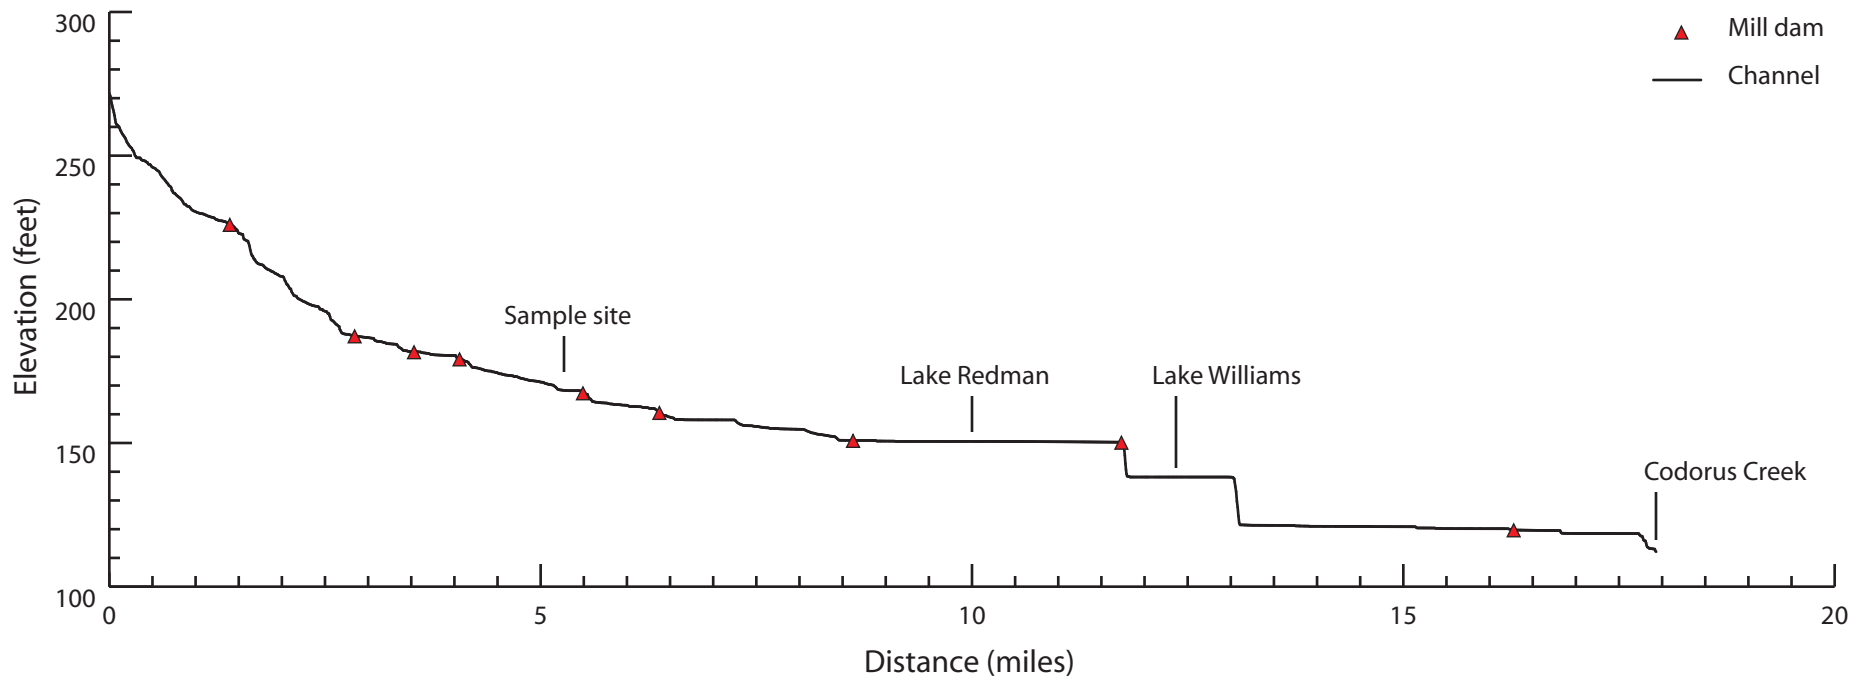
Figure 34 - East Branch Codus Creek stream long-profile. This stream profile is extracted from 1/3 arc-second USGS National Elevation Data and shows the locations of historic mill dams (red triangles) and modern City of York water supply reservoirs Lake Redman and Lake Williams.

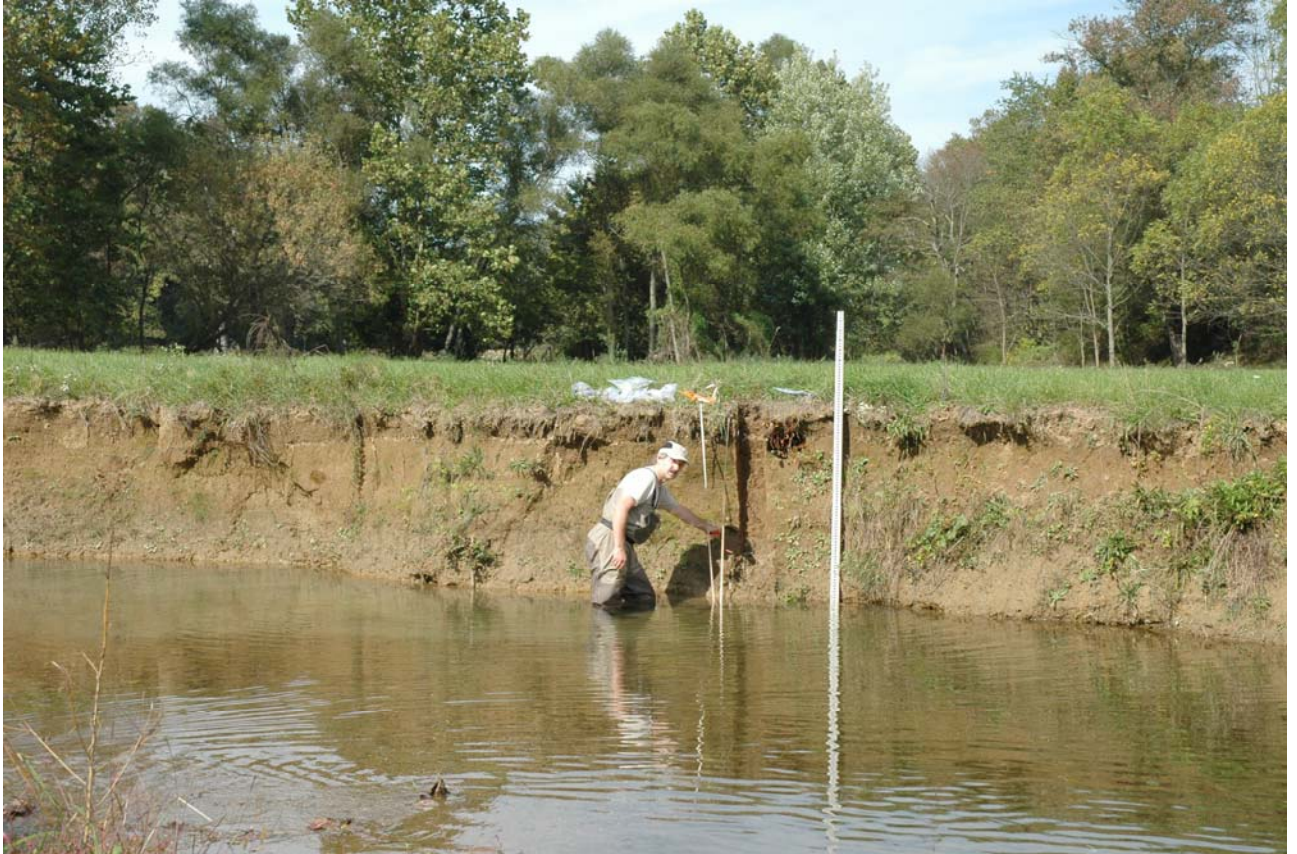
Figure 36. Sampling site for nutrient analysis, right bank E. Br. Codorus Creek, York County. Downstream flow is from right to left. Stadia rod is 3 m in height, and its zero-point is set at the base of the historic legacy sediment (~7 ft thick at this location). A 3 ft layer of coarse, rounded alluvial fan gravel (probably Pleistocene and periglacial) and a thin organic-rich, Holocene pre-settlement layer exist between bedrock and the overlying legacy sediment. Note that the lower part of the legacy sediment is darker. This phenomenon is common, and we interpret it as an indicator that the earliest sediment eroded from the landscape was the organic-rich topsoil. Upper parts of legacy sediment stratigraphic sections along stream banks represent deeper parts of eroded upland soil profiles, and are less organic rich. This reach of the E. Br. of Codorus Creek also was surveyed for bank erosion analysis. We surveyed the bank edge with a high-precision hand-held GPS unit, and compared the bank line to 2003 orthophotography (2 ft ground resolution, +/-5 ft horizontal accuracy). Erosion was not detectable for the three year period, given these image resolution and accuracy limitations. Erosion clearly is occurring at this location, but it must be at a rate that is less than ~10 ft (approximate detectable change) in three years. ARRC (Aquatic Resource Restoration Company) has estimated average bank erosion rates of ~1-2 ft per year.

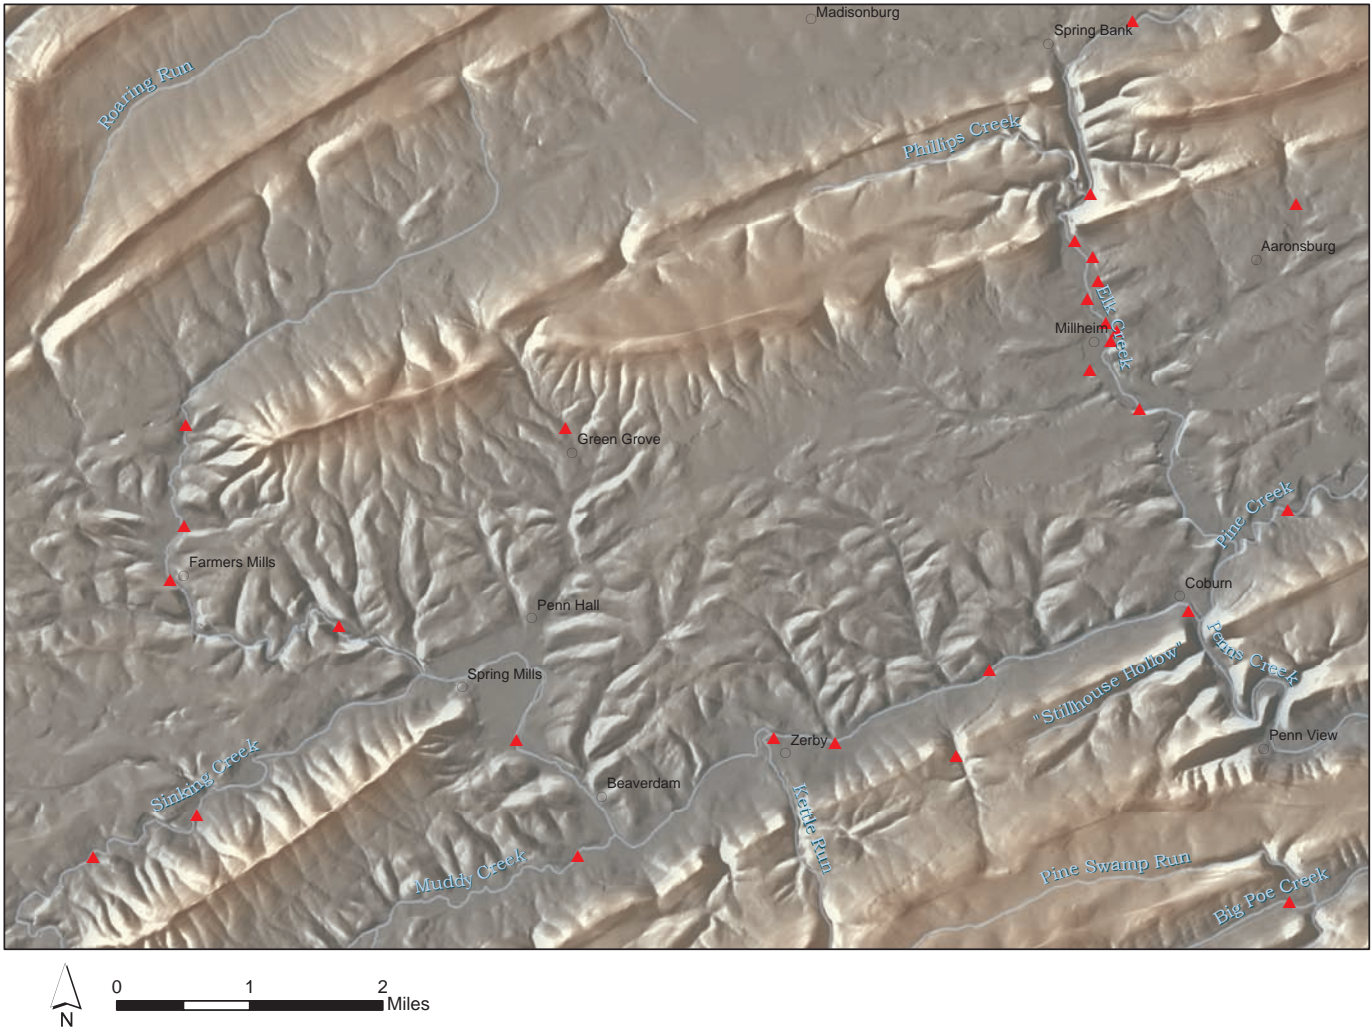
Figure 37 - Overview map of Penns Creek above the town of Coburn showing historic mill dam locations (red triangles). Within the view are twenty-eight mill dam locations, nine of which are on Penns Creek.

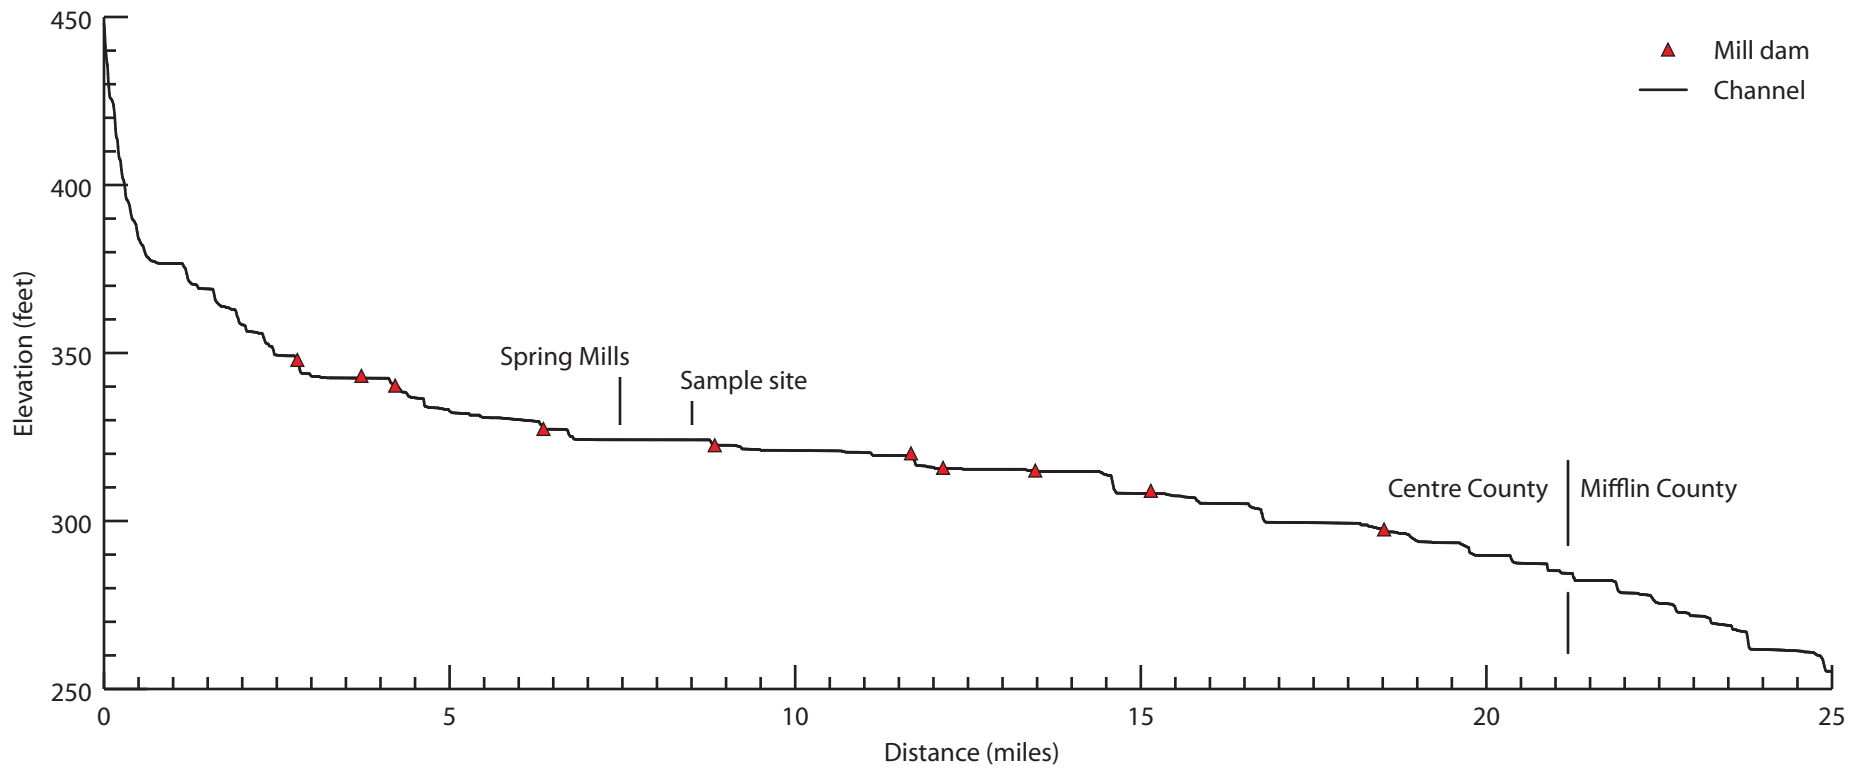
Figure 38 - Penns Creek stream long-profile showing historic mill dam locations (red triangles). This stream profile is extracted from 1/3 arc-second USGS National Elevation Data.

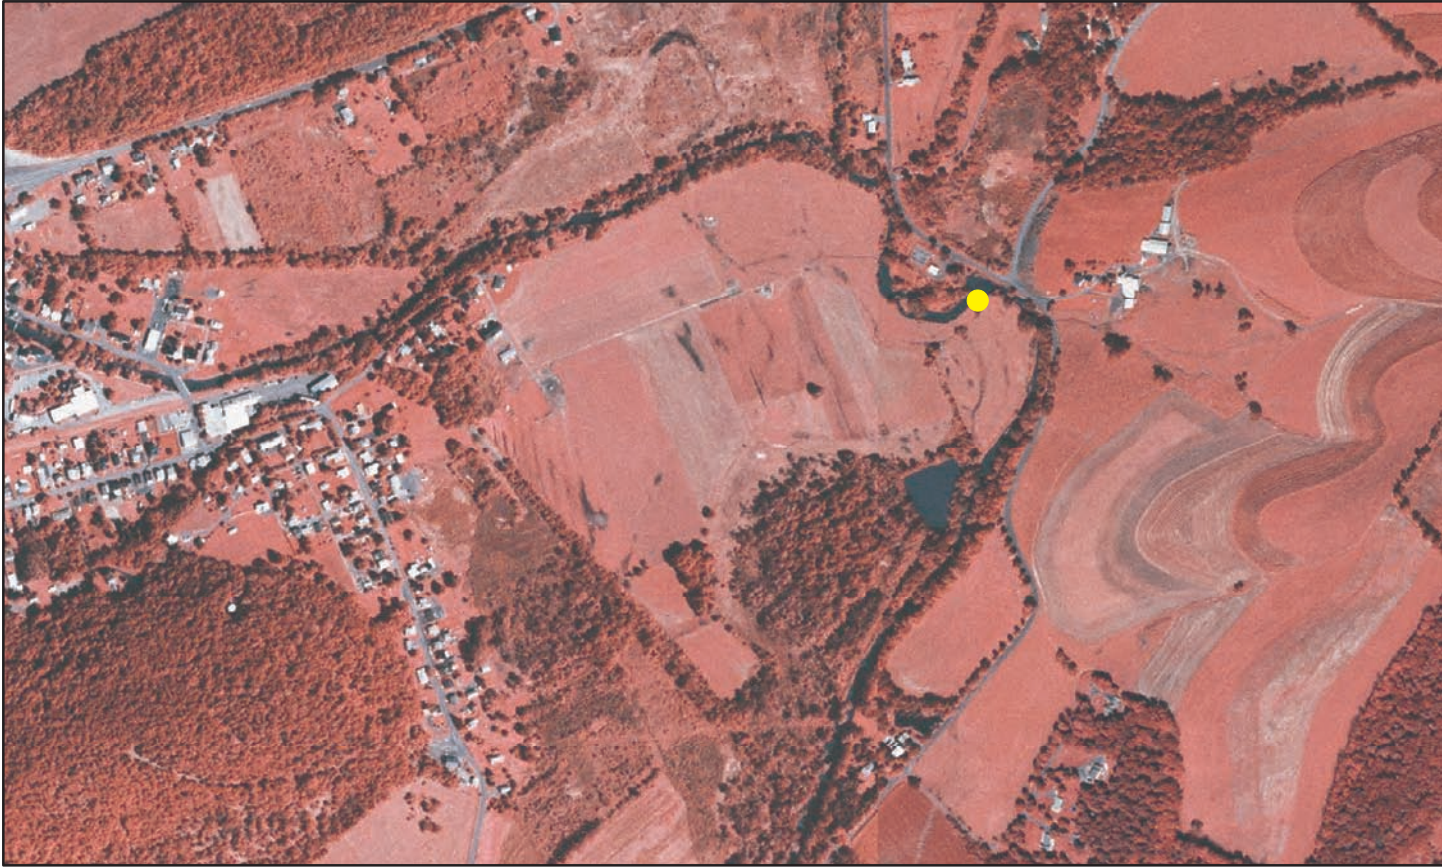
Figure 39 - Color infra-red orthophoto (USDA National Agricultural Imagery Program) map of Penns Creek below the town of Spring Mills (visible at left). The yellow dot indicates sediment sampling location.

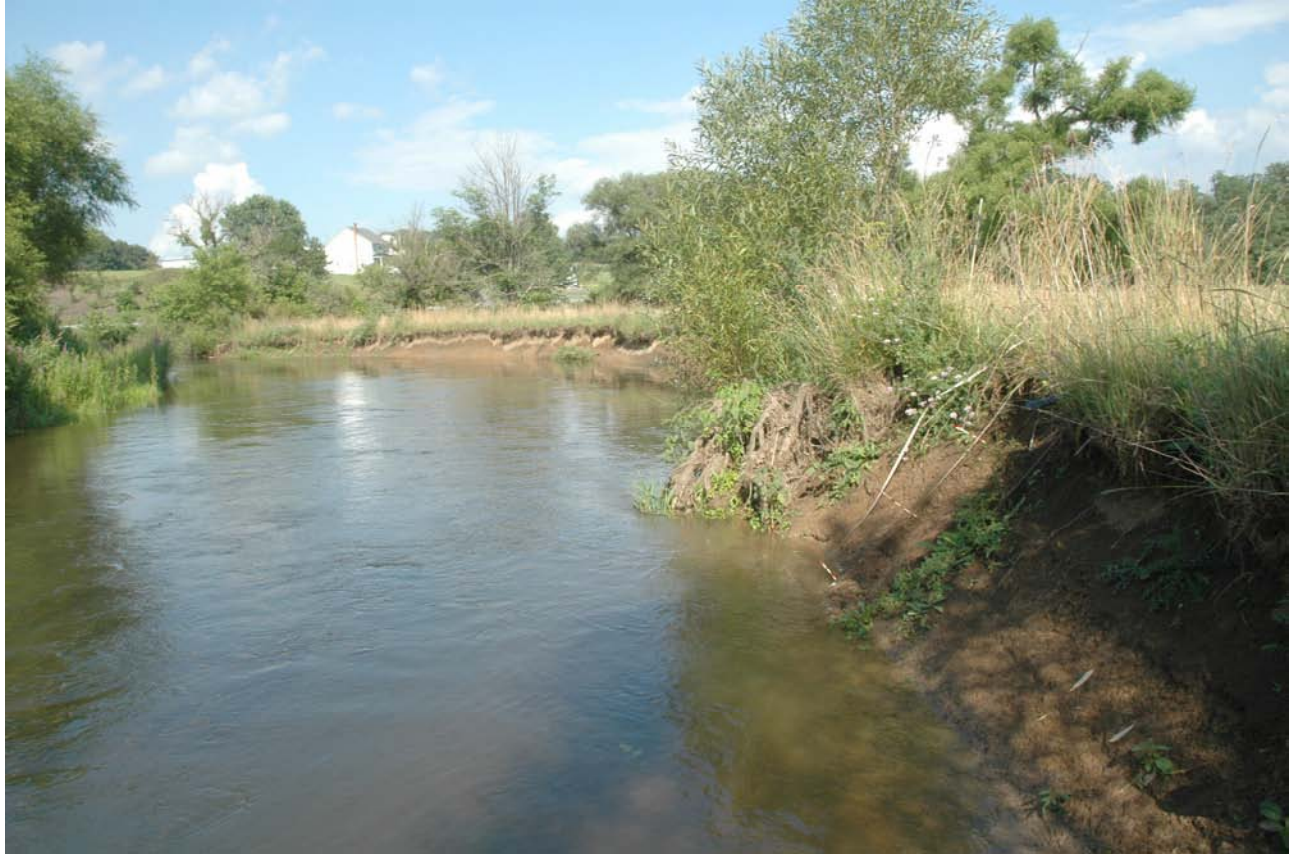
Figure 40. Right bank along Penns Creek, viewed in the downstream direction, September 2006. Tape measure draped on bank at right is the nutrient sample site location. Bank is ~ 2.5 m high. This reach was surveyed for bank erosion analysis with a high-precision hand-held GPS unit. The GPS surveyed bank edge was compared with the bank line in a 2004 digital orthophoto quadrangle. The amount of erosion was less than the error in the analysis, ~8 to 10 ft, during the 1 year period. Erosion clearly is occurring at this location, but must be at a rate that is less than or equal to 8-10 ft in one to two years. The landowner at this site showed us a fence line along the edge that was built several years ago, and was originally 10 ft from the bank edge. At several locations, fence posts are now in the channel, and we observed them in the water. Given this observation, at least 10 ft of erosion has occurred at several spots along this bank in the past several years.

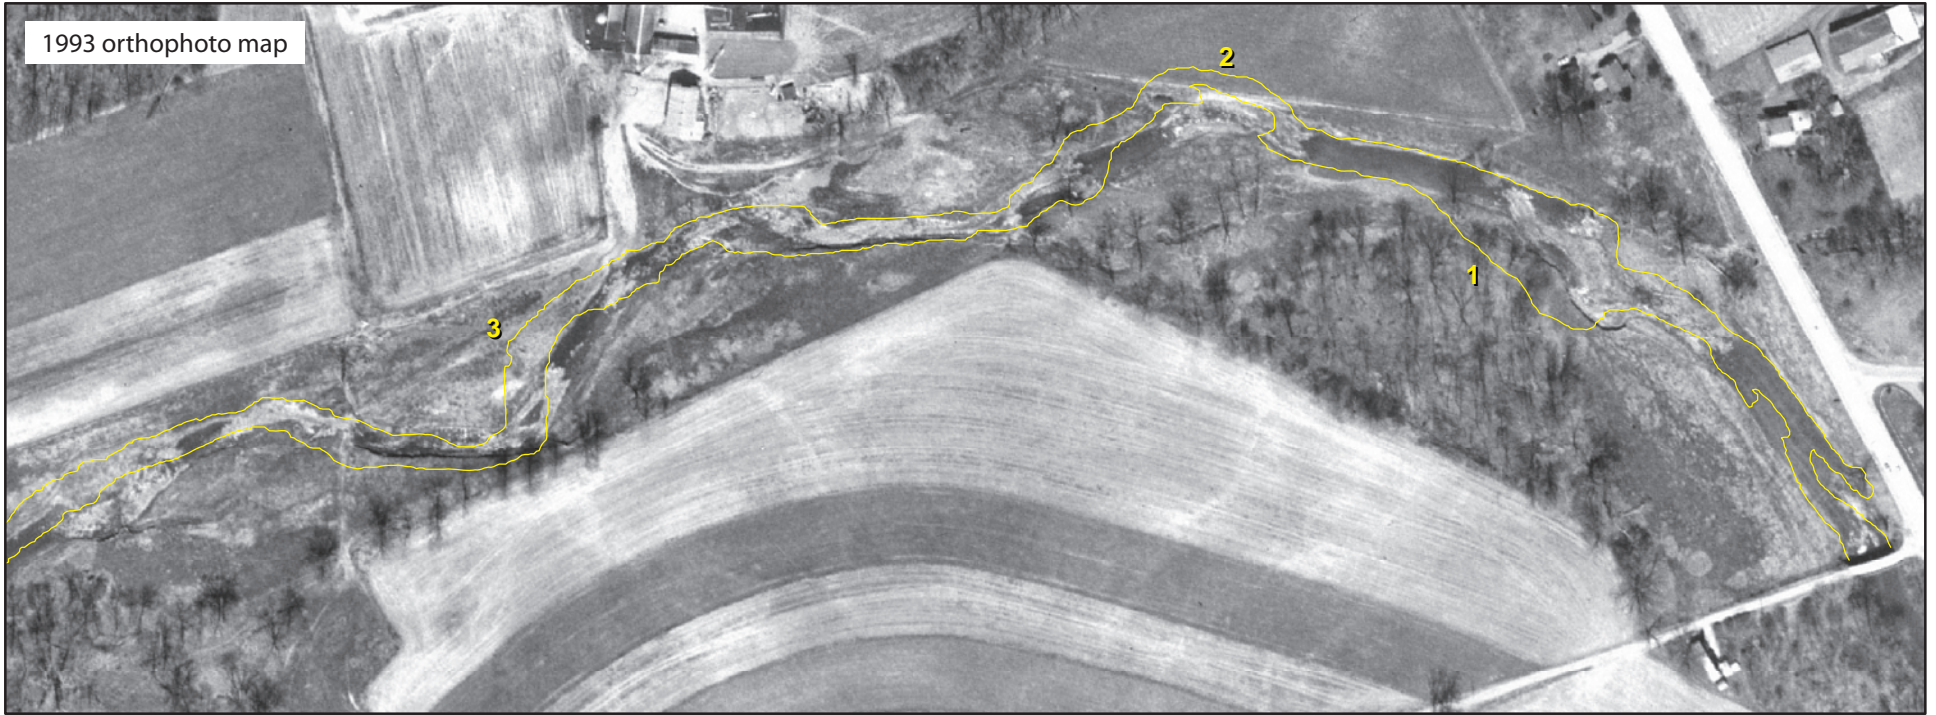
1993 orthophoto map

Figure 41 - Big Beaver Run orthophoto map comparison. The upper image is a 1993 orthophoto acquired by Lancaster County GIS (2 ft resolution); the lower image is a 2005 orthophoto acquired under the PAMAP program (1 ft resolution, 5 ft horizontal accuracy). Substantial lateral erosion is apparent between 1993 and 2005. As much as fifty feet (50') of lateral erosion has occurred at each of the locations numbered "1", "2", and "3". At location "2" the stream has eroded beyond a fenceline and into a farm field. A rough volume estimate for erosion may be obtained for this site by measuring the areas eroded and accreted. The area eroded is approximately 55,000 ft<sup>2</sup> and the area accreted is approximately 21000 ft<sup>2</sup> over the 3000 ft length of stream shown here. This equates to an average of 11 ft of lateral erosion over the 12 year timeframe or 0.9 ft/yr of lateral erosion for each linear foot of stream length. Using an average 6 ft bank height prior to erosion and 3 ft bank height for the accreted floodplain we estimate that nearly 10,000 cubic yards or 12,000 tons of material were removed over the 12 year timeframe. That means that this location produces, on average, 0.3 tons/linear-ft/yr.

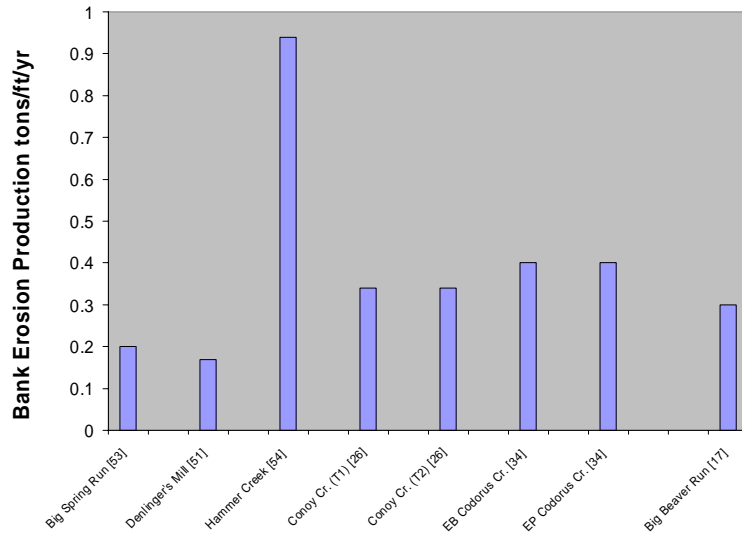
Figure 43. Bank erosion production rates in tons/ft/yr measured at six sites in Lancaster County. Production rates range from ~ 0.2 to ~0.9 tons/ft/yr, with an average of 0.39 +/- 0.24 (median = 0.34). Disregarding the highest bank erosion rates observed at Hammer Creek, results in an average bank erosion rate of 0.31 +/- 0.09.

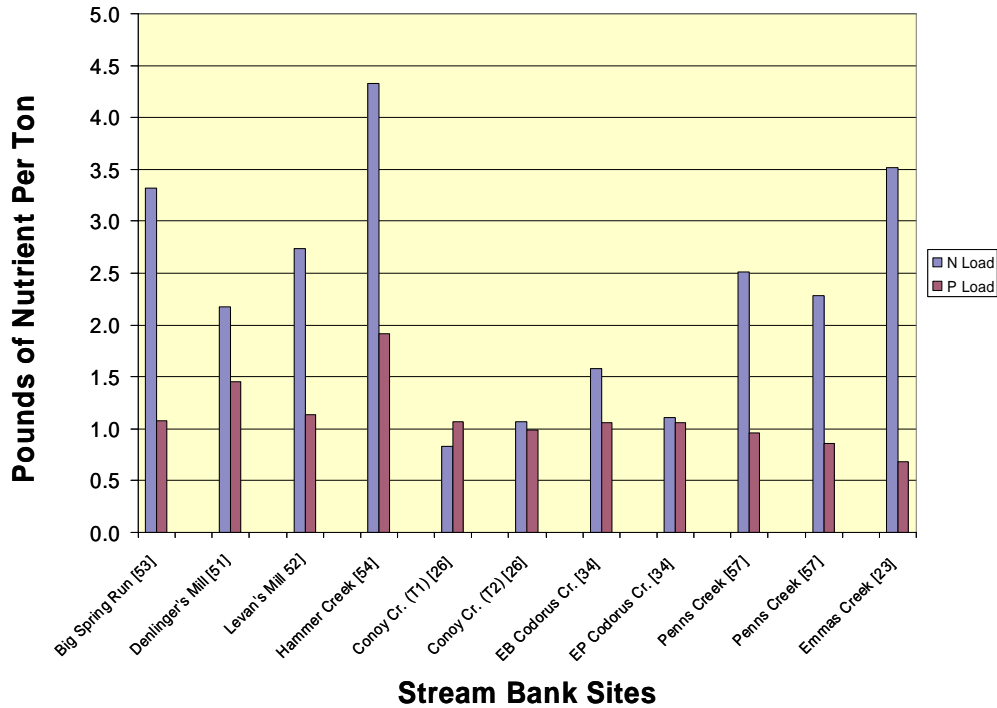
Figure 44. Summary of nitrogen (N) and phosphorus (P) loads, in pounds of each nutrient per ton of eroded stream bank sediment (lbs/ton). This plot show that : (1) N loads are variable from stream to stream (ca. 1-4.5 lbs N/ton); (2) P loads are relatively constant (ca. 0.6 to 1.8 lbs P/ton), regardless of stream or physiographic province; and (3) stream bank sediments in the Conestoga watershed of Lancaster Co. [Site #s 51-54], Penns Creek watershed of Centre Co. [Site # 57], and the Emma's Creek watershed in Huntingdon Co. [Site # 23] have the highest nitrogen loads, which might reflect long-term land use activities. See Table X for data summary.
