**ESTIMATING VOLUME, NUTRIENT CONTENT, AND  
RATES OF STREAM BANK EROSION OF LEGACY SEDIMENT IN THE  
PIEDMONT AND VALLEY AND RIDGE PHYSIOGRAPHIC PROVINCES,  
SOUTHEASTERN AND CENTRAL PA**

**A Report to the Pennsylvania Department of Environmental Protection**

**Submitted January, 2007, and Revised February, 2007, by**

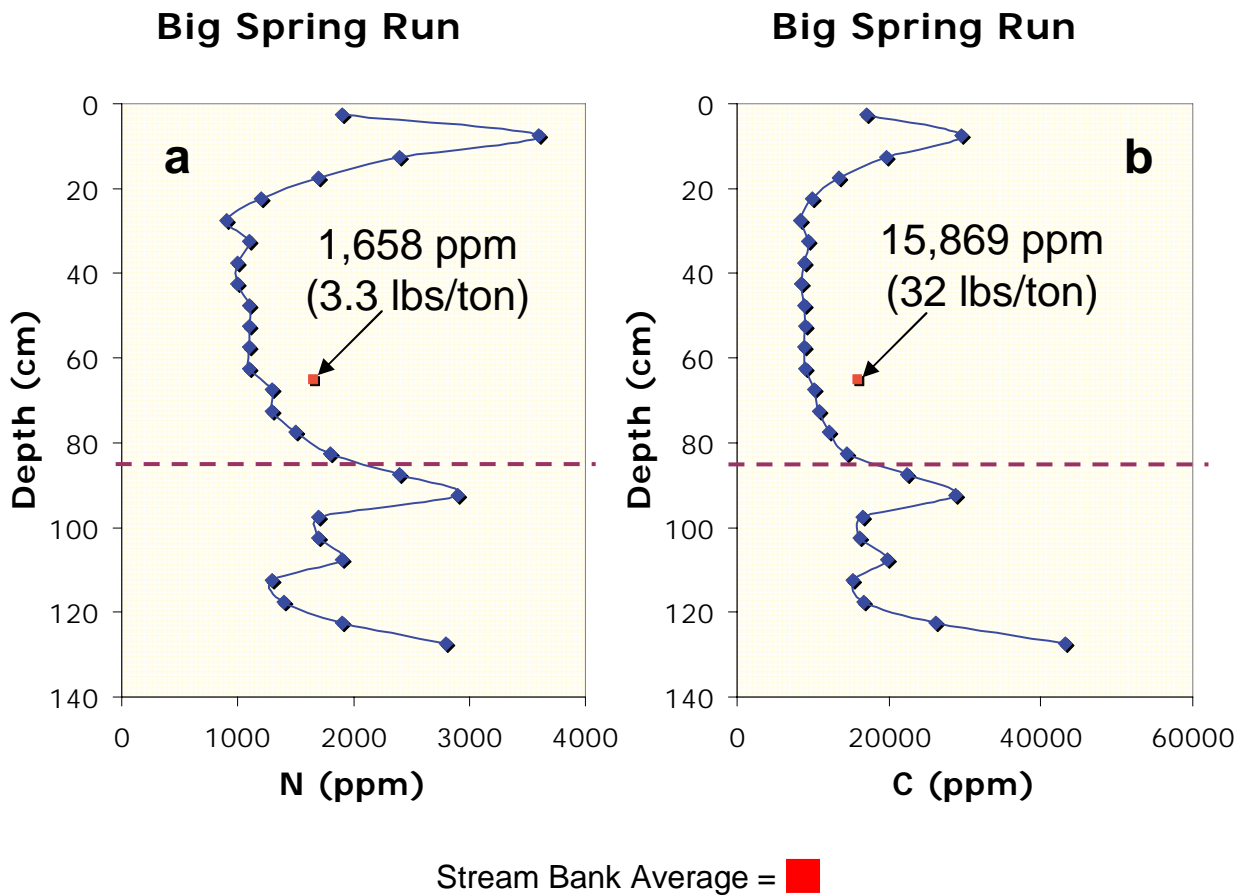
Figure 46a & b. Total nitrogen (N) and total carbon (C) concentrations measured in a vertical profile of stream bank sediments at Big Spring Run (Site # 53: Lancaster Co.). Data points connected by line show variations in these elements measured in 10 cm increments from the top of the stream bank to the base of the section. Vertical scale (depth below surface) is in centimeters ( cm). Horizontal scale (nutrient concentration) is in parts per million (ppm, equivalent to mg/kg). Dashed line represents the height of floodplain surface at the time of European settlement: sediments below this dashed line are Pre-Settlement deposits; above the line are Post-Settlement (legacy sediment) deposits. The average concentration of each element is show by the red square, with nutrient loads (lbs/ton). This average value reflects the concentration of N and C that would be contributed to the stream by bank collapse and erosion.

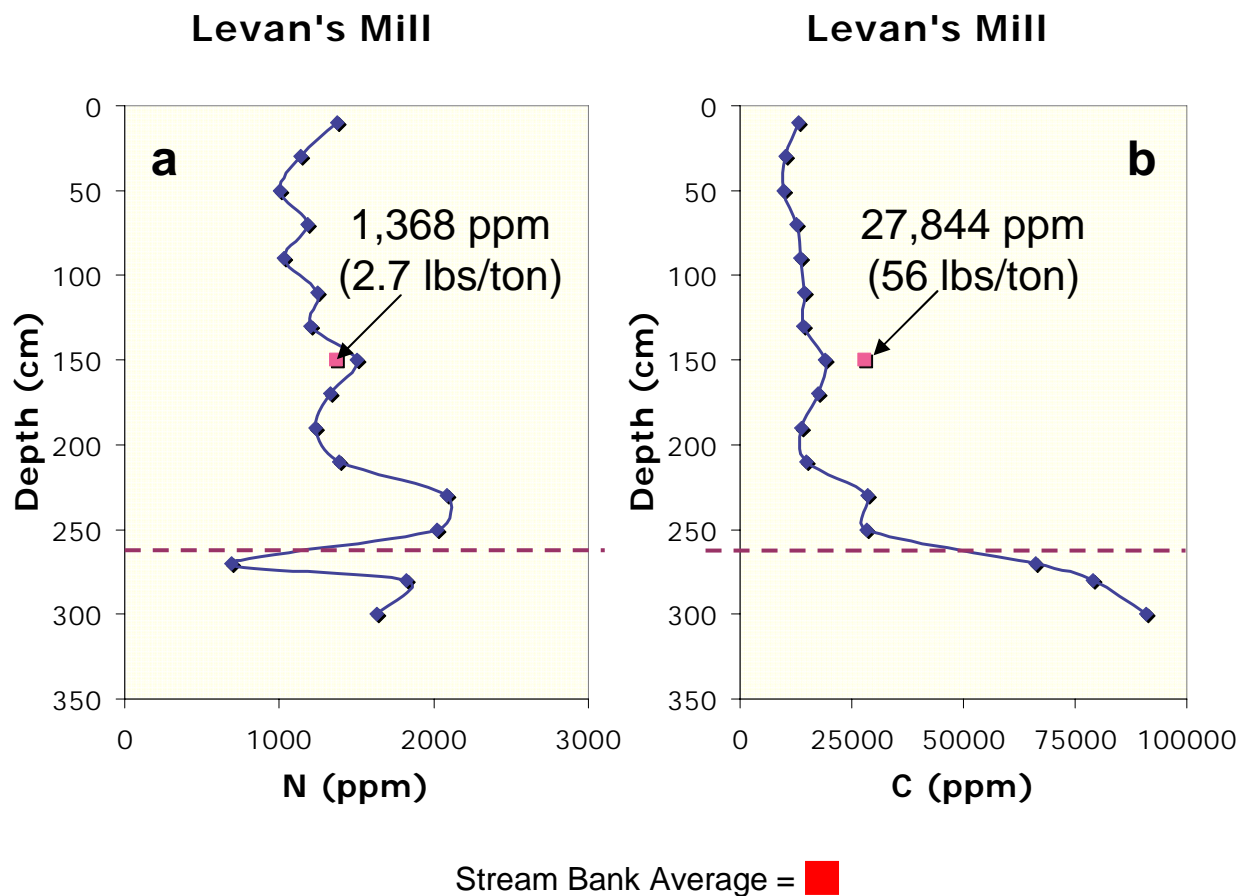
Figure 47a & b. Total nitrogen (N) and total carbon (C) concentrations measured in a vertical profile of stream bank sediments at Levan's Mill (Site # 52: Lancaster Co.). Data points connected by line show variations in these elements measured in 10 cm increments from the top of the stream bank to the base of the section. Vertical scale (depth below surface) is in centimeters ( cm). Horizontal scale (nutrient concentration) is in parts per million (ppm, equivalent to mg/kg). Dashed line represents the height of floodplain surface at the time of European settlement: sediments below this dashed line are Pre-Settlement deposits; above the line are Post-Settlement (legacy sediment) deposits. The average concentration of each element is show by the red square, with nutrient loads (lbs/ton). This average value reflects the concentration of N and C that would be contributed to the stream by bank collapse and subsequent erosion.

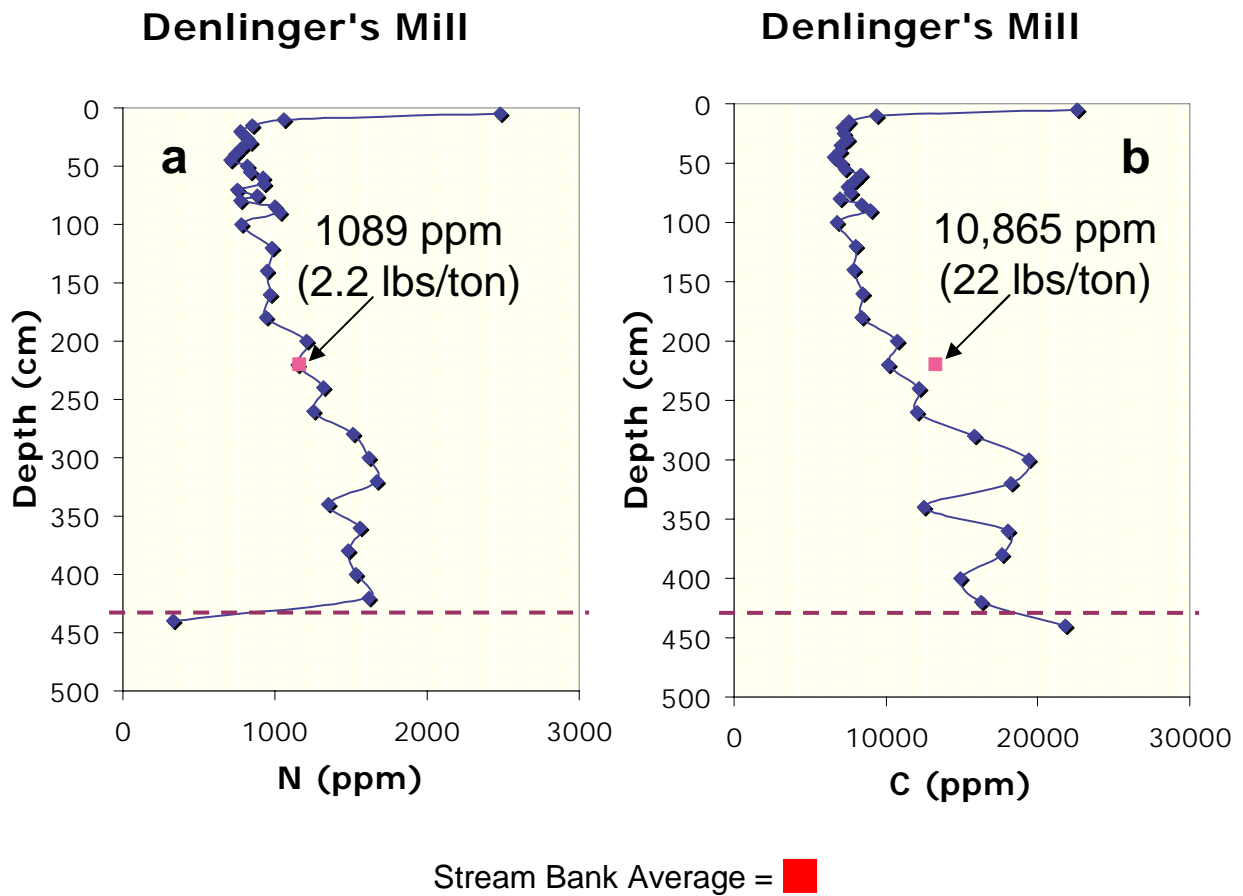
Figure 48a & b. Total nitrogen (N) and total carbon (C) concentrations measured in a vertical profile of stream bank sediments at Denlinger's Mill (Site # 51: Lancaster Co.). Data points connected by line show variations in these elements measured in 10 cm increments from the top of the stream bank to the base of the section. Vertical scale (depth below surface) is in centimeters ( cm). Horizontal scale (nutrient concentration) is in parts per million (ppm, equivalent to mg/kg). Dashed line represents the height of floodplain surface at the time of European settlement: sediments below this dashed line are Pre-Settlement deposits; above the line are Post-Settlement (legacy sediment) deposits. The average concentration of each element is show by the red square, with nutrient loads (lbs/ton). This average value reflects the concentration of N and C that would be contributed to the stream by bank collapse and subsequent erosion.
