## A Geological Appraisal of Slope Instability in Upper Alaknanda Valley, Uttarakhand Himalaya, India

### Abstract

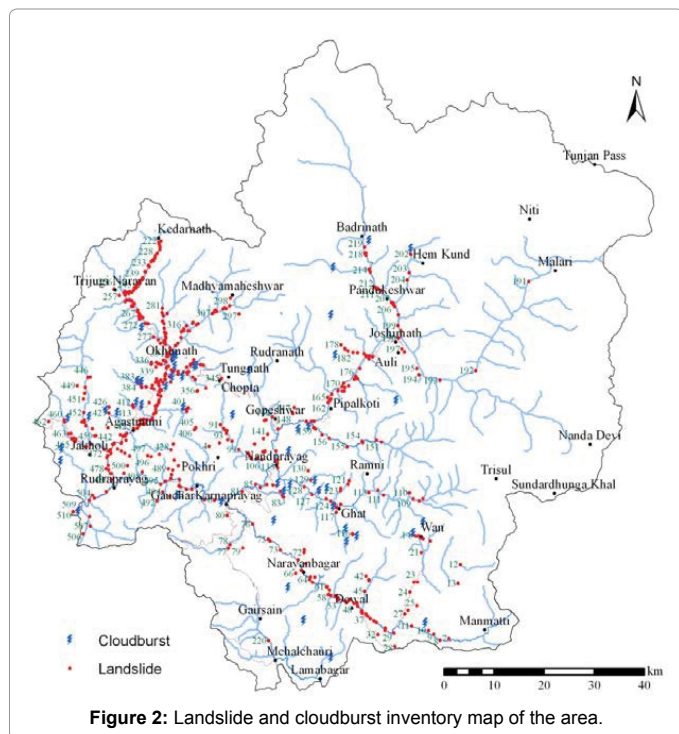
Figure 2: Landslide and cloudburst inventory map of the area.

A total of 510 landslides have been identified through field investigations in Upper Alaknanda valley (Figure 2). Observed landslides are classified on the basis of movement and rigidity of material comprising the slide mass; bed rock, debris and earth. The summary of the same is given in Table 2.

Moreover, cloudburst is one of the most considerable factors responsible for the slope instability. Such events are related to extreme hydrometrological conditions, debris flow, mud flow and landslides along the tributaries/rivers are common due to this. Torrential rainfall/cloudburst are the natural phenomenon occurs during monsoon season over the regions dominated by orography like Himalaya. High intensity rainfall of more than 100 mm/hour within a limited geographical area of a few square kilometres is defined as cloudburst [6]. In this area total 52 cloudbursts location were identified and studied (Figure 2).

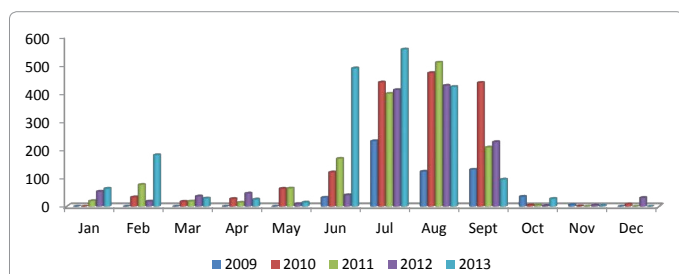
**Figure 4:** Average monthly rainfall (mm) in Upper Alaknanda Valley for last five years (Source data: IMD). Exceptionally high rainfall in July 2013 can be observed.

**Heavy rainfall/cloudburst:** Change in rainfall pattern has been observed in recent years, rainfall intensity is increasing in place of rainfall amount. The study area experiences enough rainfall due to southwest monsoon during June to September. The precipitation mainly arises during these months. The scattered rains and snowfall arise during winter months. The heavy seasonal downpour on the geologically and structurally deformed rocks creates a variety of slope failures. The rainfall data of the study area was collected and summarized in Figure 4.

It is evident from Figure 4 that the rainfall in the area is highly variable due to its orographic and geographic disposition. The rainfall data reflect that the area has been recorded average maximum monthly rainfall 555.3 mm in July 2013 and minimum rainfall 1.5 mm in Nov. 2010 besides this 0% rainfall also recorded in some months. The maximum annual rainfall is about 1912.20 mm in the year of 2013 followed by 1628.80 mm in 2010 and minimum 562.70 mm in the year of 2009. Exceptionally high rainfall in June 2013 can also observe during five years (Figure 4).

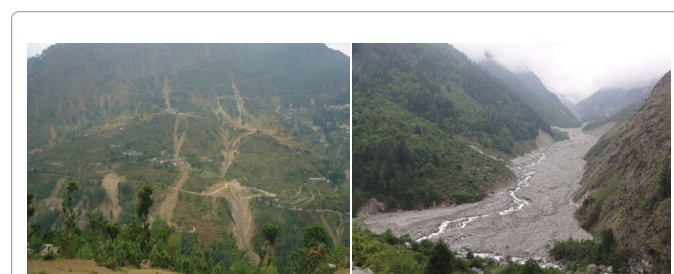
**Figure 5:** (A) Cloudburst induced landslides at Ukhimath area (2012); (B) Cloudburst incidence along Khirao Ganga valley (2013).

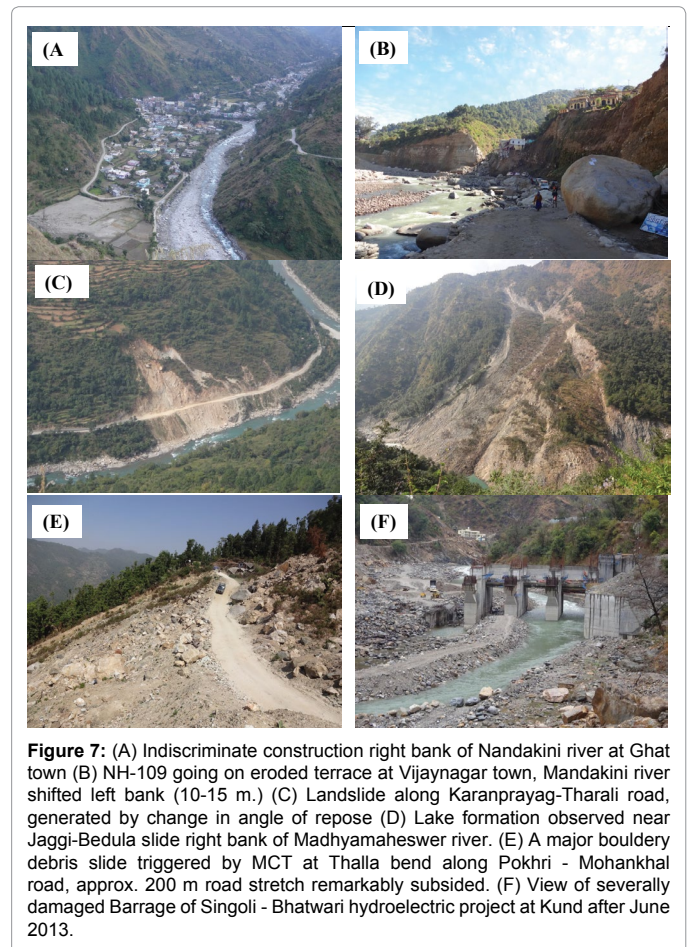
susceptible to landslides (Figure 7E). Keefer [19] in a comprehensive study has identified 14 types of landslides associated with earthquake activity. The most common are rock falls, rock slides and disrupted soil slides. Earthquakes reduce stability by imparting both a shearing
