Hysteroscopic myometrial false route – a false case of endometrial cancer

Inês Pereira¹, Margarida Bernardino², Ana Maria Coelho², Teresa Margarida Cunha³, Ana Francisca Jorge²

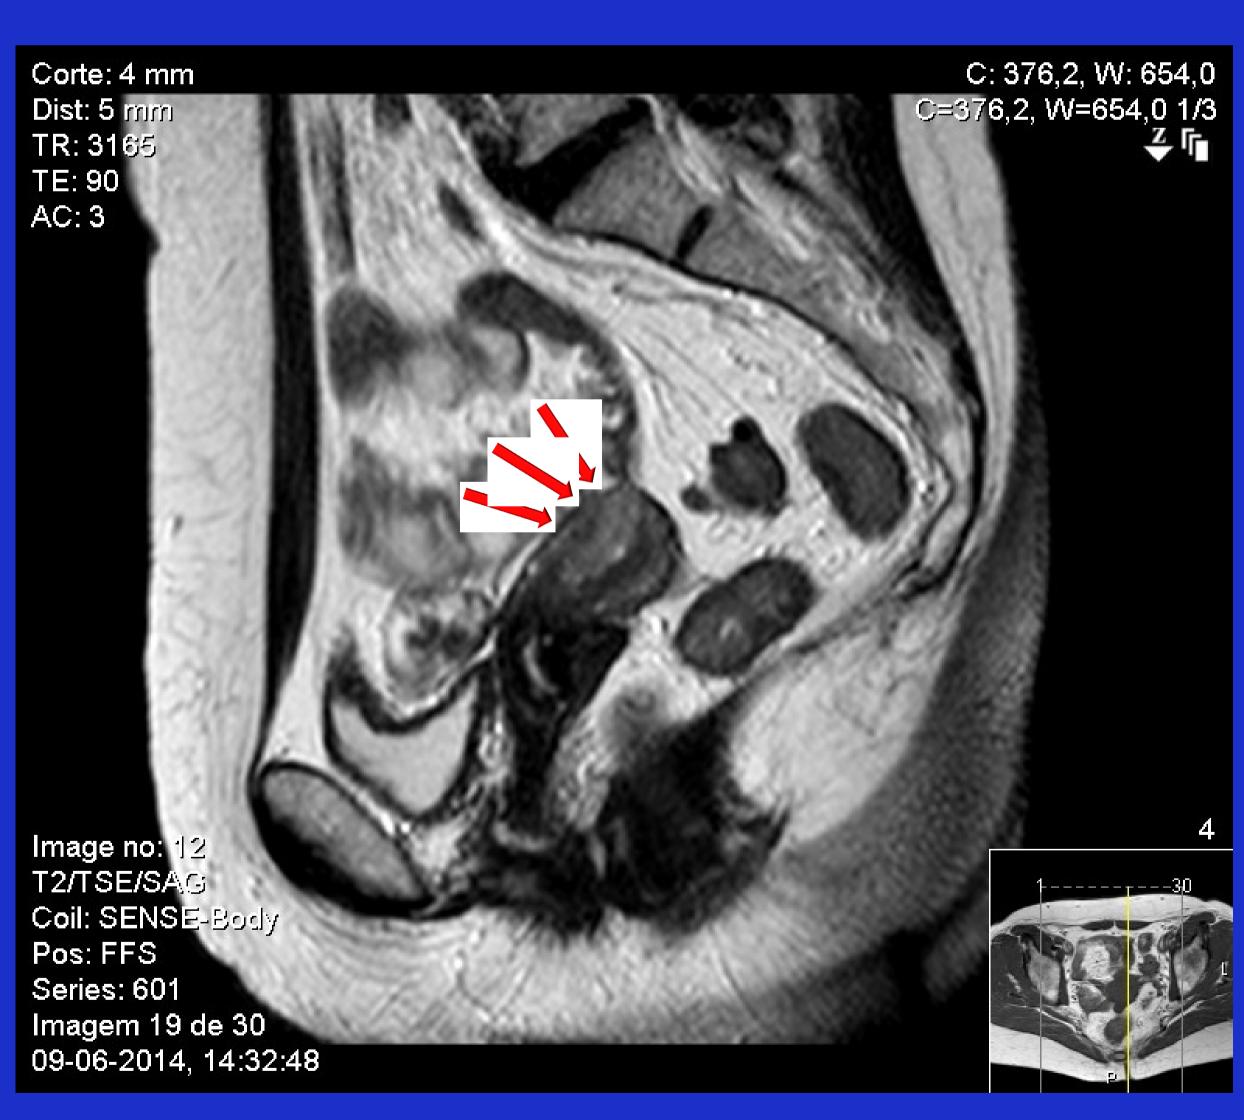
Figure 1 – Pelvic MRI in a sagittal plan presenting a high signal intensity endometrial lesion extending to the external half of the fundal anterior wall of the myometrium.

Case Report: A 65 year-old asymptomatic woman was submitted to a hysteroscopy after a sonographic suspicion of an endometrial polyp. The procedure was inconclusive due to cervical stenosis and a pelvic MRI was then performed (Figure 1). A presumptive diagnosis of an advanced neoplastic endometrial lesion was placed and the patient was referred to our hospital.

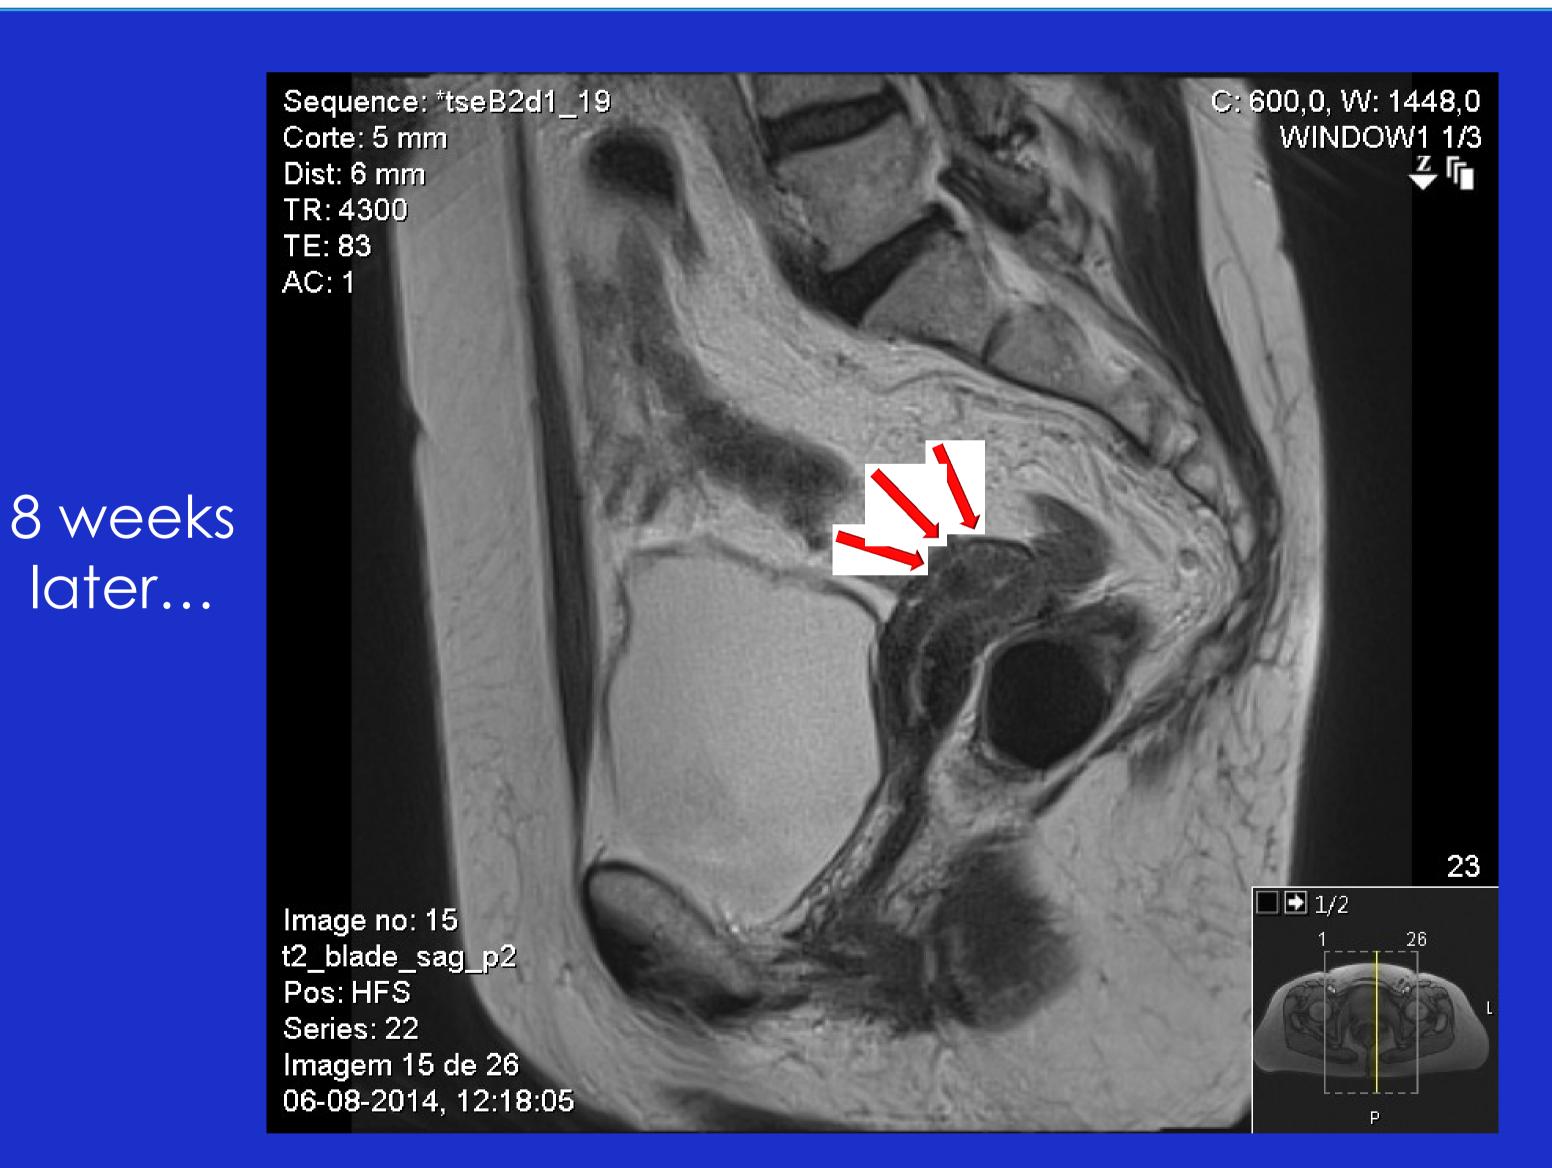
Figure 2 – Pelvic MRI in a sagittal plan showing a total regression of the first MRI findings.

A second diagnostic hysteroscopy was performed with successful entrance in the uterine cavity and an atrophic endometrium was visualized. A second MRI was then performed (Figure 2).
