Monolithic CAD/CAM Lithium Disilicate Versus Veneered Y-TZP Crowns: Comparison of Failure Modes and Reliability After Fatigue

Petra C. Guess, DDS^a/Ricardo A. Zavanelli, DDS^b/Nelson R.F.A. Silva, DDS, MSc, PhD^c/
Estevam A. Bonfante, DDS^d/ Paulo G. Coelho, DDS, PhD^e/Van P. Thompson, DDS, PhD^f

Purpose: The aim of this research was to evaluate the fatigue behavior and reliability of monolithic computer-aided design/computer-assisted manufacture (CAD/CAM) lithium disilicate and hand-layer-veneered zirconia all-ceramic crowns. **Materials and Methods:** A CAD-based mandibular molar crown preparation, fabricated using rapid prototyping, served as the master die. Fully anatomically shaped monolithic lithium disilicate crowns (IPS e.max CAD, $n = 19$) and hand-layer-veneered zirconia-based crowns (IPS e.max ZirCAD/Ceram, $n = 21$) were designed and milled using a CAD/CAM system. Crowns were cemented on aged dentinlike composite dies with resin cement. Crowns were exposed to mouth-motion fatigue by sliding a WC-indenter ($r = 3.18$ mm) 0.7 mm lingually down the distobuccal cusp using three different step-stress profiles until failure occurred. Failure was designated as a large chip o

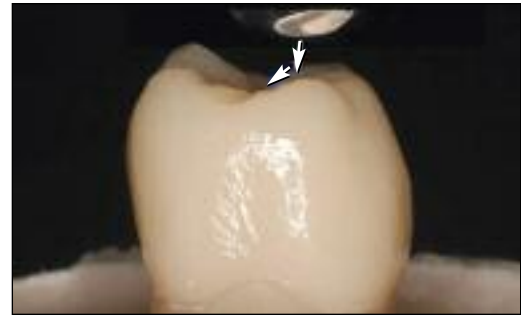
Fig 2 Mouth-motion fatigue with load application on the distobuccal cusp of the crown (arrows).

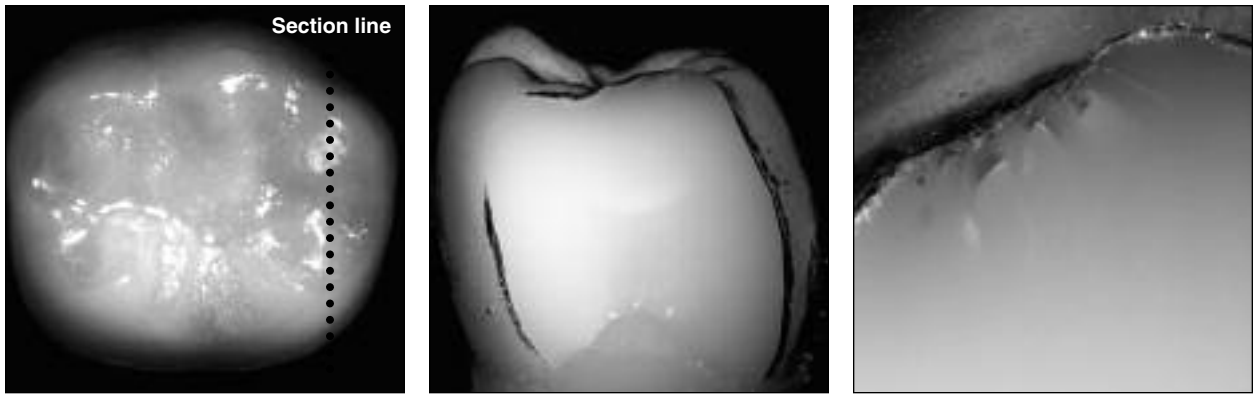
Fig 4 (left) Occlusal view and (center) cross section of an IPS e.max CAD crown at a load of 900 N exhibiting only minor occlusal damage (right) at 180,000 cycles after mouth-motion fatigue.

and 180,000 cycles (Table 1). Only superficial surface damage was observed (Fig 4). Survival of all IPS e.max CAD mouth-motion step-stress fatigue specimens ($n = 6$) in the first 3:2:1 distribution grouping resulted in moving staircase fatigue testing to 1,000,000 cycles. At loads in the range of 900 to 1,000 N, no failures were observed at 1,000,000 cycles (Fig 5). Based on the results of these r ratio fatigued samples ($n = 10$), it appeared that fatigue damage had only a minimal effect on the IPS e.max CAD ceramic (Table 2). At loads above 1,100 N, IPS e.max CAD crowns failed by bulk fracture (Fig 6).

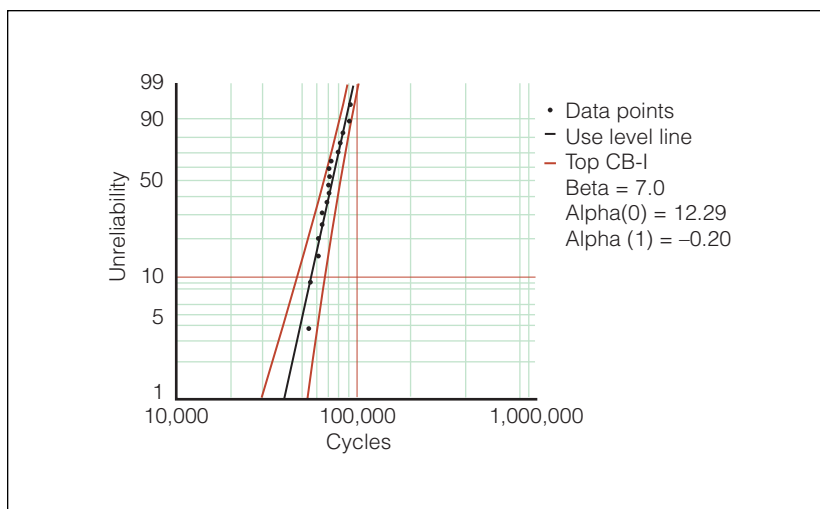
Fig 8 IPS e.max ZirCAD/Ceram unreliability (Weibull distribution) versus time (cycles) at a 200-N load (90% two-sided confidence bounds).

Using a power law cumulative damage model, the two-parameter Weibull beta value for the ZirCAD specimens was 7.0 (4.5 to 10.2, two-sided 90% confidence bounds). This indicates a threshold for damage accumulation in these specimens. The calculated reliability for hand-layer-veneered ZirCAD core crowns for a

mission of 100,000 cycles and 200 N was < 0.01 (0.03 to 0.00, two-sided 90% confidence bounds), while for 200 N and 50,000 cycles, the reliability was 0.95 (0.99 to 0.80). The hand-layering technique on ZirCAD resulted in limited reliability, where at 200 N, more than 90% of specimens failed by 100,000 cycles (Fig 8).
