CONSERVATION OF CULTURAL PROPERTY IN INDIA

Conservation of M.F.Hussain's Mural- oil painting on canvas – A case study

Akshaye Aggarwal* and Sreekumar Menon**

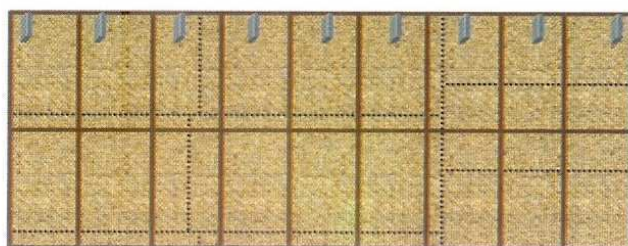
Painting consists of three parts, the main painting being 1321.8 cm in length and 273.4 cm in height, and other two parts (referred to as panels in the remainder of the paper) one above the lift and other to the left side of the lift. The panel above the lift is 389.8 cm in length and 63 cm in height and panel to the left of the lift is 57 cm in length and 274.7 cm in height. Auxiliary support of the main painting is made of 9 strainers, with a horizontal member at the center, of an average length of 134 and height of 273.4 cm joined together with nuts & bolts to make a large strainer of the size of the painting. Auxiliary support of the panel above lift is a strainer with three vertical members and that of the panel to the left of the lift is a strainer with two horizontal members, Figure 2. The support of the main

Fig.2. Graphical representation of the support, strainer and position of wooden blocks on wall as seen from verso

painting is made by stitching together 9 pieces of canvases, support of the panel above the lift is made by stitching together two pieces of canvas and the support of the panel to the left of the lift is made by stitching together three pieces of canvas. The main painting was hung by resting the top member on nine wooden blocks, tapered towards the edge screwed to the wall. Similarly panel above the lift was hung on three wooden blocks and panel to the left of the lift is hung by one wooden block. The canvas used by the artist was imported as evident from the seal of Winsor & Newton on the verso of the canvases, Figure 3. A white ground layer was applied on the canvas that was visible on the areas of the losses. Thick impasto with application

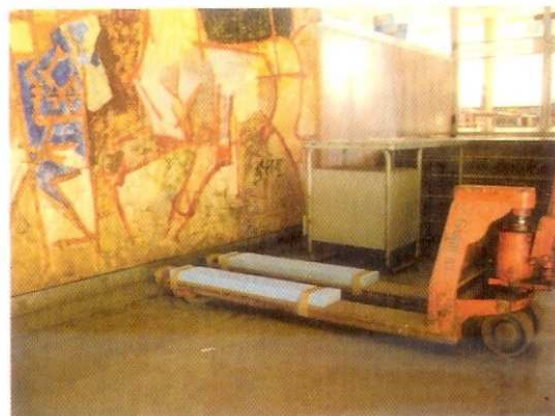
Fig.6. A padded trolley used for supporting the painting.

Consolidation of the paint layer had to be carried out with painting in standing condition. Since paint layer was thick and area of flaking was major, there was a requirement of a stronger adhesive that could be applied in vertical condition. Beva 371 gel was found to be ideal for the purpose due to its adhesive strength, its property of consolidation by re-activation and other tested properties like high durability and compatibility for oil paintings on canvas. Prepared Beva 371 gel was applied with a temperature of about 60°C in the areas of delamination of paint layer using fine brushes and allowed to cool down. After that the adhesive is reactivated with heat there by settling the delaminating paint layer and adhering it to the support. Dust and dirt deposit in the paint layer was removed by dry brushing. It was then decided to get the painting down from the wall so as to have a clear picture of the condition of the verso of the painting. Padding was given on the four trolleys that were to be utilized to move the painting and to the projection on the opposite wall to provide cushioning to the painting when painting would be resting on it after removal from the wall. Figures 6-7.

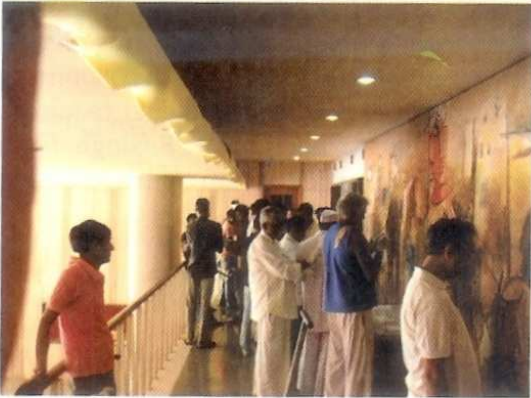
Fig.7. Padding given to the projection on the opposite wall for resting the painting after removal.
