# Performance-Based Evaluation of Historical Structures

## IV. CASE STUDY: ERZURUM CLOCK TOWER

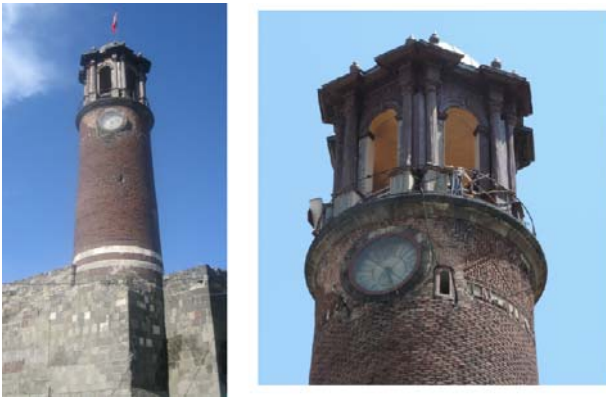
Erzurum has a historical and cultural background since almost 7,000 years. Over the centuries, the ancient city has imposed many different cultural effects and architectural styles. One of the valuable historical structures in the city is the Erzurum Clock Tower. This fascinating tower is also known as the Tepsi Minare (Tray Minaret) due to the former structural shape. The tower is situated on the southwest side of the Erzurum Castle and has a slender structural form. It was built originally as a minaret by Muzaffer Gazi Bin Ebu'l Kasım in the 12th Century [10]. This minaret had a balcony, which was placed on top of the minaret; however, this balcony disappeared for unknown reasons. After the disappearance of the balcony, the minaret served as a watchtower. Moreover, a clock mechanism, cupola (small dome) and bell of the clock were installed in the 19<sup>th</sup> century and the watchtower turned into a clock tower [10]. As of today, the clock mechanism of the body and bell of the clock included in the cupola do not work properly and the tower is visited as a historical heritage site (Fig. 4).

Fig. 4. Erzurum clock tower
