# **TREATMENT EFFICACY OF KAUMA WASTEWATER TREATMENT WORKS IN LILONGWE, MALAWI FOR POLLUTION CONTROL AND WASTEWATER REUSE**

**Principal Mdolo  
(NRC)**

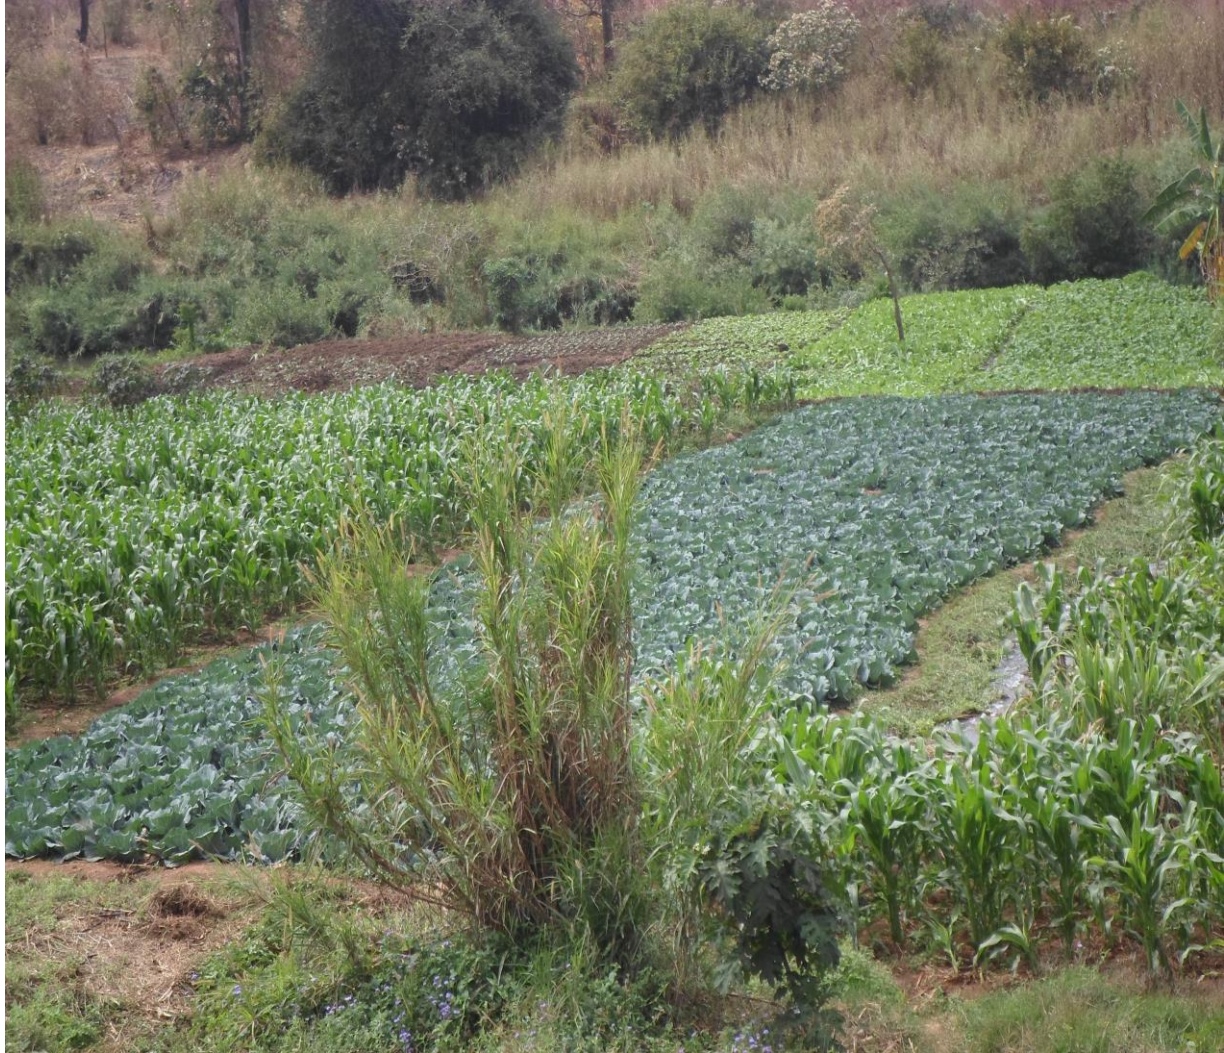
Mdolo 2014

Discharge of poor quality effluent causes pollution

Discharge of poor quality effluent negatively impacts on their livelihoods

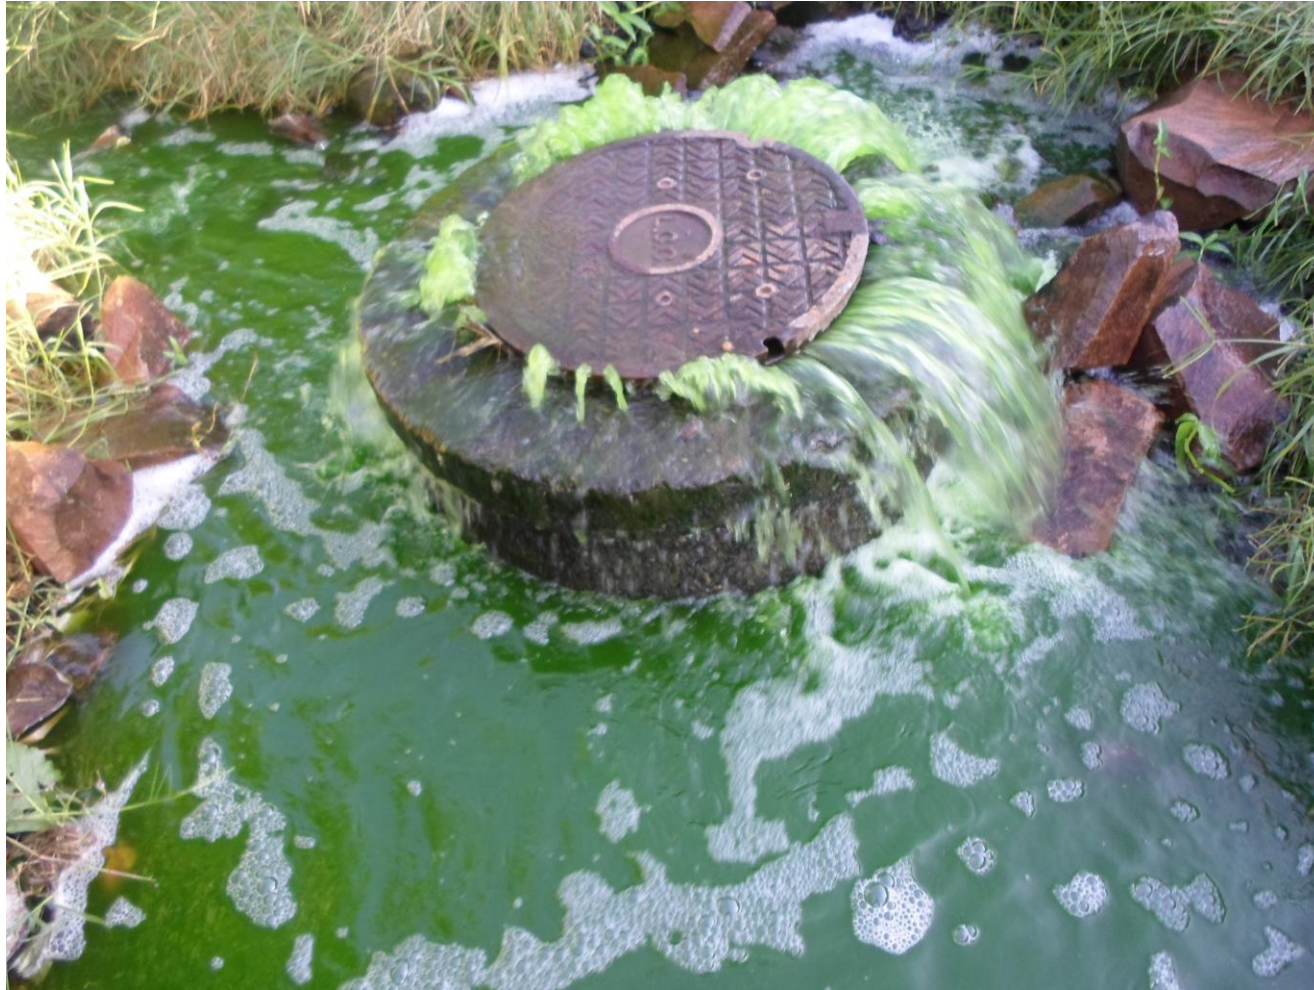
- Effluent discharged at Kauma is of poor quality
- The efficiency of the pond system is poor in removing pollutants
- The effluent can impact negatively on public health and the environment
- O & M works at Kauma are inadequate
- Therefore, further treatment is required to make the effluent reusable

- All broken and blocked pipes be repaired
- Effluent quality be monitored regularly
- An O & M plan be developed and followed
- Records of all O & M activities be maintained
