Experimental assessment of post-earthquake retrofitted reinforced concrete frame partially infilled with fly-ash brick

Keywords: captive column effect; epoxy injection grouting; fly-ash infill; full-scale experiment; partial infill wall; retrofitting; steel jacketing

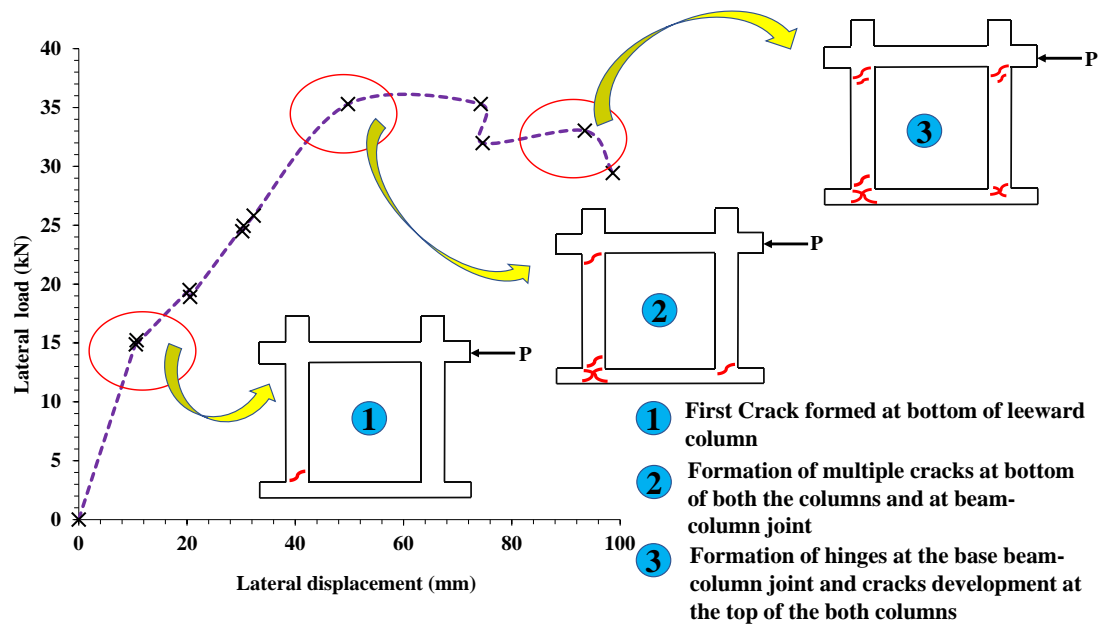
Fig. 12 Progressive failure of the retrofitted bare frame (DBFR-G) with increasing cycles of loading

The progressive failure of the retrofitted frame (DBFR-G) with an increasing cycle of loading is illustrated with the help of the backbone curve and is shown in Fig. 12. The initial stiffness of the frame suddenly dropped by 36% during the first 20 mm displacement cycle due to the formation of cracks at the bottom of the leeward column. After that, the stiffness almost remained constant with displacement. The frame attains its maximum lateral strength of 35 kN at the displacement cycle of 50 mm. At this stage of loading, multiple cracks are formed at the bottom beam-column joint, and at the top and bottom of the columns. Following that cycle of loading, the load-carrying capacity of the frame almost remains constant up to 75 mm displacement. The frame fails to resist more load in its final 100 mm displacement cycle due to the failure of the bottom beam-column joints and damages caused at the top of the columns. The comparative hysteresis curve of the undamaged bare frame (BF) and the retrofitted one (DBFR-G) is shown in Fig. 11 (for drift value of 3.6%). The BF shows more symmetric behavior (in pull and push loadings) as compared to the DBFR-G. A pinching effect has been observed during the pull loading (negative displacement cycle) of the specimen DBFR-G.

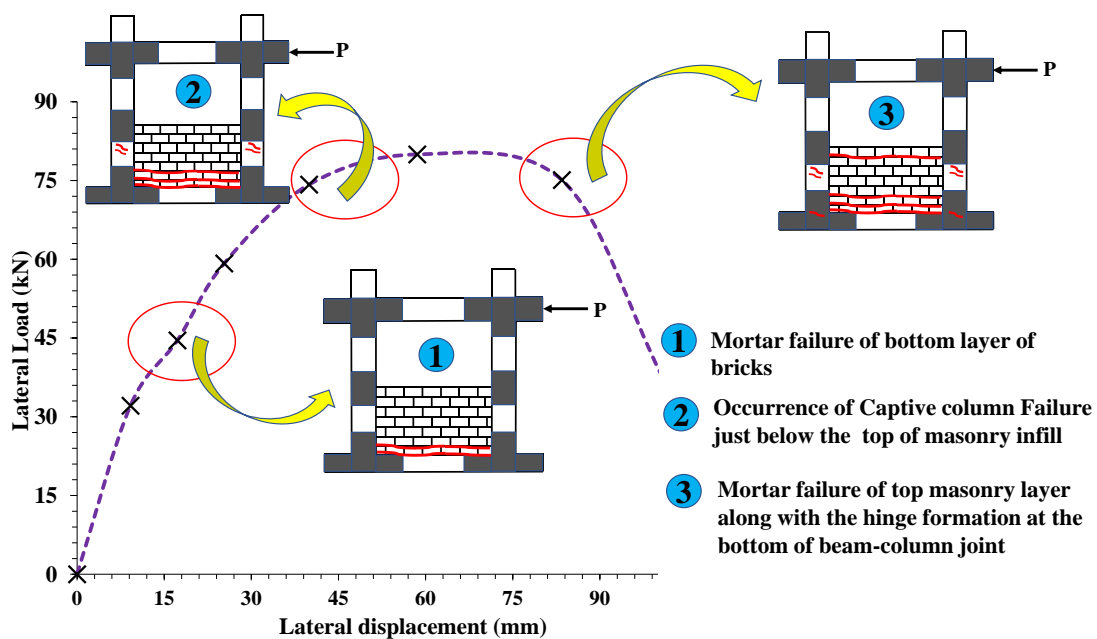
Fig. 16 Progressive failure of DPIFR-GS with increasing cycles of loading

The progressive failure of DPIFR-GS with the increasing cycle of loading is shown with the help of the backbone curve in Fig. 16. The initial stiffness drops by 30% due to the failure of bed-joint at the tie-beam wall interface at a 20 mm cycle of displacement (0.8% drift). The frame attained its capacity of 80 kN in the 50 mm cycle of displacement (2% drift), after which the load-carrying capacity remained constant due to the formation of captive column failure and sliding failure of bottom two bricklayers. The ultimate failure occurs during the 75 mm displacement cycle (3% drift), after which the load
