Post-Earthquake Assessment and Strengthening of a Cultural-Heritage Residential Masonry Building after the 2020 Zagreb Earthquake

3. Case Study-Building in the Street Ribnjak

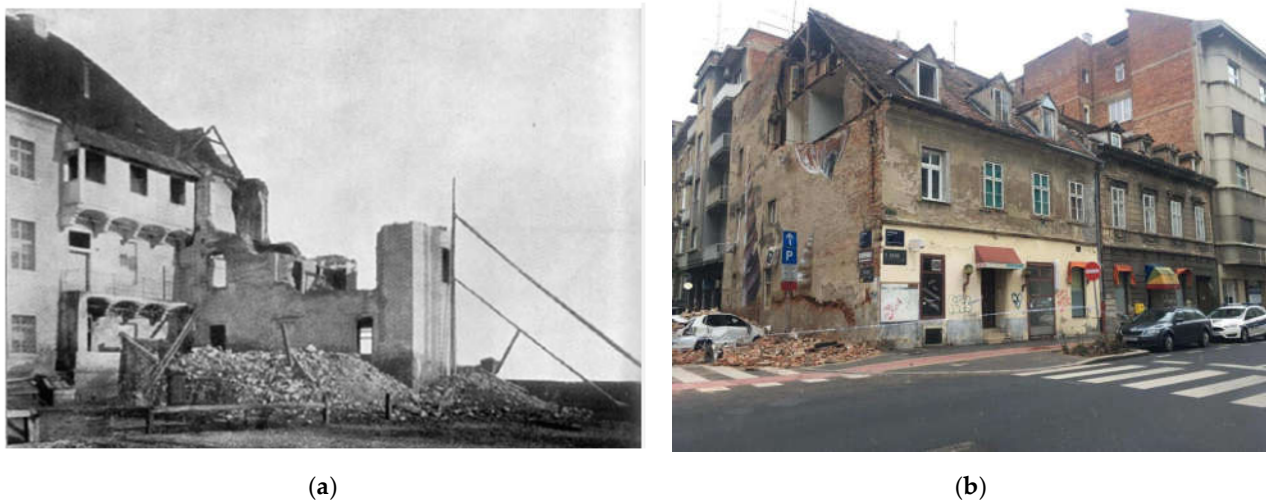
Figure 1. Building devastation after: (a) 1880 Zagreb earthquake [4] Reproduced with permission from Zagreb City Museum, 2022.; (b) 2020 Zagreb earthquake (author's figures).

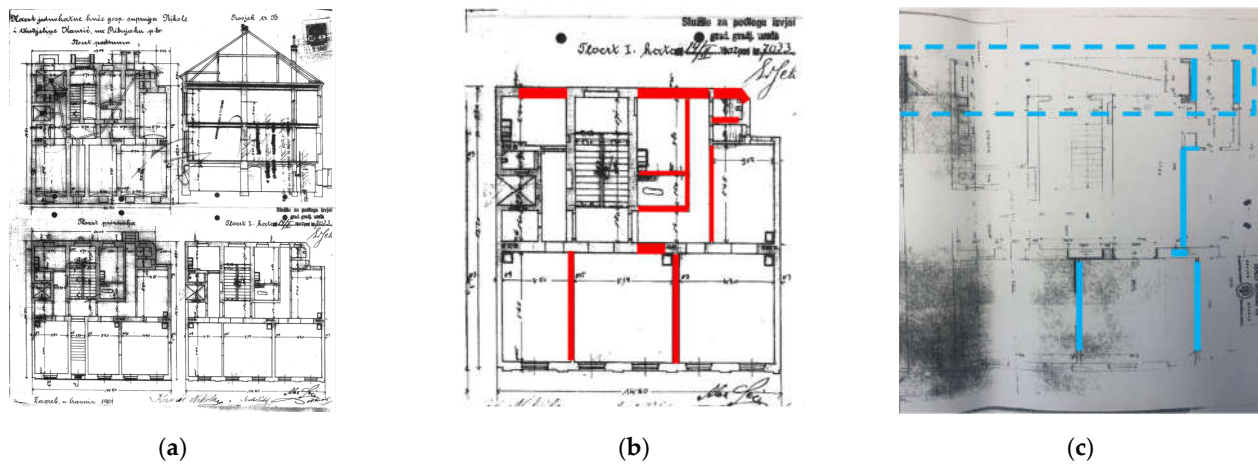
walls looking at the courtyard additionally decreased the loadbearing capacity of the structure in the X direction. To make a wider open space, the construction of the new walls did not follow the position of the existing walls on the ground floor causing the change in load transfer. The reconstruction of the apartments was not synchronized causing a change in the global behavior of the structure. In 1998, several reconstructions were conducted on the first floor, while in 2015, in the apartments, several steel girders have been constructed. The demolition of the longitudinal walls, as will be proved later on by the calculations, caused a lot of difficulties in the reconstruction process. A new lodge was constructed (see Figures 4c and 5b) founded on new steel columns. The constructed lodge is not adequately connected to the existing structure, the steel columns do not have adequate foundations, and this additionally modified the behavior of the structure.

Figure 4. Investigated buildings Ribnjak 44: (a) original drawings from the State Archives in Zagreb; (b) reconstruction-demolished walls shown in red color State Archives in Zagreb; (c) construction of new walls and a lodge [32]. Reproduced with permission from State Archives in Zagreb, 2022.

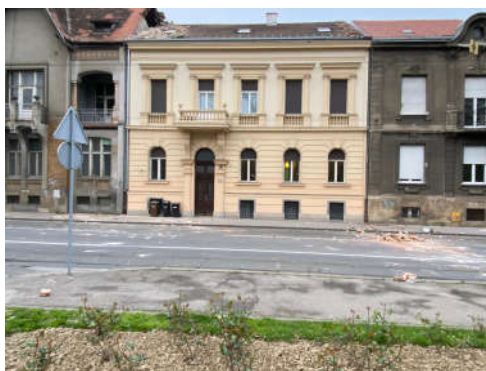
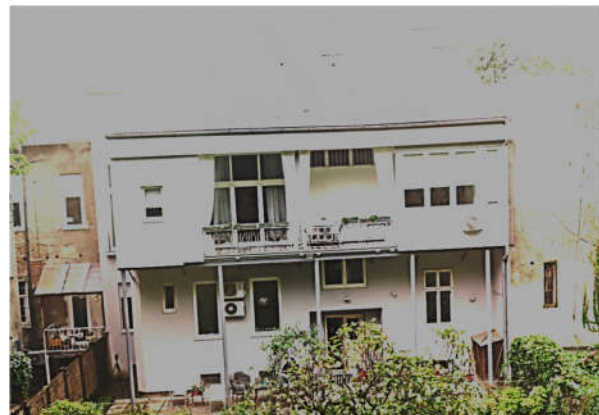
The present state of the unreinforced masonry (URM) buildings is presented in Figure 5a,b. It is a row building (the yellow one) located between two buildings of the same height (on the north and the south side). The building has a regular shape with dimensions 14.5×17.20 m in plan, the floor plan of the building is 217 m^2 , and the gross construction area is equal to 799.07 m^2 . The structure consists of a basement, two storeys (ground floor and first floor), and an attic.

Figure 5. Investigated buildings Ribnjak 44: (a) street view (building in the middle); (b) courtyard view [32]. Reproduced with permission from Projekt na kvadrat d.o.o., 2022.

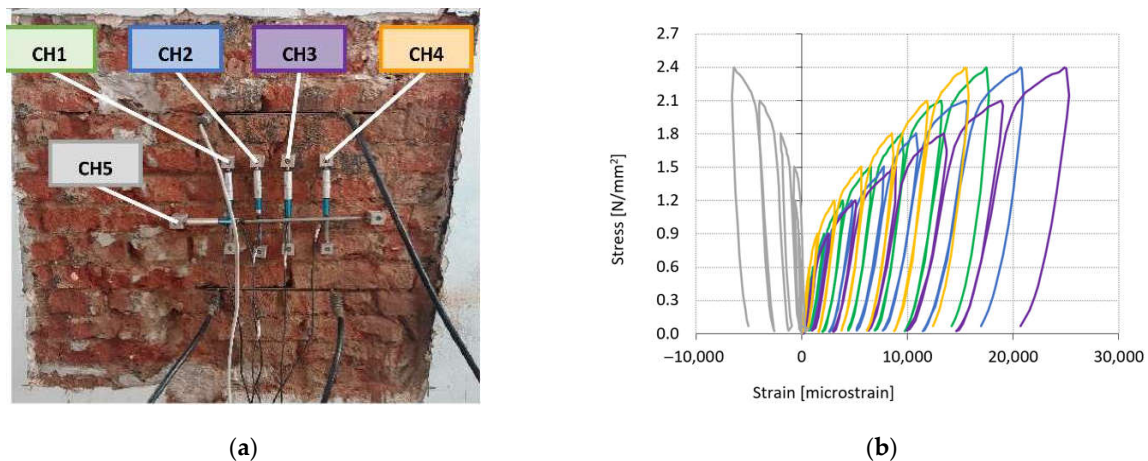
Figure 8. (a) 3D Sensors' layout; (b) Stress-strain relationship measured at different sensors.

The tests were made in accordance with the ASTM C1197-14a [38]. The maximum attained stress values were in the range of 2.4 to 2.7 N/mm². Maximum values were limited also for the great deformability encountered in masonry. The modulus of elasticity at the first and second sampling positions were in fact 554 and 470 N/mm² at the beginning of the loading paths (between 0.00 and 0.30 N/mm²), and tests were carried out almost until material plasticization or strong Young's modulus reduction of masonry. The obtained values are rather low compared to the suggested values found in the literature, and this may be explained by the relatively thick joints and by a very deformable mortar. It has also to be stressed that maximum tests values do not correspond to the material strength, since the tests induced "compaction" in the material (seen in the hardening effect at the end of the second test) and that almost no cracks—indicating masonry crushing—were noticed throughout the tests. This once again emphasizes the importance of on-site testing and the fact that each building represents a case study of its own and has to be separately examined. The values that were selected as input in the numerical modeling were cautiously defined as $f_m = 2.2$ N/mm² for the compressive strength of masonry and the modulus of elasticity $E = 500$ N/mm².

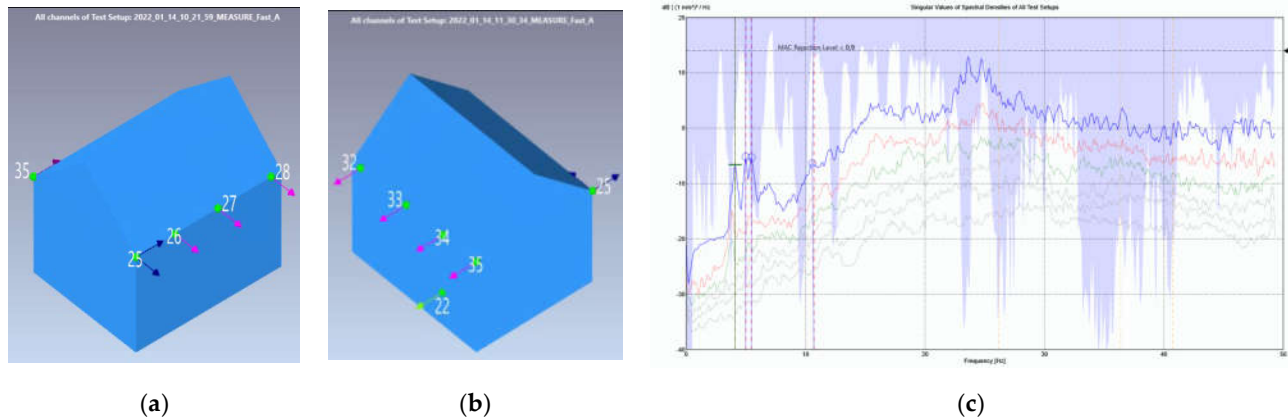
attic level, at the building corners, and on the long side. Reference sensors no.1 and 2 (in blue) are in the S–W corner of the building—ch. 1 dir. N–S (Y), ch. 2 dir. E–W (X) sensors no.3–6 moved from the South to the North side (Figure 9a). Sensor no.7 was used only in setup 2, at a lower level (Figure 9b). The singular value decomposition of the acquired data is shown in (Figure 9c).

Figure 9. (a) Set up no. 1; (b) Set up no. 2; (c) Singular value decomposition of the acquired data.

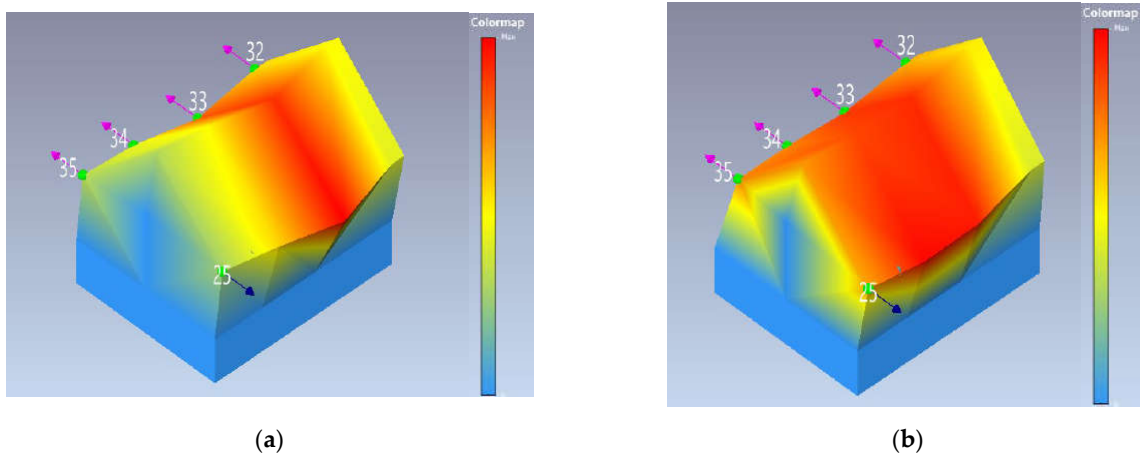
The first two modes were out-of-plane modes, the first one in bending and the second one translational (Figure 10a,b) both in the Y direction.

Figure 10. (a) 1st mode; (b) 2nd mode.

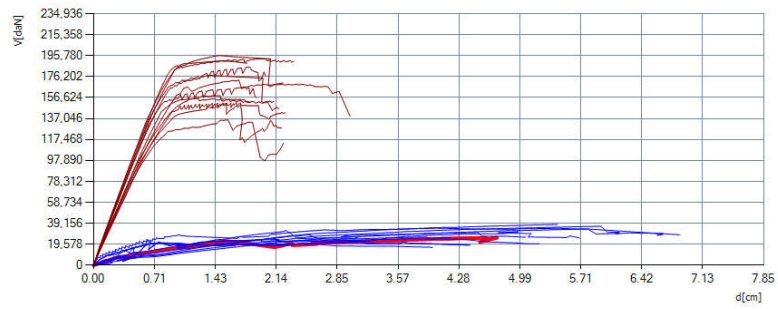
As a result, capacity curves are obtained for all the cases as presented in Figure 13. The structure has rather inferior resistance in the X direction, the appearance of the first crack was observed already at 95.70 kN, while the maximum reached load was 204.17 kN. The structure has rather superior resistance in the Y direction, with the first crack occurring at the force 13.30 times larger, and the maximum load reached was equal to 1468.35 kN, being 7.19 times larger than in the X direction. This can be connected to a large number of openings and a much lower percentage of load-bearing walls in the X direction.

Figure 13. Capacity curves in X and Y directions.

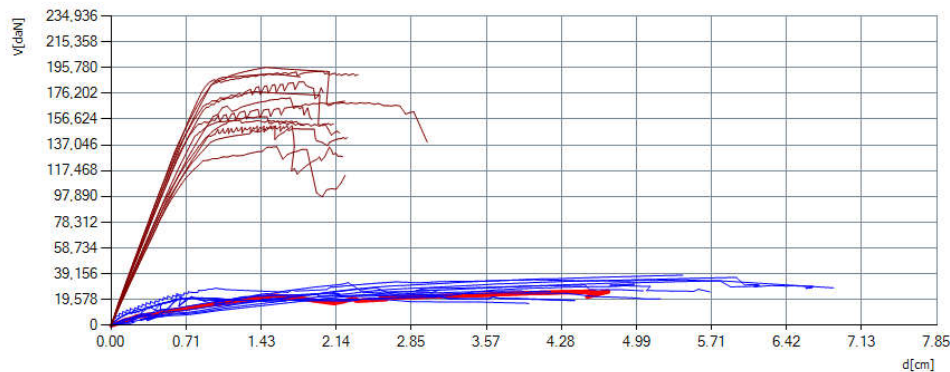
The capacity curves in the X and Y directions of the strengthened existing URM structure are presented in Figure 21. The first crack is noted at the value of 1152 kN in the X direction while the ultimate load reached 1345 kN. In the Y direction, the structure has a much larger capacity, and the occurrence of the first crack is noted at 2423 kN and the ultimate load reached 2549 kN.

Figure 21. Capacity curves in the X and Y directions of the strengthened structure.

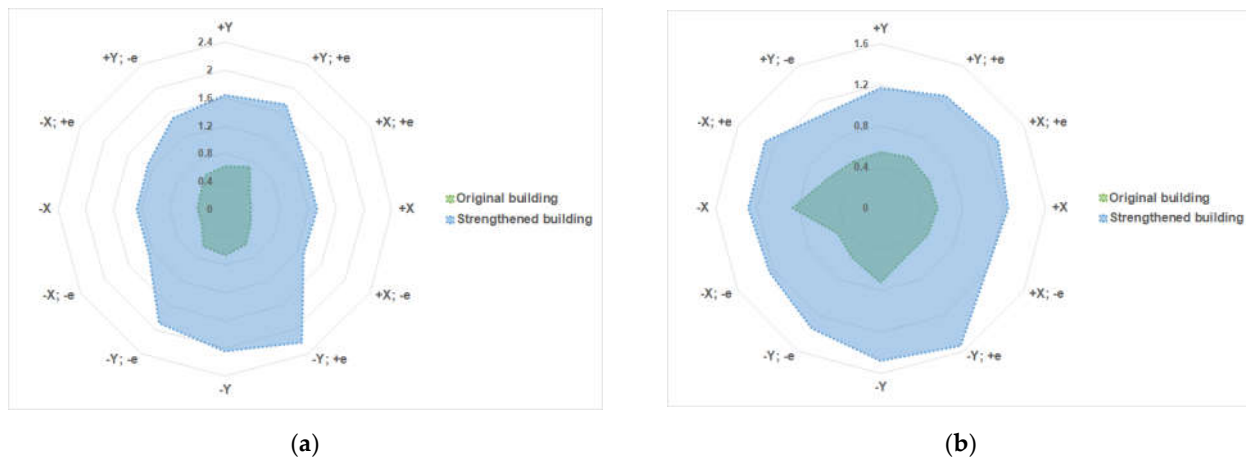
In order to see the effectiveness of the proposed strengthening methods, it is feasible to compare the capacity curves of the unstrengthened and strengthened existing URM structure under consideration. With the application of all given strengthening procedures, it was possible to increase the seismic capacity of the building in both directions. The inferior X direction was now upgraded so that the occurrence of the first crack happened at a load that is 12.04 times larger than for the unstrengthened structure. The increase in initial stiffness in the X direction was 6.4 times, while in the Y direction it was 1.4 times. Additionally, the ultimate reached load in the X direction is more than 6.5 times larger compared to the unstrengthened structure. The ultimate load reached in the Y direction increased by 75% in relation to the unstrengthened structure. It is important to state that the global eigenmodes did not change significantly and this is beneficial, as there should not be a major difference in this aspect. It was observed that now the mode shape in the X direction is translational, while in the unstrengthened structure there were unequal movements of the nodes. In this way, better structural behavior was obtained. The strengthened structure passed all the seismic verification. The value of α was greater than 1 for all the conducted analyses and limit states. The effect of the strengthening is shown in Figure 22 for the two load distribution patterns.

Figure 22. Comparison of α values for the original building and strengthened building for (a) uniform load distribution; (b) modal load distribution.
