# THE EFFECT OF NATURAL VENTILATION ON REDUCING RADON LEVELS WITHIN AN EXISTING DWELLING

Steve Goodhew, Paul Bird and Paul Murray  
University of Plymouth

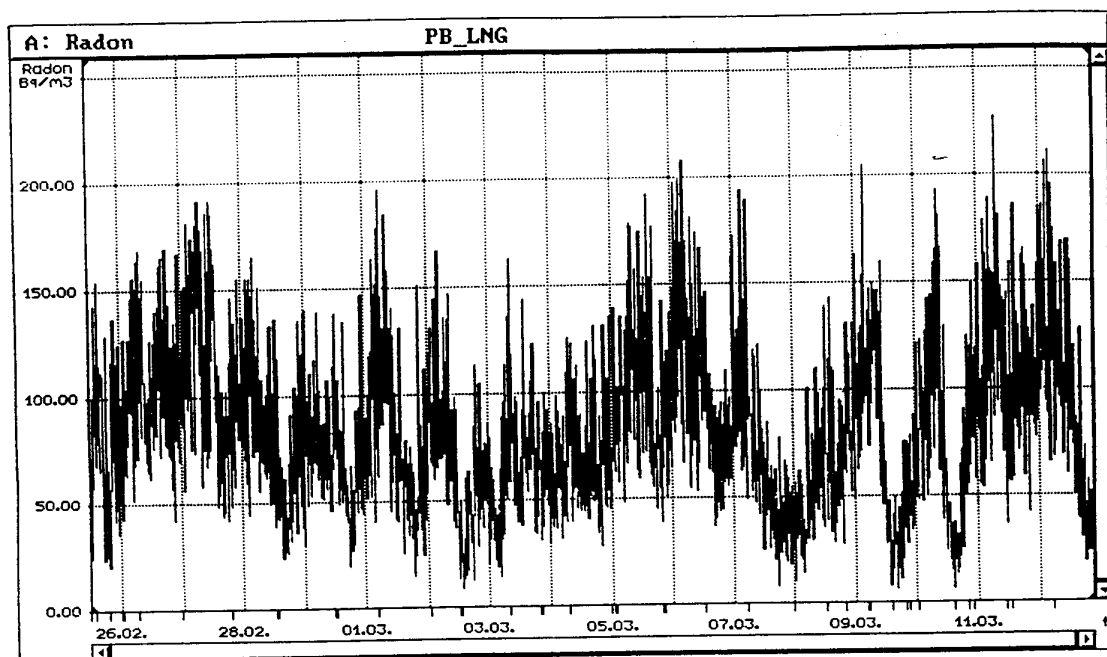
Fig 4 Radon Concentrations in the Test House - lounge, 26/2/96-11/3/96  $\text{Bq m}^{-3}$

A fourth series of tests was carried out in 1996 with the Alphaguard Radon Monitor (Genitron Instruments). Figs. 4 & 5 are results from the lounge, giving a (weighted) average of 86 Bq m<sup>-3</sup>. Bedroom 1 results are in Figs 6 & 7, averaging to Bq m<sup>-3</sup>. No attempt has been made to allow for seasonal variations in these figures and so comparison with earlier NRPB results must be made with

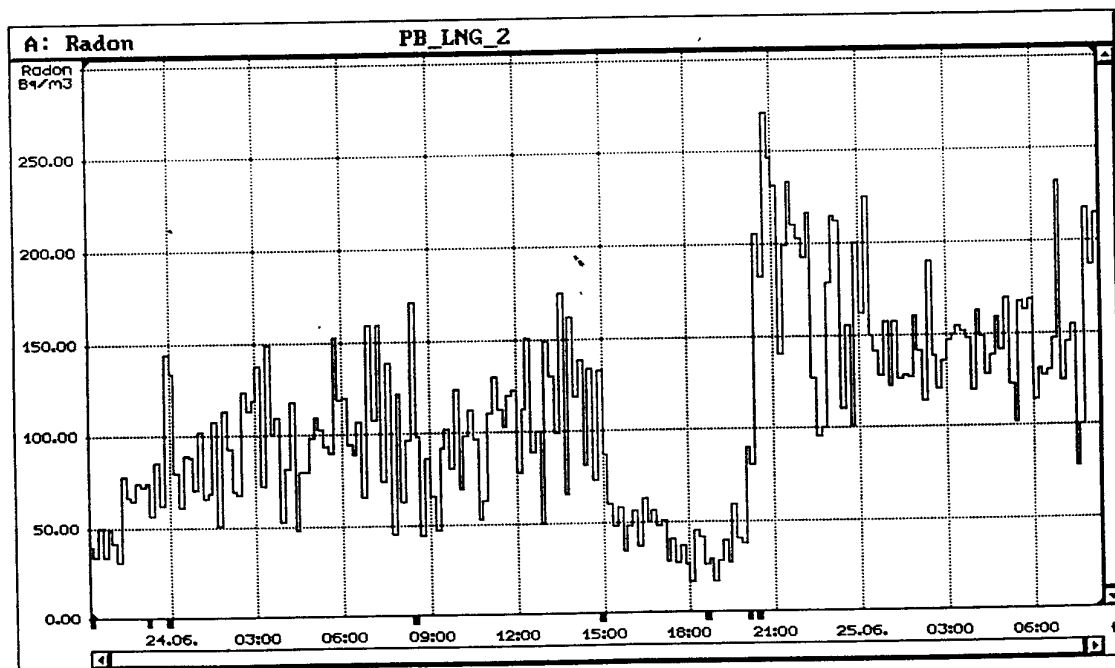
Fig 5 Radon Concentrations in the Test House - lounge, 24/2/96, daily cycle, Bq m<sup>3</sup>

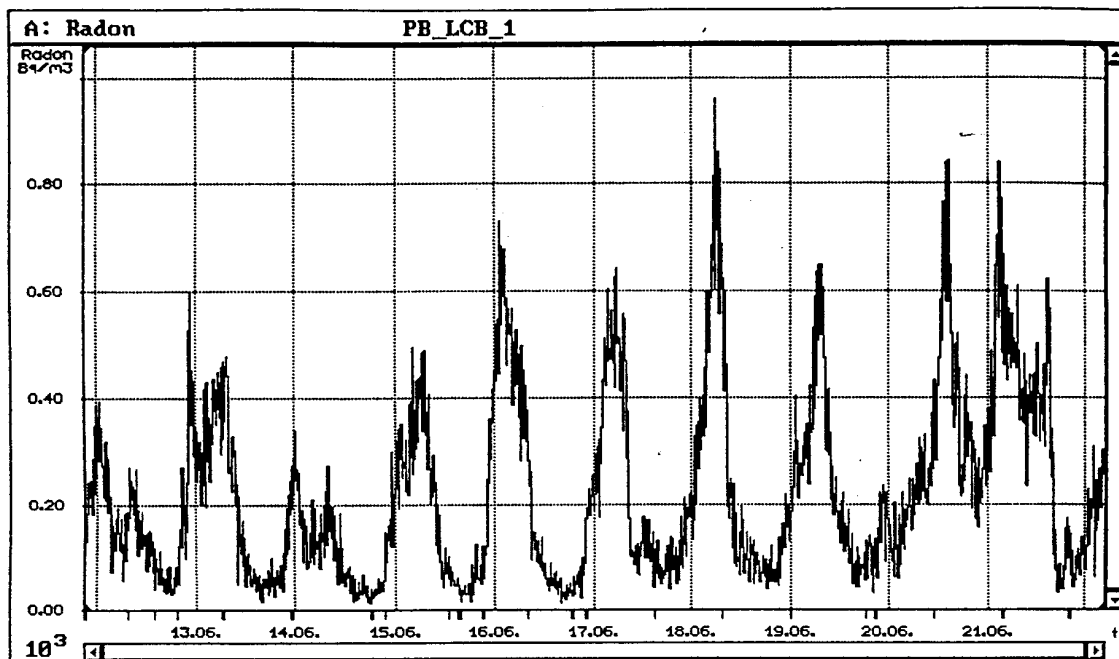
Fig 8 Radon Concentrations in the Test House - Under-stair Cupboard, 17/3/96-31/3/96 Bq m<sup>3</sup>

caution. Figs. 8 & 9 were taken in the lounge (under staircase) cupboard which is situated in the centre of the ground floor and has low rates of ventilation. Fig. 10a is from the bathroom, with 10b showing humidity over the same period. Radon levels in a carport and open courtyard outside the test house recorded a mean level of  $15 \text{ Bq m}^{-3}$  and  $5 \text{ Bq m}^{-3}$  respectively showing how very high rates of dilution by outside air reduce radon levels effectively to zero.

Third, it appears from Fig. 8a that there is no significant contribution to radon levels from the water supply. Closer analysis may reveal a correlation between the humidity peaks coinciding with baths and showers and radon levels, but it is clear from inspection that there is no strong relationship. A daily variation is very apparent from the records taken in the lounge cupboard. (Figs 8 especially, & 9). One would expect higher radon levels in this area of poor ventilation, but it is surprising why the peaks in the early hours should be so strong. The cupboard door is opened about five times a day. Apparently that causes sufficient air change to bring the night-time  $600\text{-}800 \text{ Bq m}^{-3}$  levels down to those typical of the lounge itself.

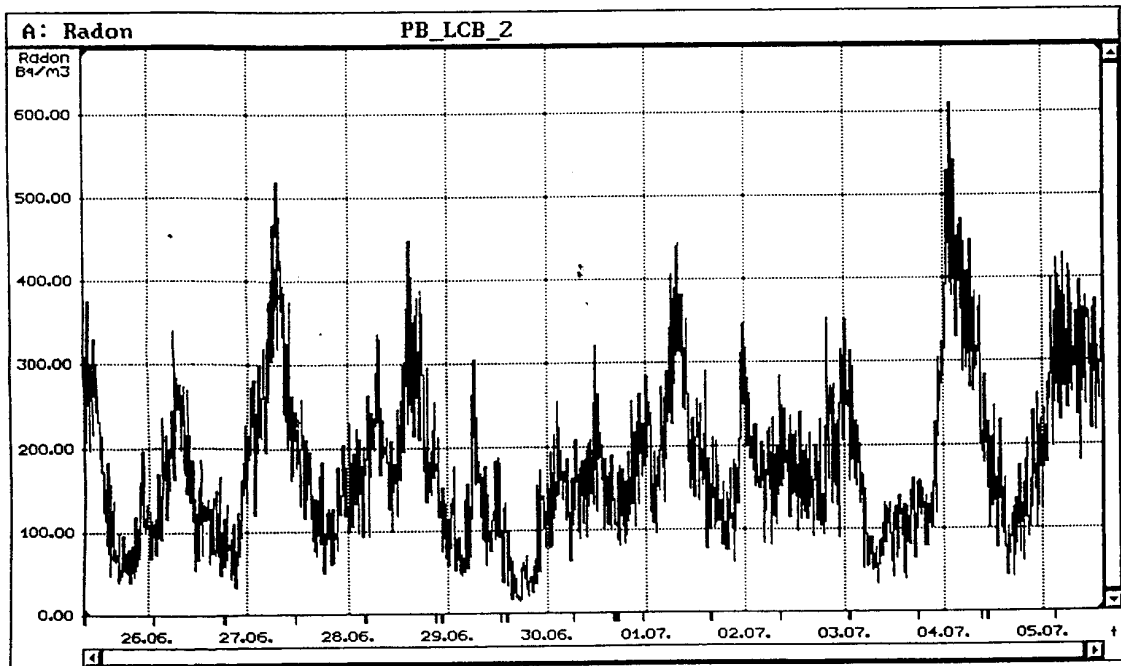
Fig 9 Radon Concentrations in the Test House - Under-stair Cupboard, 26/6/96-5/7/96 Bq m<sup>3</sup>

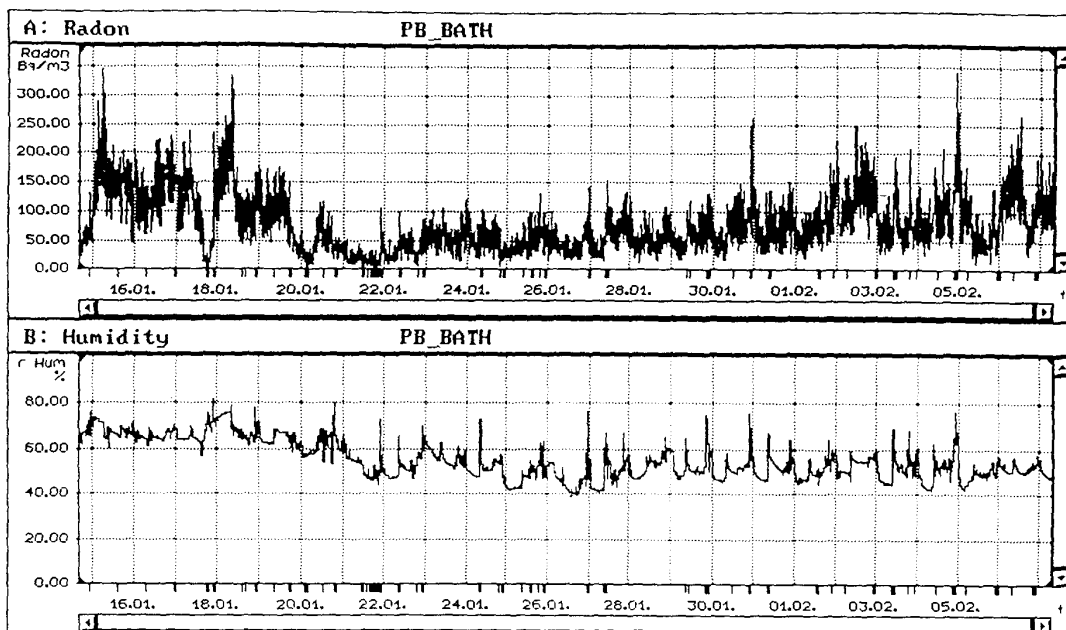
**Fig 10a & 10b Radon Concentrations and humidity levels in the Test House - Bathroom, 26/6/96-5/7/96**  
**radon measurements Bq m<sup>3</sup> & % relative humidity**
