RUNNING-IN BEHAVIOUR OF RAIL AND WHEEL CONTACTING SURFACES

J.LUNDMARK, E.HÖGLUND, B.PRAKASH

*Luleå University of Technology, Division of Machine Elements
SE-97187 Luleå, Sweden*

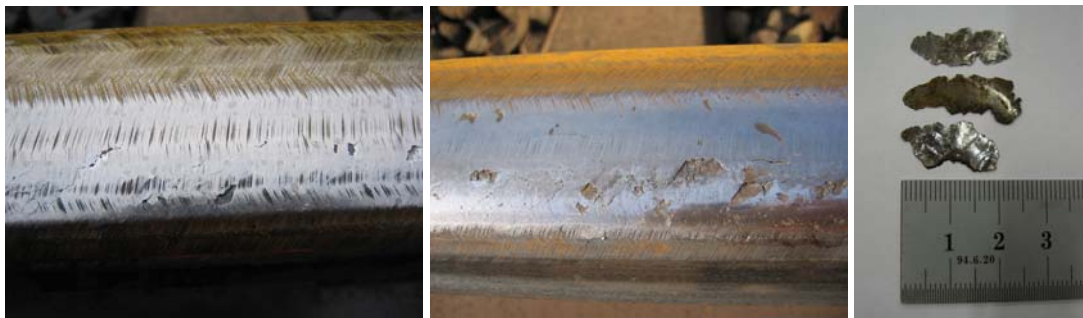
Figure 8: Surface fatigue cracks on high rail on the Malmbanan, 9th September and 15th September and worn-off flakes, (scale in millimetres).

The visual inspection of the rail directly after grinding revealed that surface fatigue cracks were still present, especially on the high rail. It was also found that an accelerated rate of flaking occurred after the rail was ground due to the presence of surface fatigue cracks, see Figure 8.

Samples of the flaked-off material were collected for hardness measurements. The micro-hardness measurements on these samples showed signs of work hardening. Six measurements were made on each of the four collected wear flakes and the mean hardness of all wear flakes was ~ 502 HV at 300g load, which is substantially higher than the original hardness of the UIC 1100 rail (340-380HV).
