# Corrosion behavior and protective performance of robustness mineralized layer formed on AZ80-0.38Nd (wt%) alloy

In our previous work, a novel robustness mineralized layer was prepared on surface of AZ80–0.38Nd (wt%) alloy, which mainly consisted of rod-like structure  $\text{MgCO}_3 \cdot 3\text{H}_2\text{O}$  and flake structure  $4\text{MgCO}_3 \cdot \text{Mg}(\text{OH})_2 \cdot 4\text{H}_2\text{O}$ . The mineralized layer exhibited outstanding robustness structure. While its corrosion protection for magnesium alloy has not been explored. In this paper, the corrosion behavior and protective performance of the robustness mineralized layer were investigated via hydrogen evolution and electrochemical measurements, systematically. The results show that the mineralized layer exhibited excellent anti-corrosion property in the NaCl solution compared with the oxide layer, due to the outstanding impermeability. And the mineralized layer presented better corrosion passivation and micro-galvanic corrosion inhibition effects due to the characteristics of slight defects and good adhesion to matrix. Besides, the mineralized layer could launch  $\text{CO}_3^{2-}$  during degradation of corro

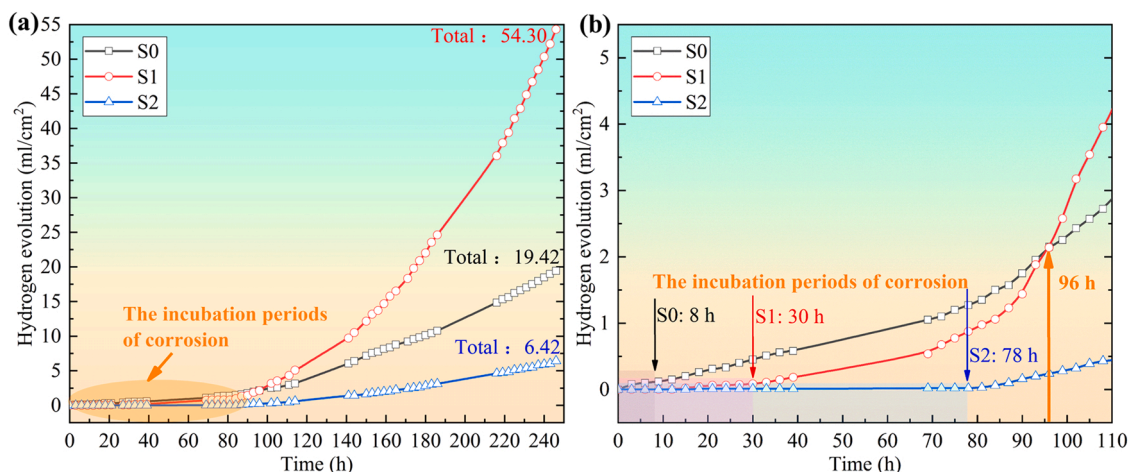
Fig. 6. Hydrogen evolution curves of test samples immersed in 3.5 wt% NaCl solution: (a) 0–246 h and (b) 0–110 h.

Fig. 6 illuminated the hydrogen evolution curves of S0, S1 and S2 with the immersed time extension. Even though samples all exhibited an increase in the volume of hydrogen with the whole time of immersion, remarkable differentiation could be observed in the corrosion behavior, which reflected the significant difference of corrosion resistance. Fig. 6 (a) showed that two corrosion stages containing the incubation period of corrosion and accelerated corrosion were included of all samples as the corrosion process advanced. The incubation period of corrosion corresponds to quite low corrosion rates. And the incubation periods of S0, S1 and S2 were 8 h, 30 h and 78 h, respectively, as shown in Fig. 6(b). Besides, after 246 h immersion, the total hydrogen evolution volumes of S0, S1 and S2 were  $19.42 \text{ ml/cm}^2$ ,  $54.30 \text{ ml/cm}^2$  and  $6.42 \text{ ml/cm}^2$ , respectively. In addition, as the incubation period of corrosion and the total  $\text{H}_2$  evolution volume of S1 was 30 h and  $54.30 \text{ ml/cm}^2$ , the oxide

layer showed corrosion protective performance in the initial period of immersion. Subsequently, corrosion of S1 achieved higher rate owing to the defects of oxide layer and less protective products film. The corrosion preferentially started and grew at the defect sites, such as the cracks and holes as shown in Fig. 3(c,d). The result in Fig. 6(b) indicated that the oxide layer could provide 96 h protectiveness for magnesium substrate. Similar results were also reported in our other work [22]. And based on the above results and discussion, it can be concluded that S2 showed the best corrosion resistance which means the best corrosion protective performance of the mineralized layer.

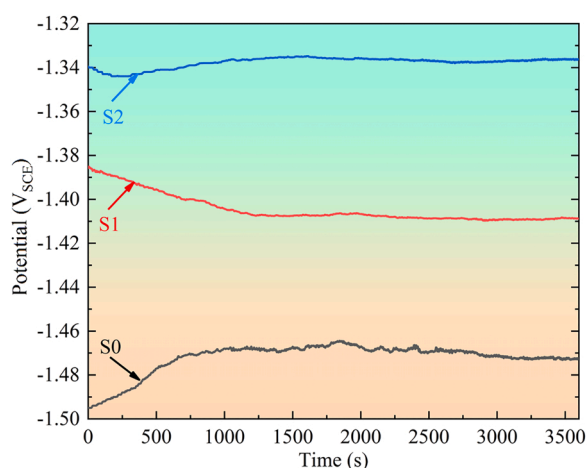
Fig. 7. Evolution of the OCP for S0, S1 and S2 samples in 3.5 wt% NaCl solution during 1 h of immersion.

Fig. 7 exhibits the evolution of the OCP for samples in 3.5 wt% NaCl solution during 1 h of immersion. The three samples showed quite different behaviors, with the OCP drifting to more positive or negative values as immersed time elevated. The OCP of S0 drifted to more positive values with the extension of immersed time. This increase was obvious within the first 1000 s of testing. Then, the OCP tended to be stable. It is obviously that S1 displayed higher OCP values than S0 for all the time, but the OCP of S1 drifted to more negative values as immersed time extension, which was in direct contradiction to that of S0. This decrease was obvious within the first 1250 s of testing. Then the OCP tended to be stable. S2 showed the most special OCP behavior compared with S0 and S1. The OCP of S2 drifted to more negative values within the first 250 s, then to more positive values within 1250 s, after that the OCP tended to be stable. It should be noted that S2 exhibited the highest OCP values for all the time among the three. The more positive OCP values of magnesium alloy could be associated with a more noble behavior, thus with a higher corrosion resistance [27]. Accordingly, S2 demonstrated the noblest behavior and the highest corrosion resistance.

Report revealed that a drifted OCP value depicted the beginning and extension of corrosion, nevertheless a relatively stable OCP value indicated a stable state between the deposition of corrosion products and the advance of corrosion [28]. Thus, the OCP profiles suggest that at the initial period of immersion in 3.5 wt% NaCl solution, a relatively stable corrosion film formed on samples surface, which shifted the corrosion potential (OCP) in the noble direction. On the contrary, the slightly dissolution and immediate destruction of oxide, mineralized or corrosion product films in the  $\text{Cl}^-$  contained solution resulted in shifting of corrosion potential (OCP) in the humble direction. The result showed in Fig. 7 indicated that dissolution and rupture of the mineralized layer might occur at the initial period of corrosion, while the corrosion products could repair the dissolution and rupture of the mineralized layer and corrosion passivation formed, meaning formation of a substantial uniform corrosion resistance film. Hence, S2 showed the best corrosion resistance.
