Ten-year persistence of native plant species on a green roof in Northeast US

Lubell JD, Connolly B, Jones KN. 2017. Ten-year persistence of native plant species on a green roof in Northeast US. *Native Plants Journal* 18(3):227–234.

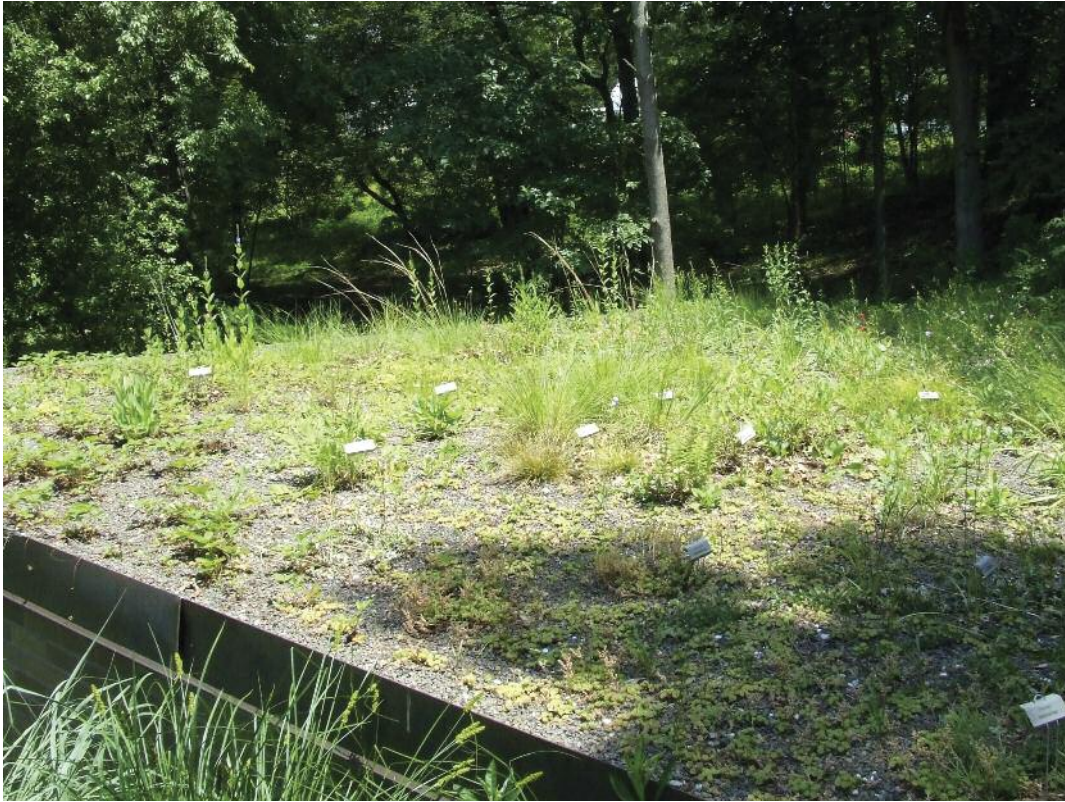
Figure 1. Wellesley College Water Treatment Facility green roof in August 2008.

In July 2016, 10 y after the green roof was installed, we assessed plant survival (Figure 1, Figure 2). The green roof was sectioned into 9 belt transects, 1 m (3.3 ft) wide, and each transect was meticulously surveyed for all plants present. We recorded the presence or absence of each of the 28 original native species per transect. For each of the 28 species, we determined plant status based on the total number of transects in which the species were found, where presence in 7 to 9 transects indicated the plant had expanded greatly, 5 to 6 transects indicated the plant had expanded slightly, 1 to 3 transects indicated the plant had declined, and 0 transects indicated the plant had perished. Over the 10-y study period, emergent species, both native and nonnative, colonized the green roof, and their presence in transects was noted. For emergent species, we described plant status as *present* for plants found in 1 to 5 transects and *thriving* for plants found in 6 to 9 transects.

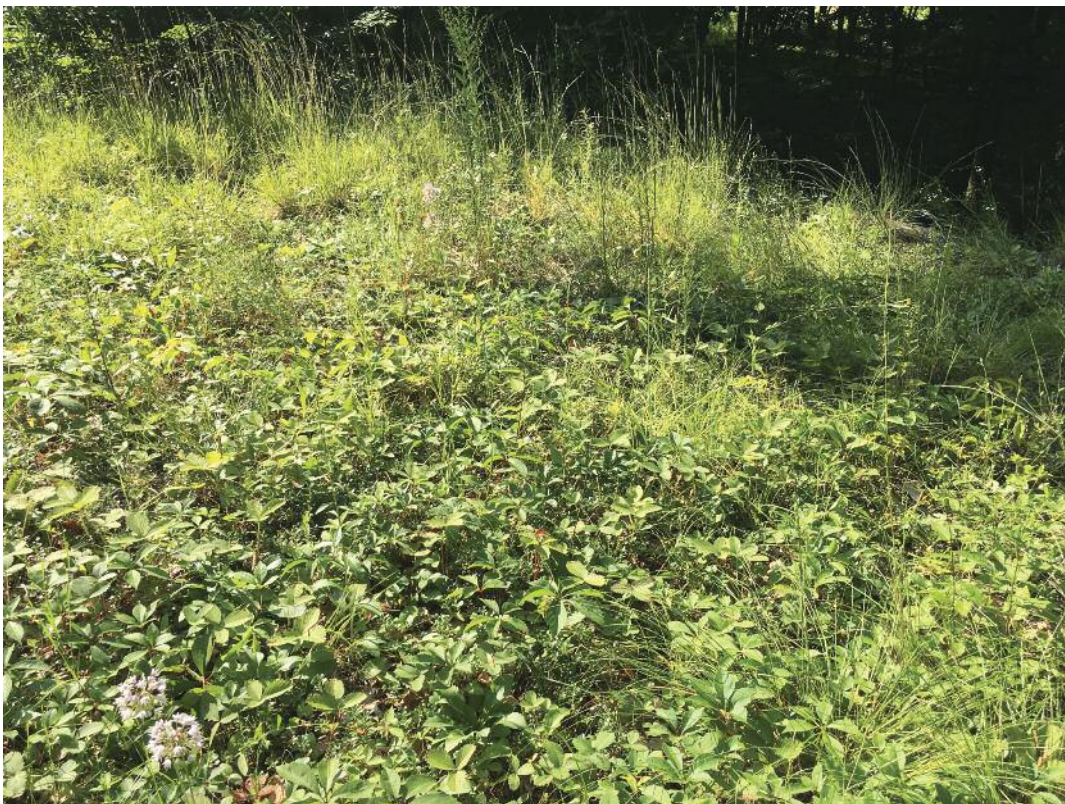
Figure 2. Wellesley College Water Treatment Facility green roof in August 2017.
