## Stability and Stiffness Contribution of the masonry in the Borbone Anti-seismic System

**ABSTRACT:** The Borbone construction system, comprises of masonry panels reinforced within a timber frame, originated in the Calabria region at the end of '700. The buildings with such anti-seismic technology have been subjected to general checks after the 1905 and 1908 catastrophic earthquakes, showed high resistance to the dynamic actions. This ductile behaviour was witnessed by several historical photos and by important scholars of the time. The system represents the synthesis of the scientific knowledge on the anti-seismic engineering of the XVIII C, in which the masonry confers stiffness to the timber frames and contemporaneously it dissipates seismic energy through the friction generated among the component elements. The timber structure role is to limit or to make reversible the displacements generated in the masonry mass in case of seismic acceleration.

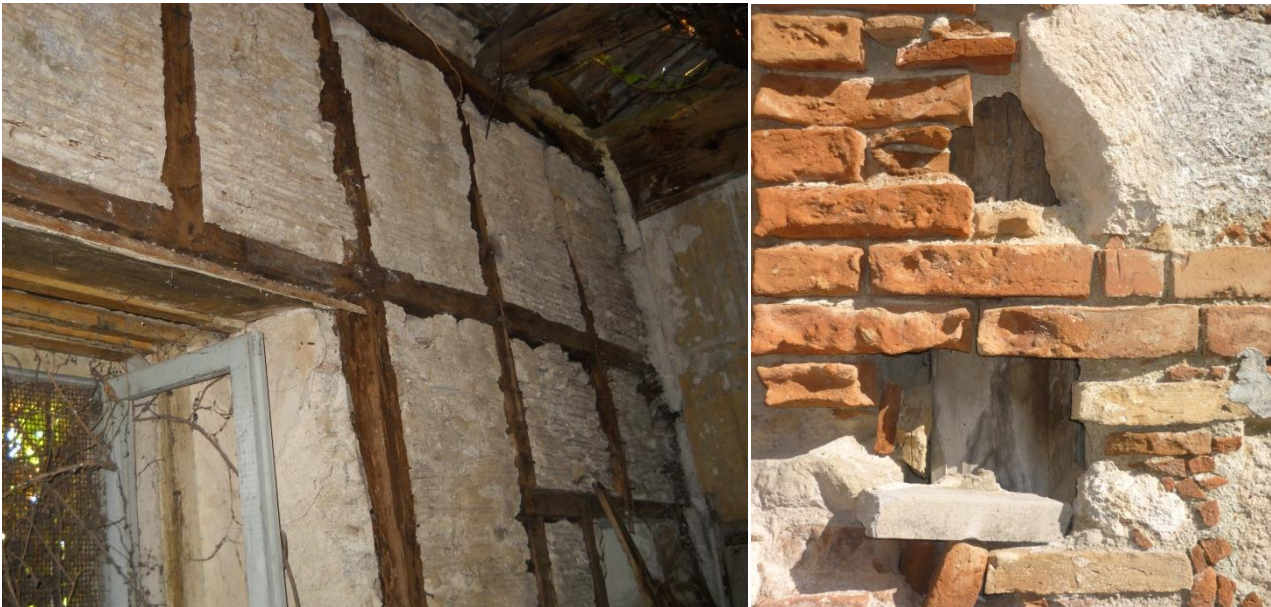
**Figure 1.** Different types of timber frame arrangement. The framing is placed in the internal (on the left) and in the external part of the wall on the right.

The Borbone system was developed in a variety of ways during the reconstruction after earthquakes, characterized by different arrangements of the timber frames and by diverse geometric dimensions of the members (Figure 1). In fact, some examples present in the Calabria region are characterized by Saint Andrew wooden crosses, other types in which the stiffness to in plane action is provided by only the masonry infill. Other *baraccati* edifices exhibit a double timber framing suitably bonded through transverse members. Among possible variations around the "*ossatura di grossitravi*", the location down the wall of the timber frames inside the masonry wall varied and in some cases, the wall was made out of more than one leaf. These if not properly bonded by means of lateral elements, usually stone, are vulnerable under seismic action perpendicular to the wall, with possible overturning of the outer leaf even under low and moderate earthquake conditions.

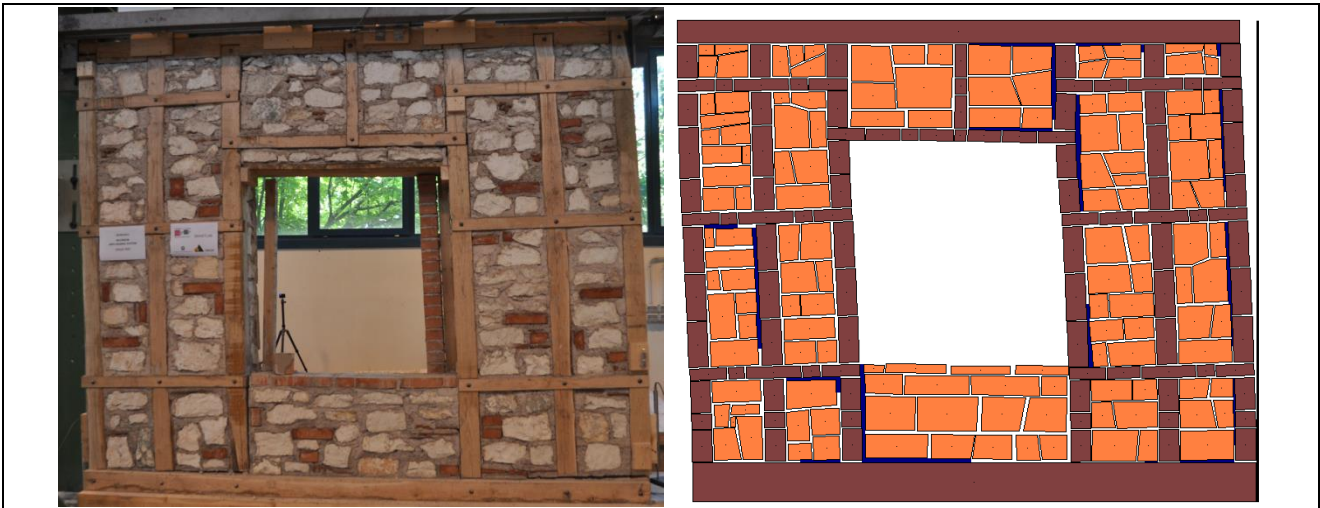
**Figure 9.** Ultimate deformed shape and cracking pattern. Comparison between experimental test and numerical modelling.

The final results for a load applied at the top equal of 103,64 kN were achieved after 311 iterative steps of the calculation algorithm with a final horizontal displacement, measured at the top of the specimen, equal to 59,90 mm, very close to the actual one.

It is interesting to notice how, in terms of fracture and detachment, the crack pattern produced as the output of numerical analysis has shown a significant similarity with the real one (Figure 9).
